VIRTUAL MEETING OF THE ADVISORY PARKING COMMITTEE
WEDNESDAY, June 2, 2021 @ 7:30am
<https://zoom.us/j/98209276859> or dial: 877 853 5247 US Toll-free,
Meeting ID: 982 0927 6859

As requested, Wiss, Janney, Elstner Associates, Inc. (WJE) has completed limited condition assessments of the North Old Woodward, Park Street, Peabody, and Chester parking structures. These assessments were performed with the intent to determine the current and future infrastructure needs in support of a capital improvement plan; the intention of the plan is to extend the useful life of the structures and to maintain the structural integrity to ensure the structure can support the code-prescribed loadings. This report summarizes our observations at the Chester Parking Structure, located at 180 Chester Street in Birmingham, Michigan, and provides recommendations for your consideration.

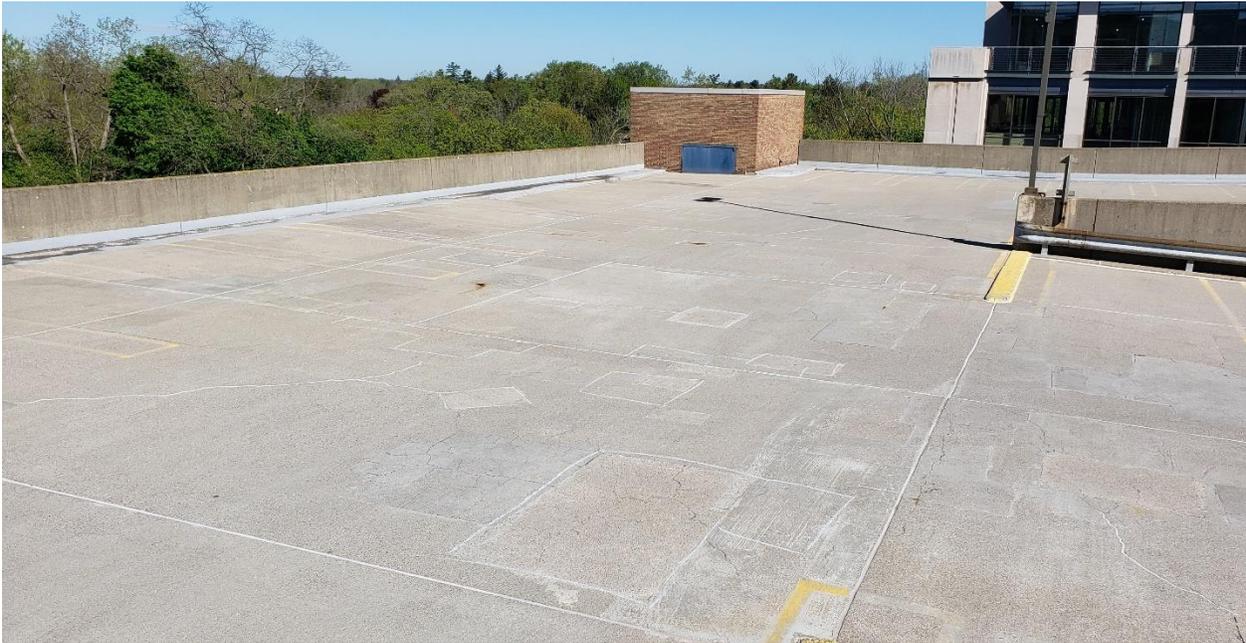
Figure 4. Partial overview of Level 5 with multiple locations of unsound concrete outlined in chalk.

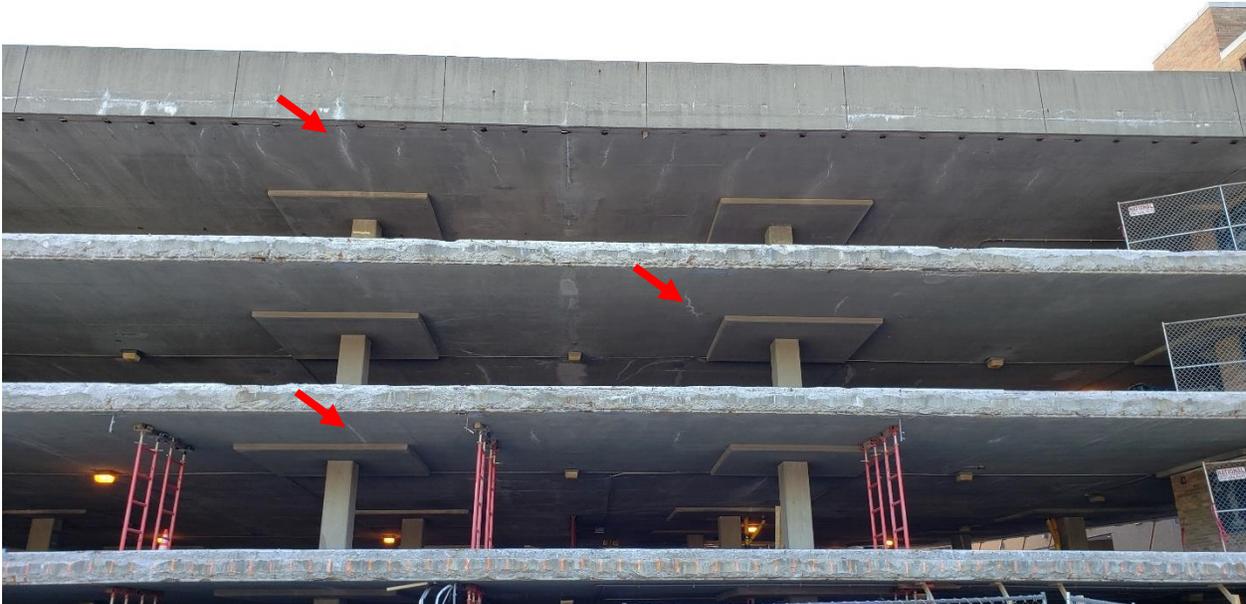
Figure 5. West elevation during slab edge repairs. Note the multiple cracks with efflorescence. A few locations are indicated by arrows. This photo was taken during the installation of the cable barrier system.

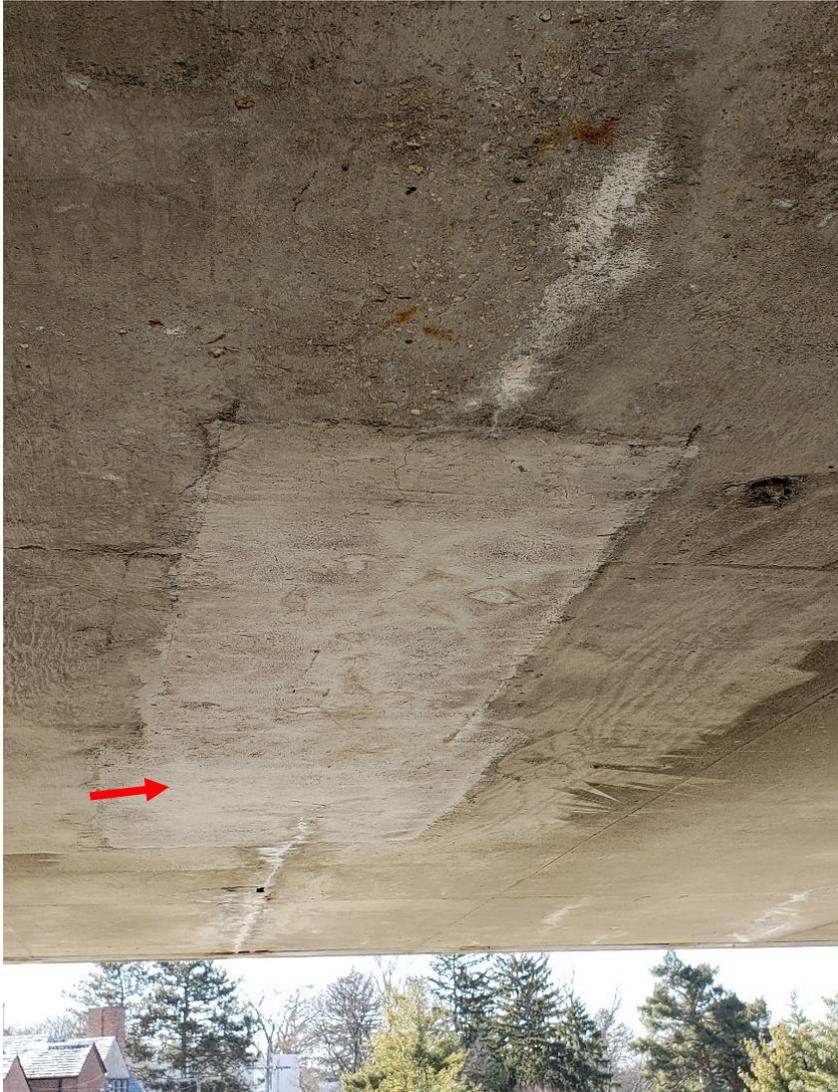
Figure 6. Previous concrete repair and unsound concrete (indicated by the arrow) in line with a crack with efflorescence.

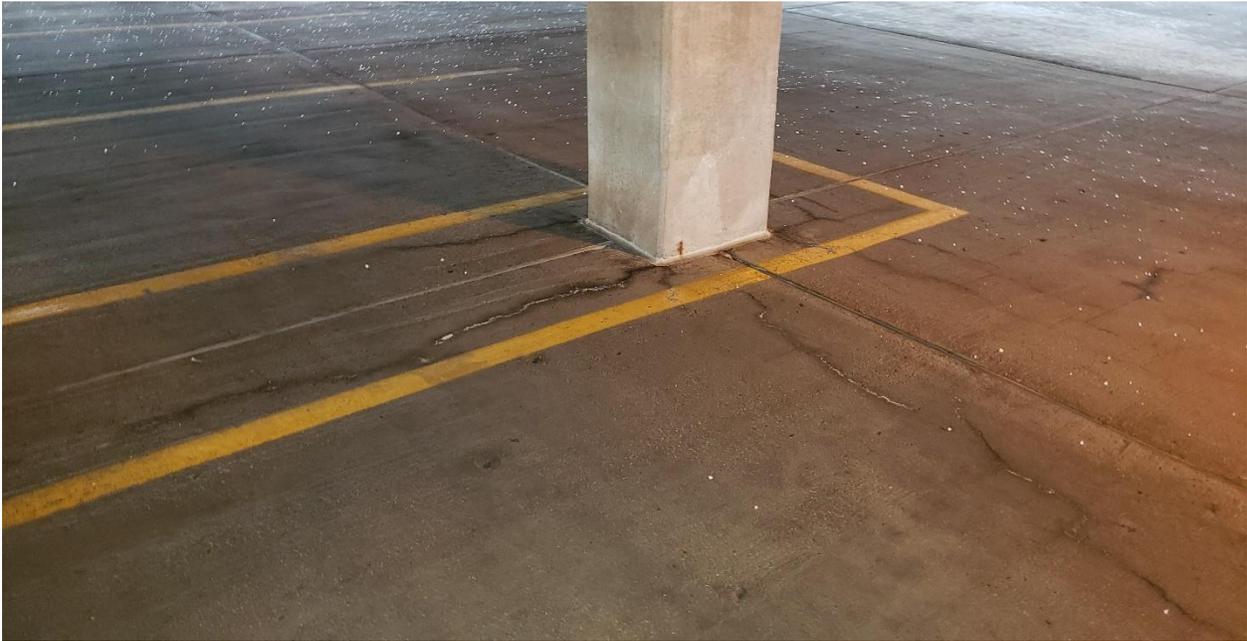
Figure 7. Radial cracks extending from a column.

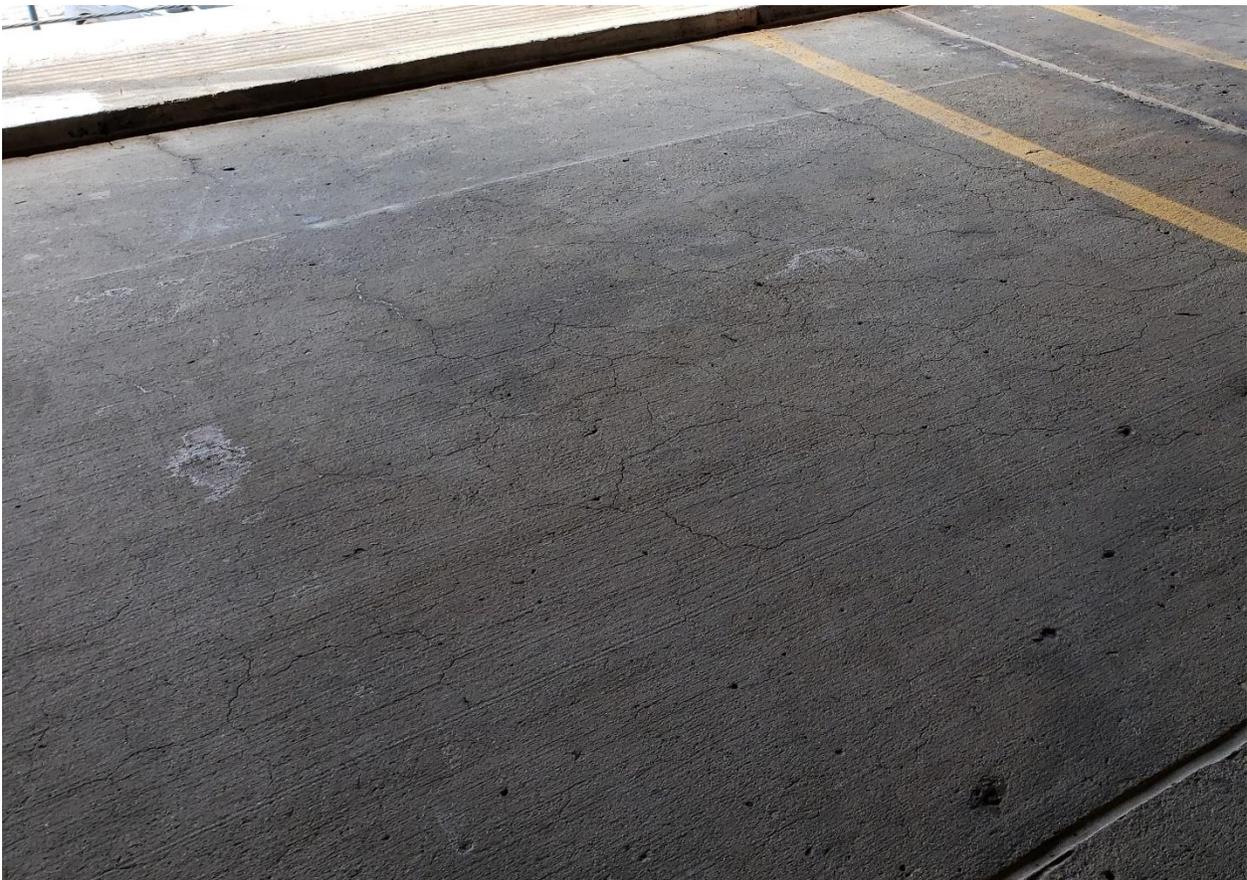
Figure 8. Example of crazing cracks on the top surface of a concrete slab.

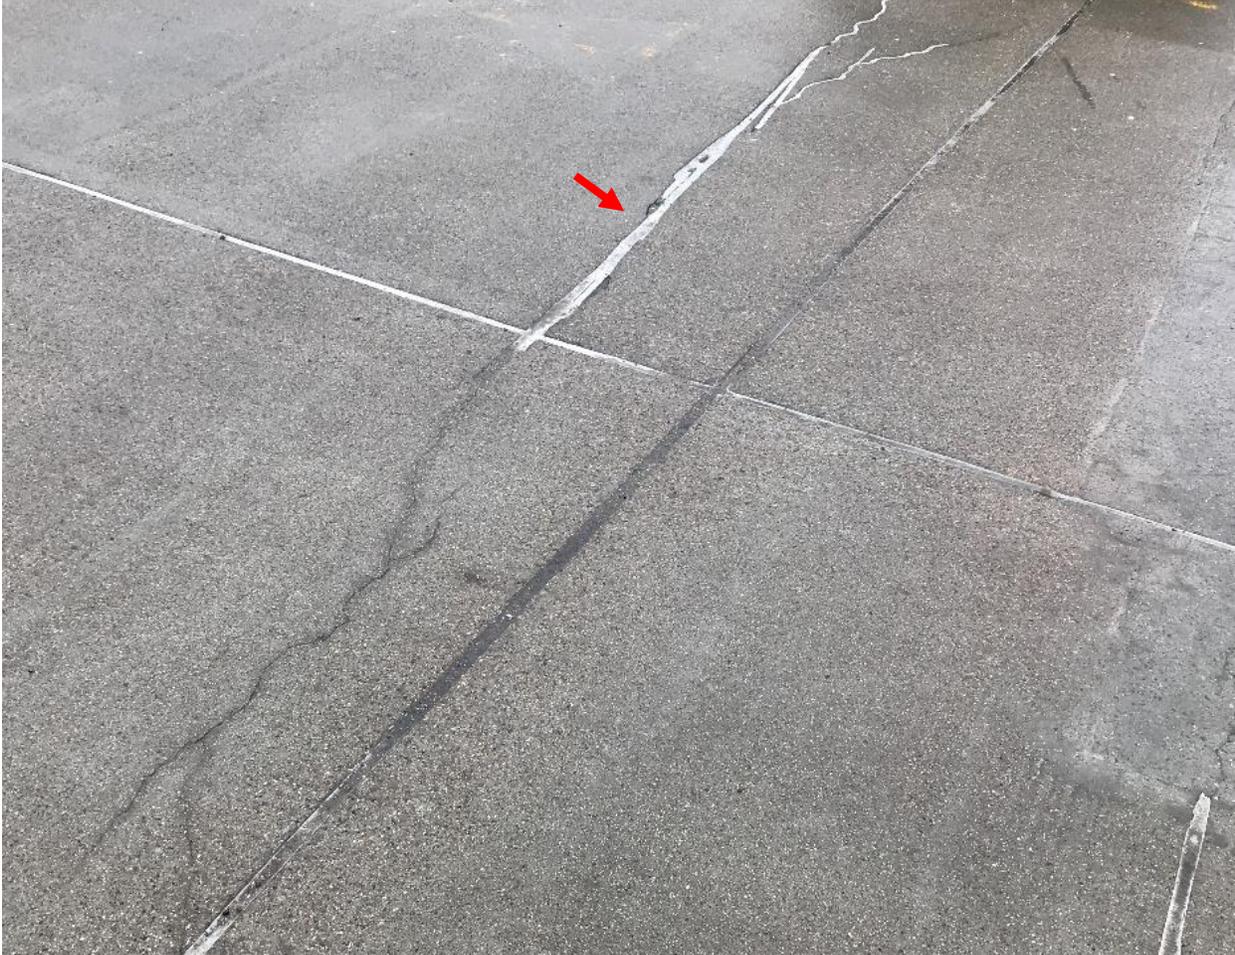
Figure 9. A crack propagating beyond an existing sealed crack. Note a location adhesion failure indicated by the arrow.

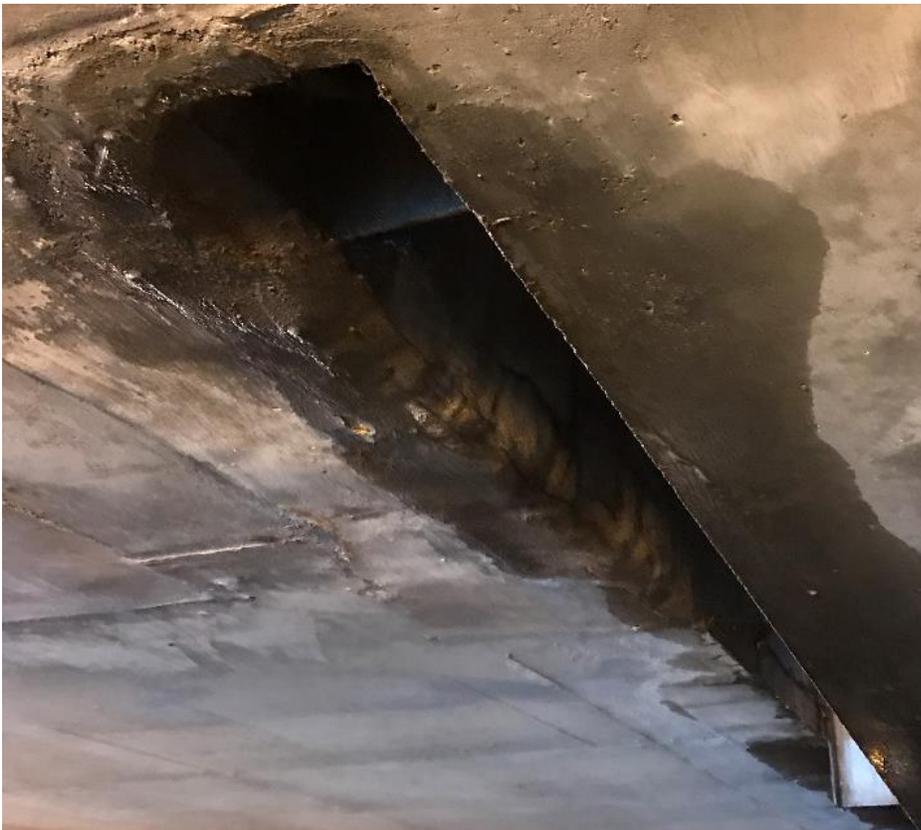
Figure 12. Unsound and cracked previous repairs at the interior slab edges.

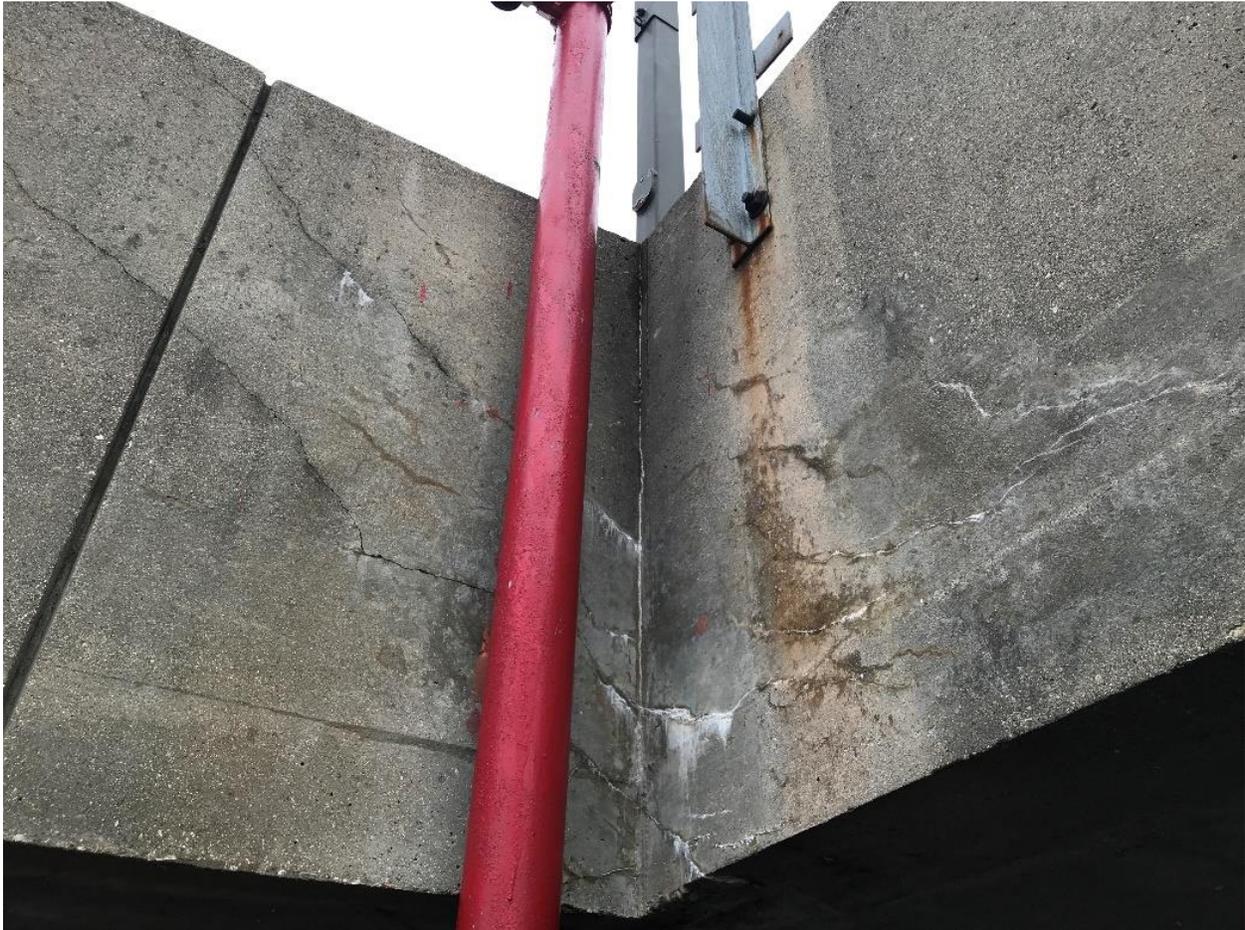
Figure 17. Cracking with efflorescence at the wall corner above the top ramp.

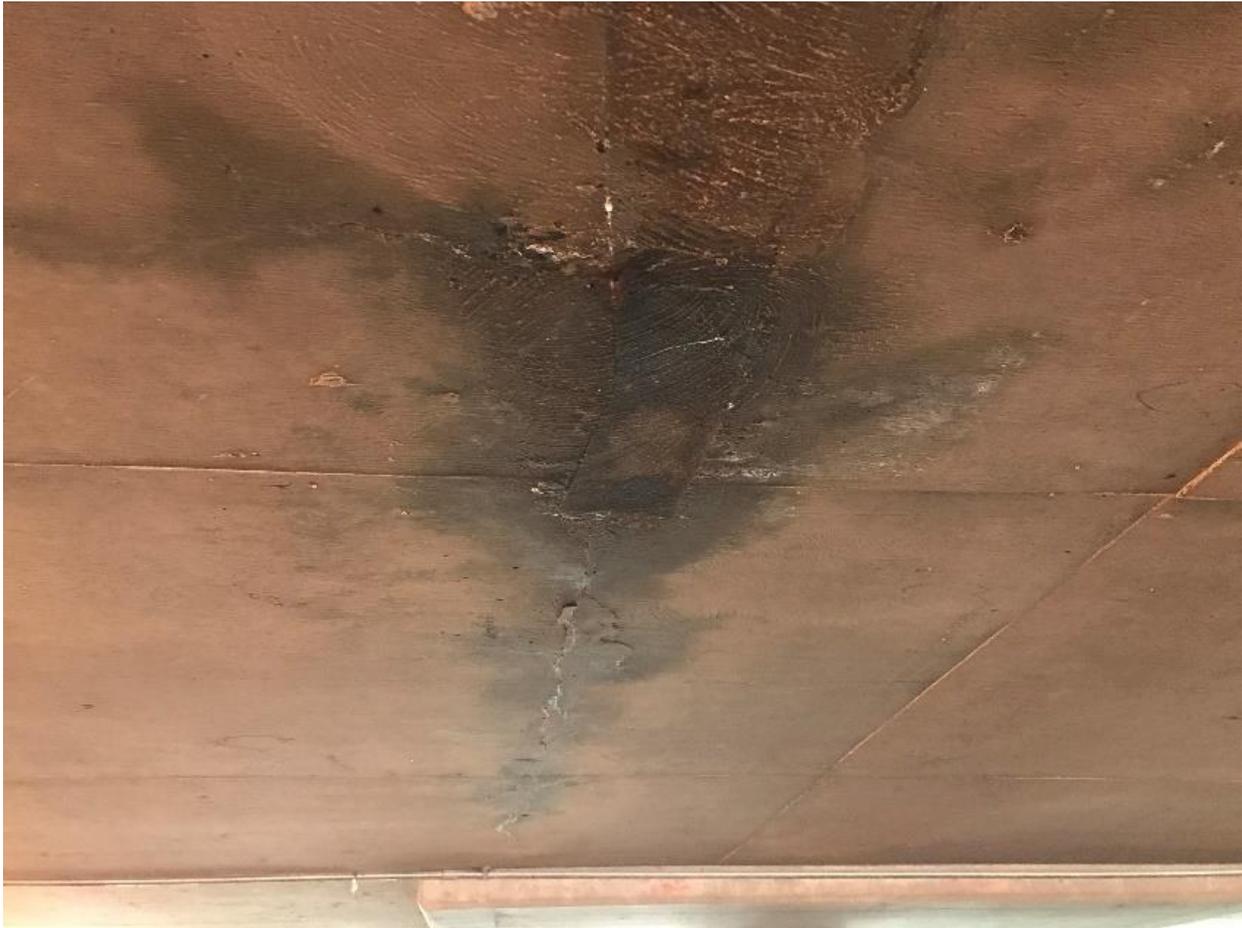
Figure 20. Active water leak at a previous repair area.

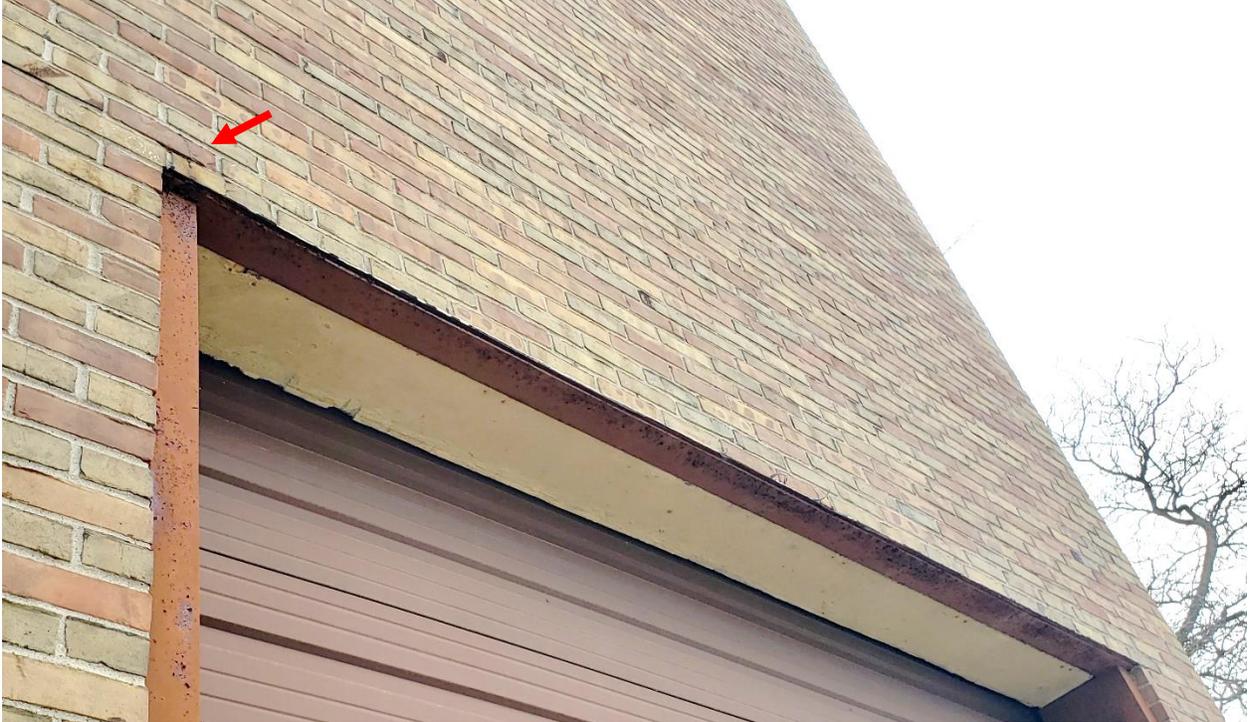
Figure 23. Corroding steel lintel and cracked brick masonry at ends (indicated by the arrow).

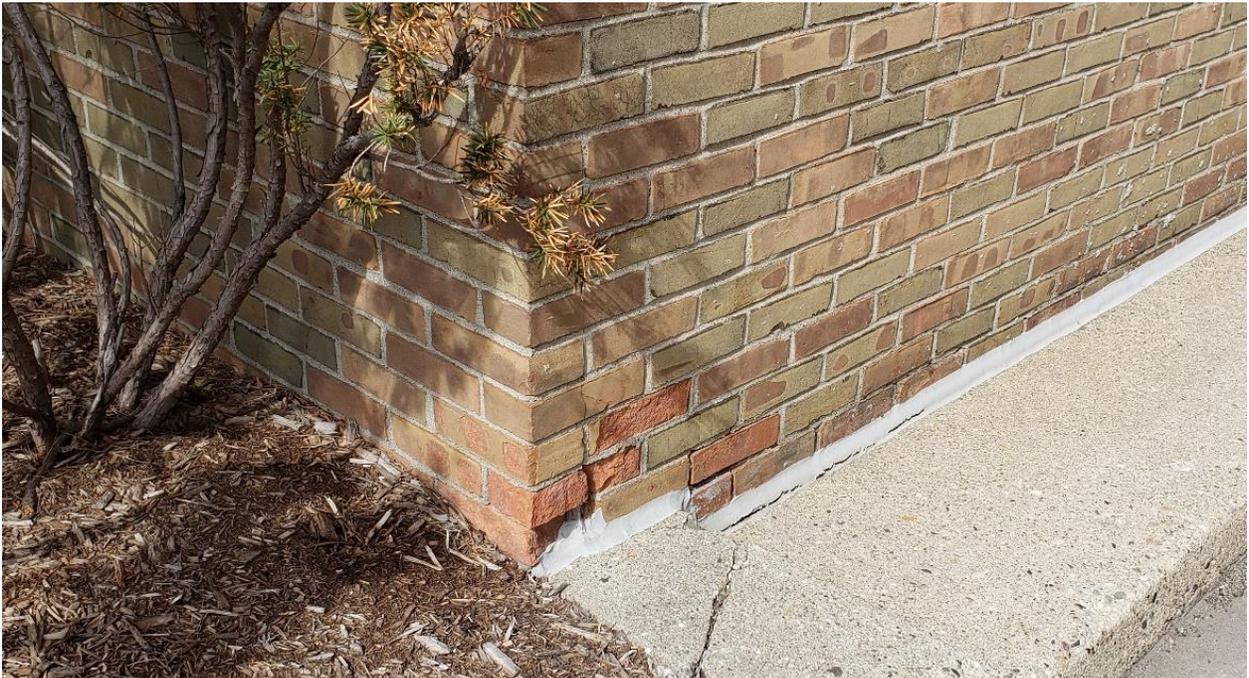
Figure 24. Spalled brick masonry at exterior of a stair tower.

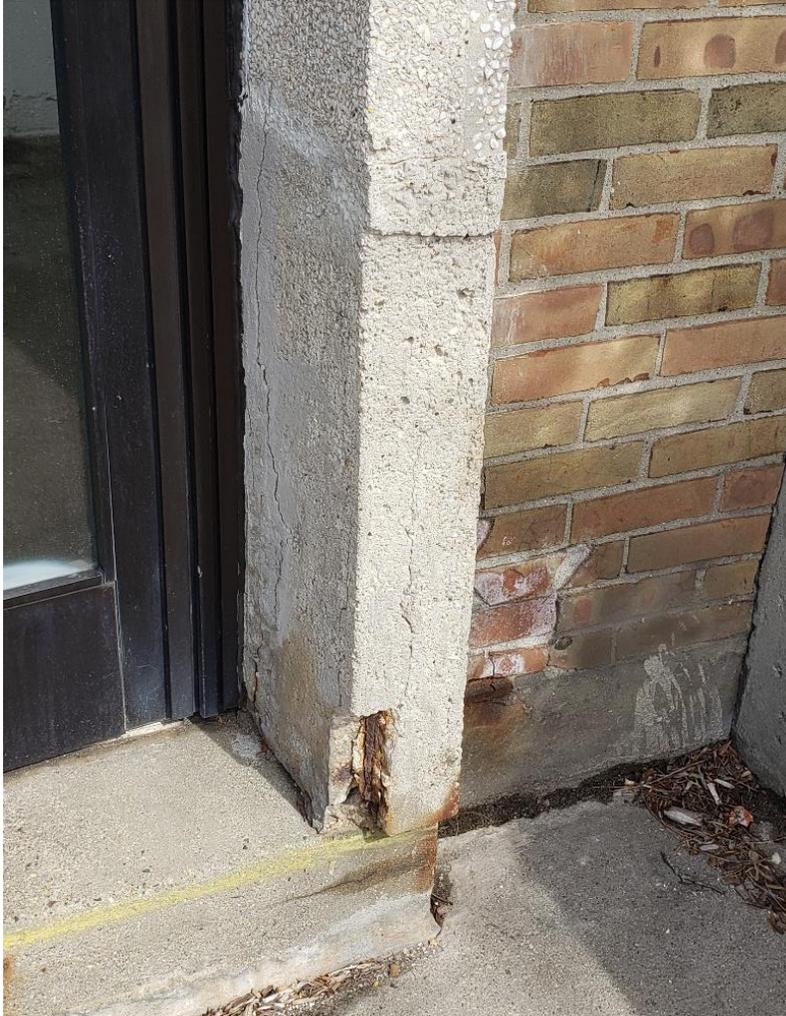
Figure 25. Cracked and spalled concrete panel at entrance door.

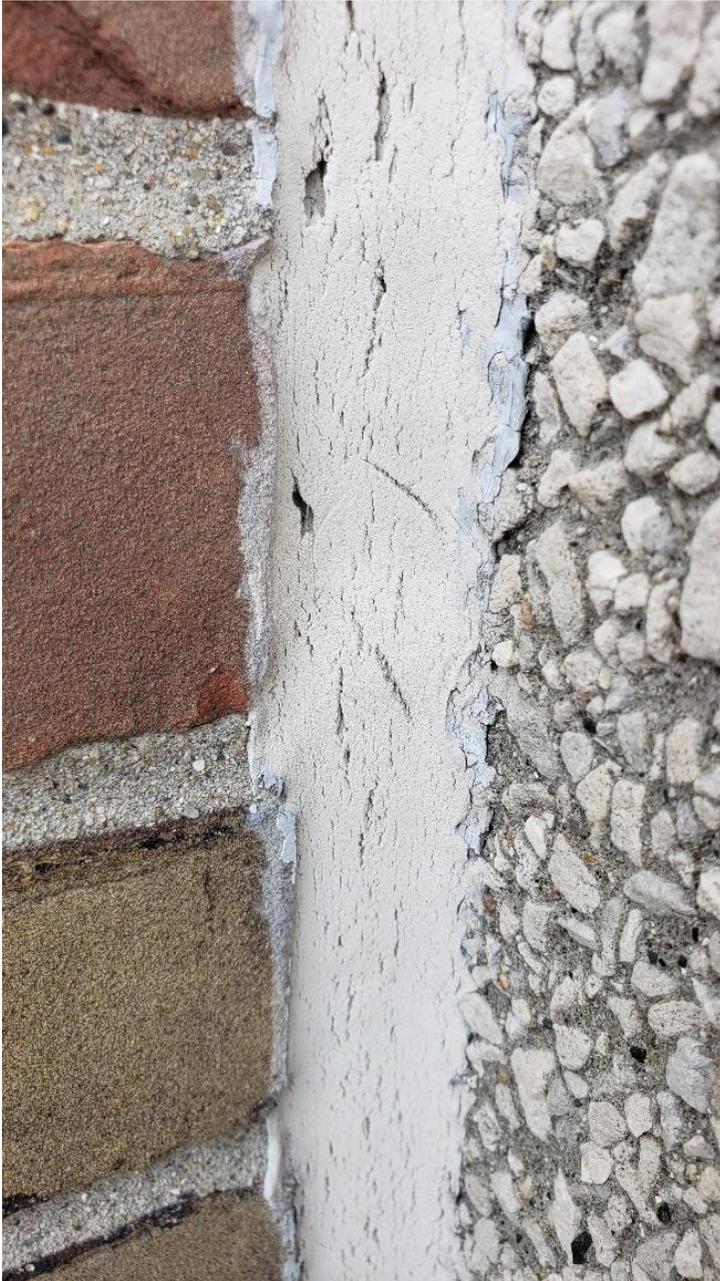
Figure 26. Cohesive and adhesive failure of cove seal.

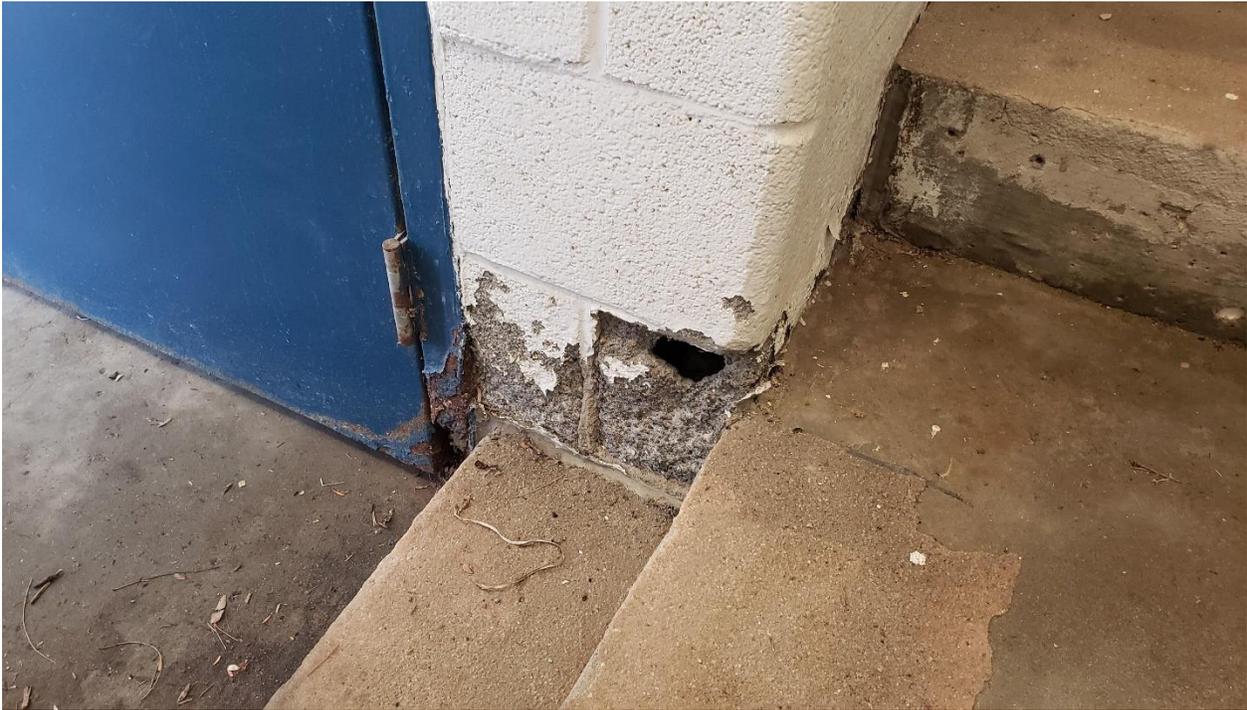
Figure 27. Deteriorated CMU blocks at the base of the stair.

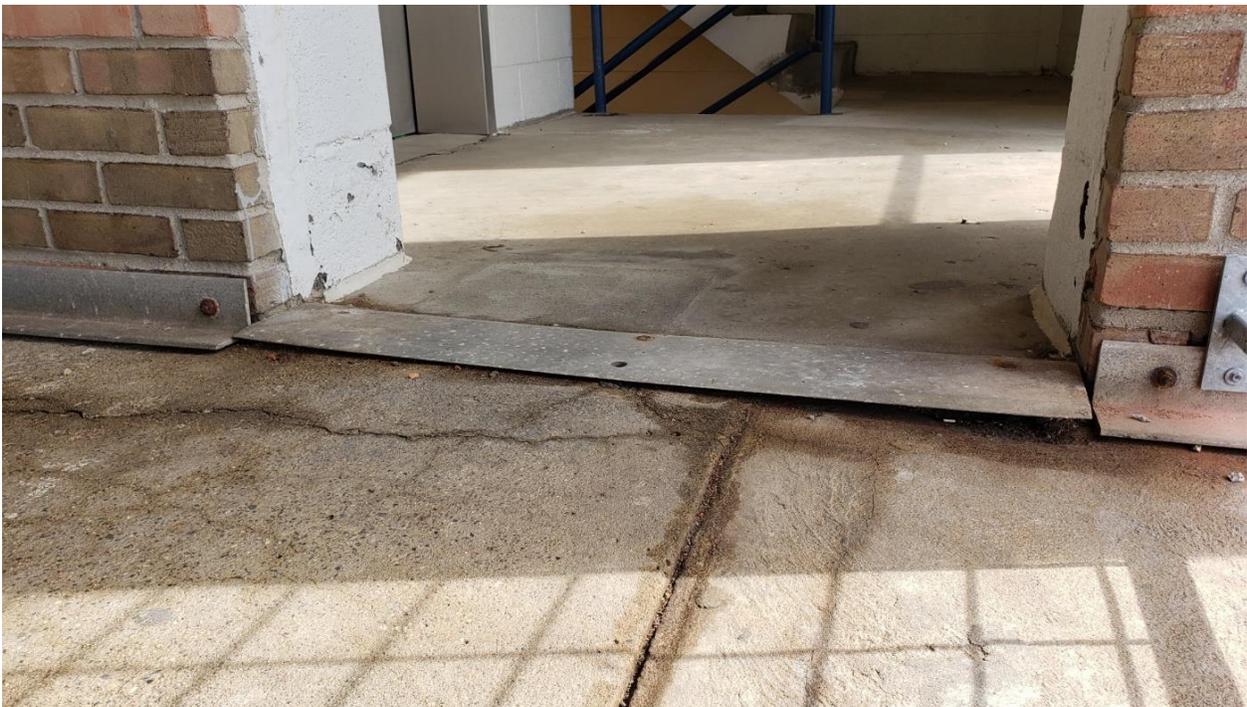
Figure 28. Loose cover plate with gap.

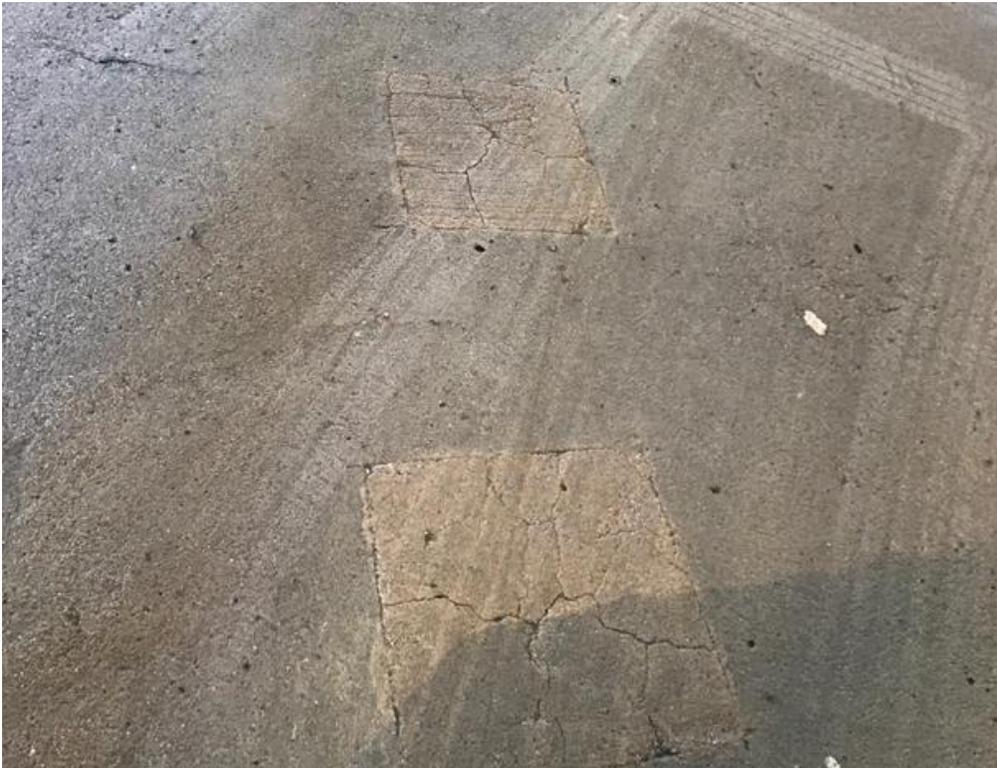
Figure 4. Unsound previous repairs along the top of a beamline.

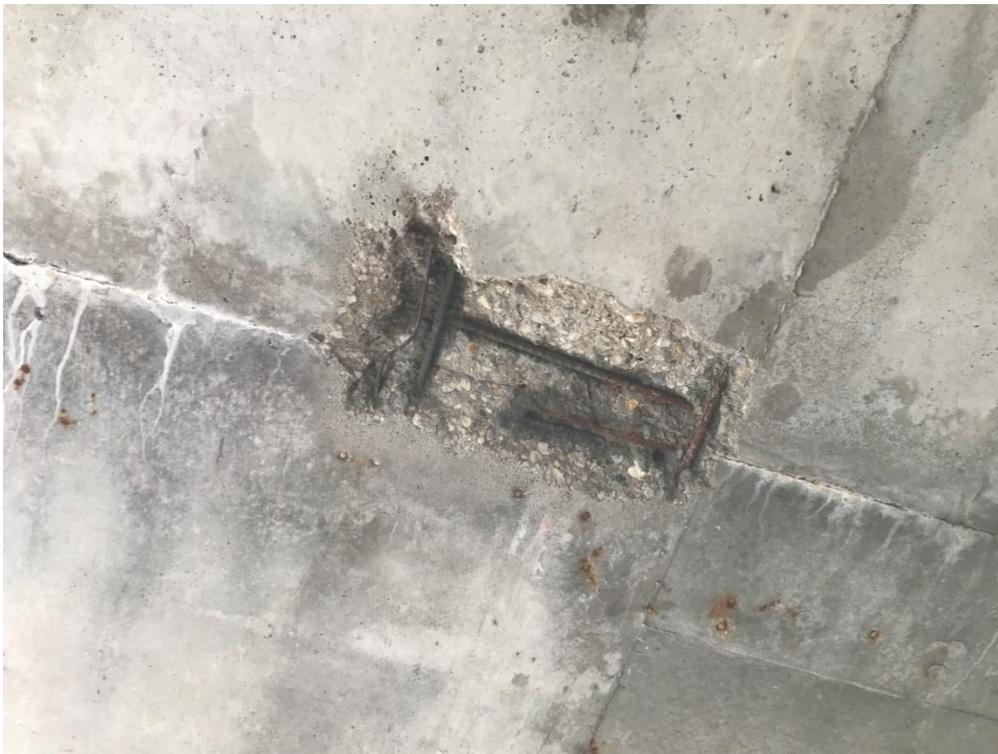
Figure 6. Exposed, corroded mild reinforcement within spall at construction joint. Note efflorescence and water staining along joint.

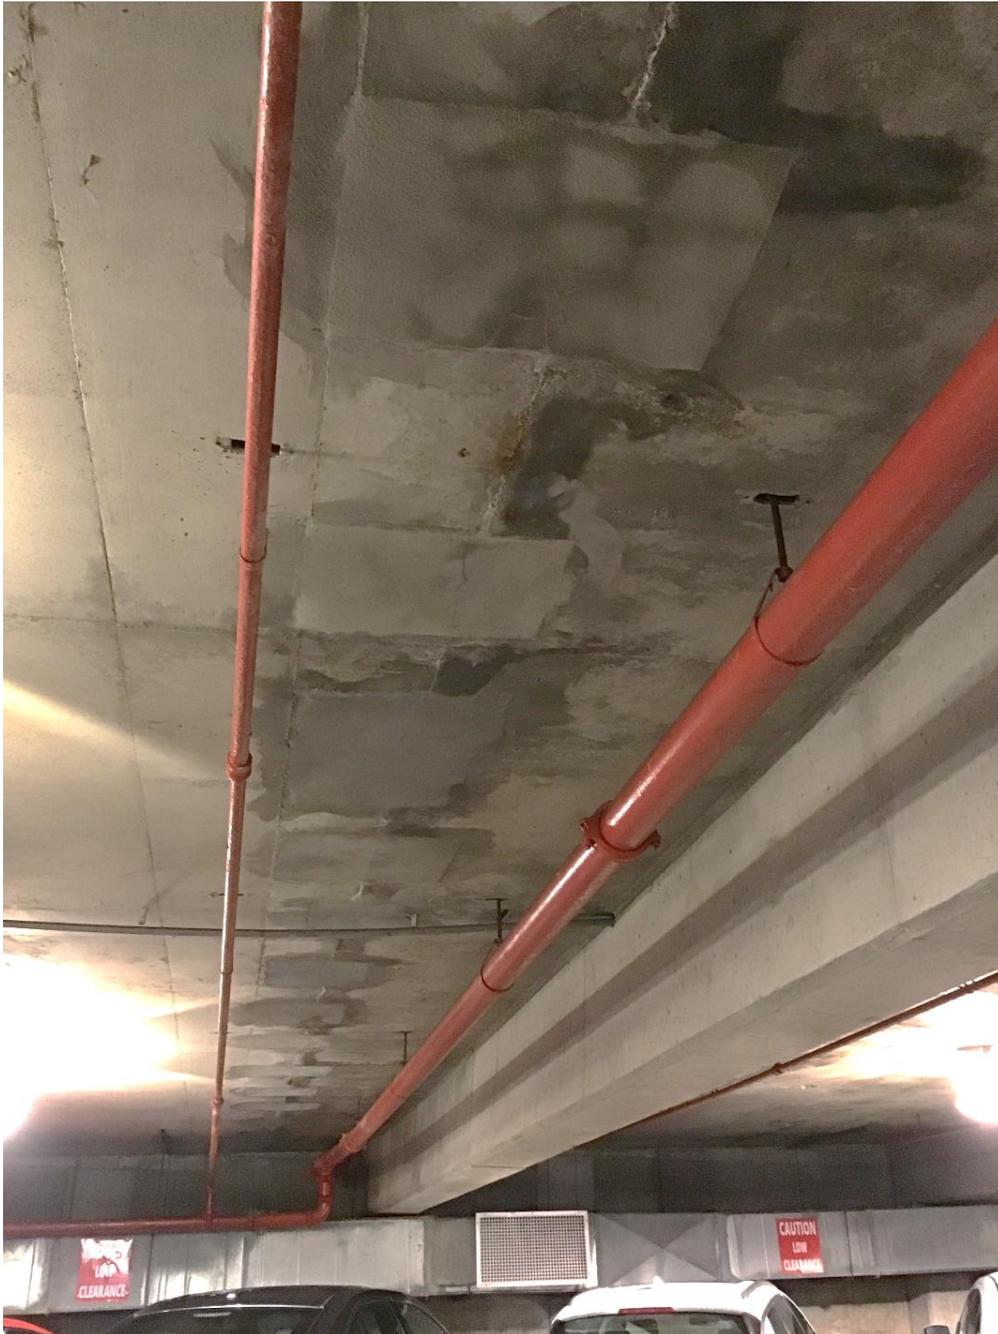
Figure 7. Previous partial-depth concrete repairs at Level 1 construction joint, aligned with mild reinforcing bars near bottom of slab surface.

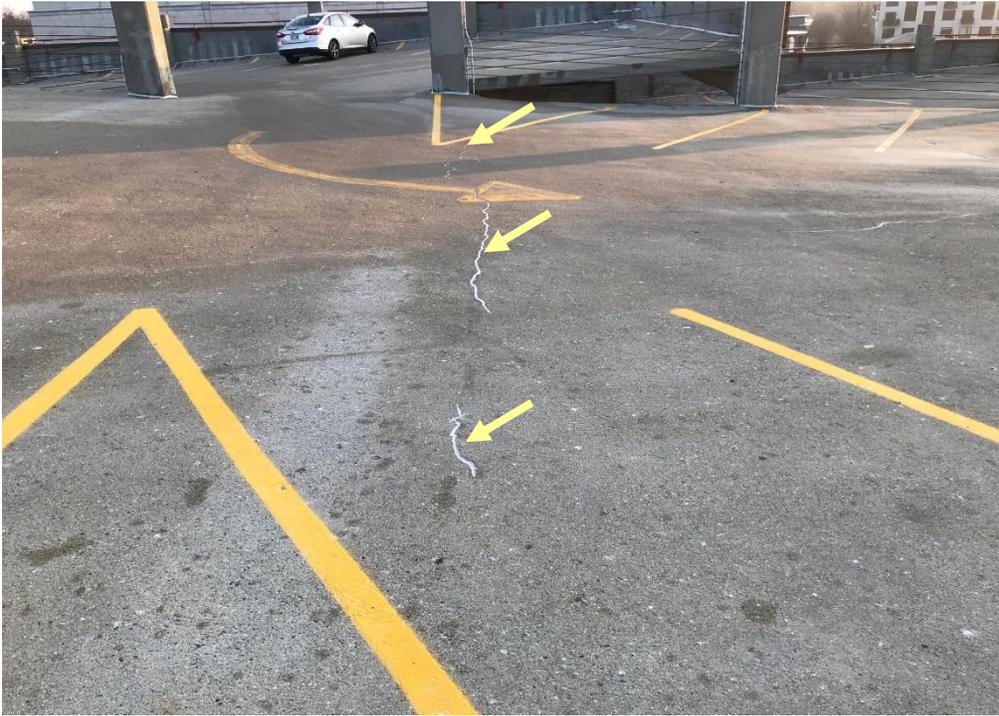
Figure 8. Crack in slab at along beam line.

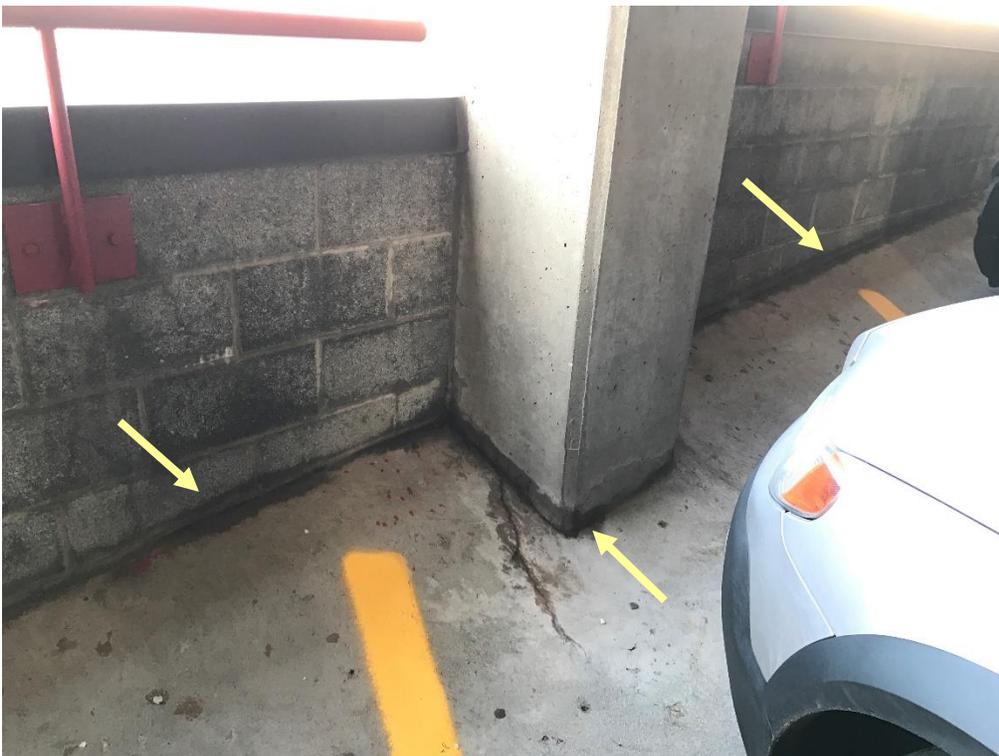
Figure 9. Isolated water staining and cracking in the slab near a perimeter column.

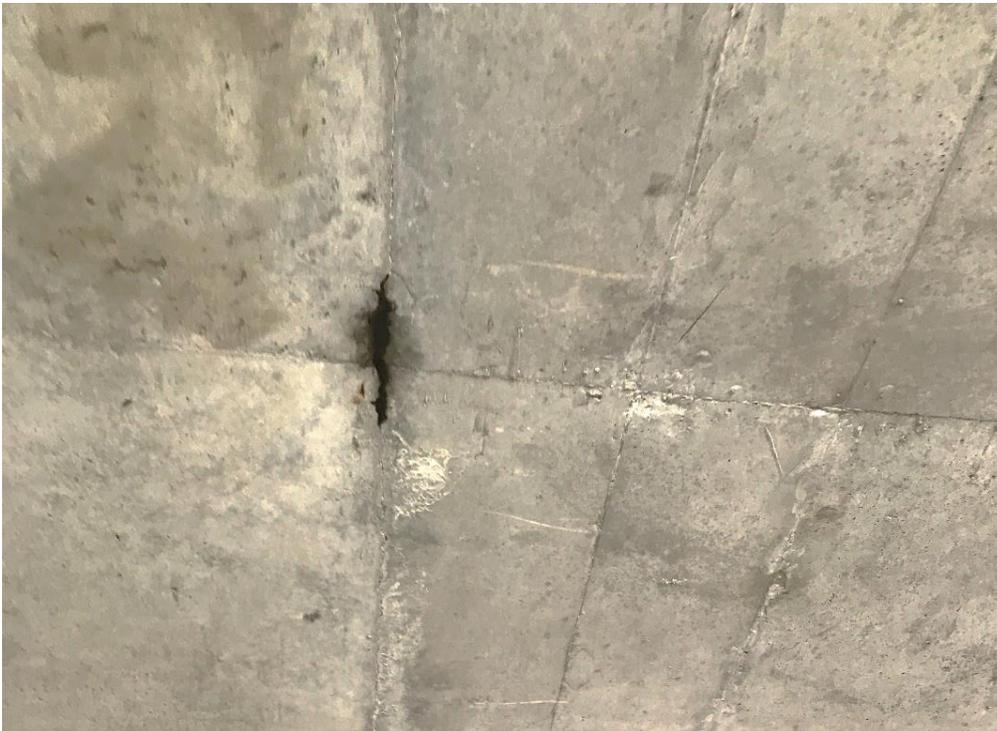
Figure 11 . Grease stains at underside of elevated slab at construction joint.

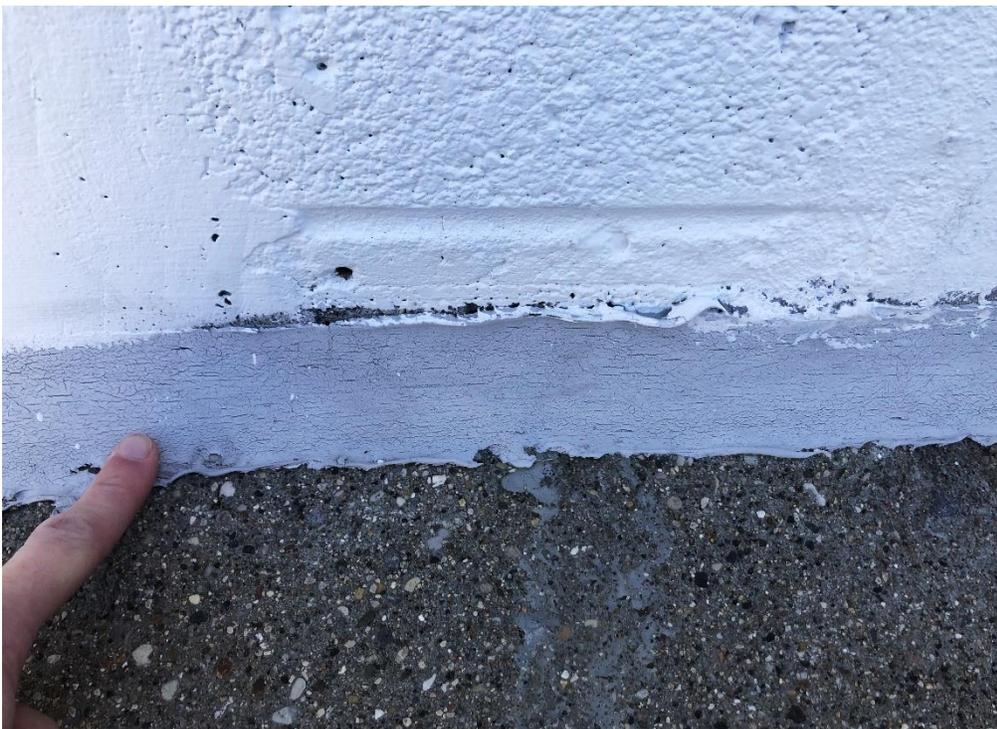
Figure 20. Water staining at perimeter joint between slab and wall intersection.

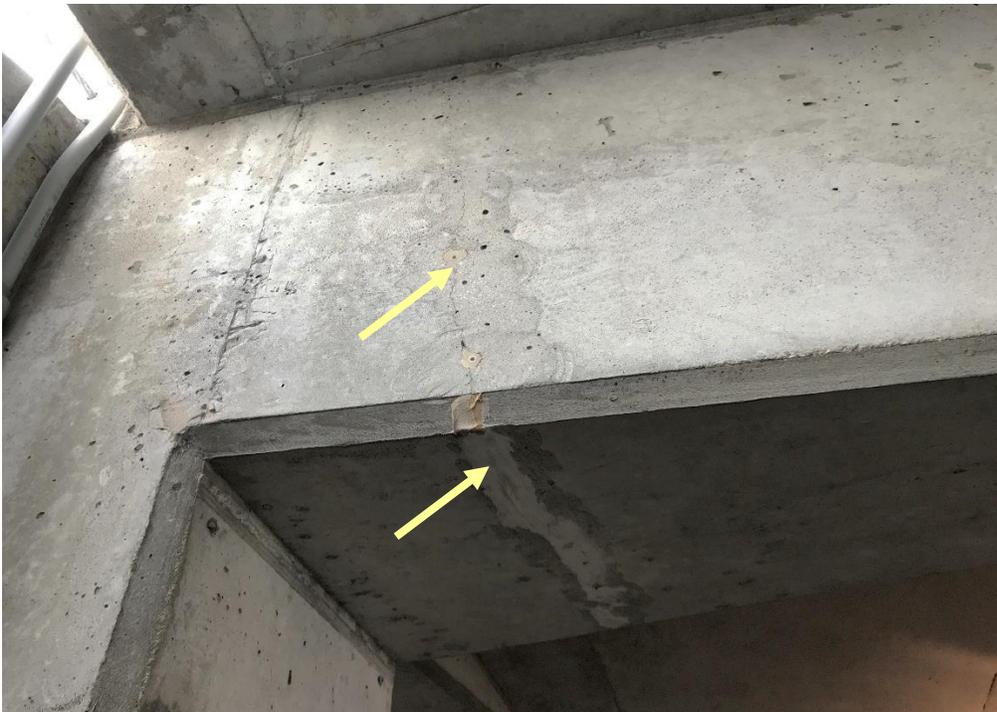
Figure 22. Previous epoxy injection repair at isolated crack at beam end.

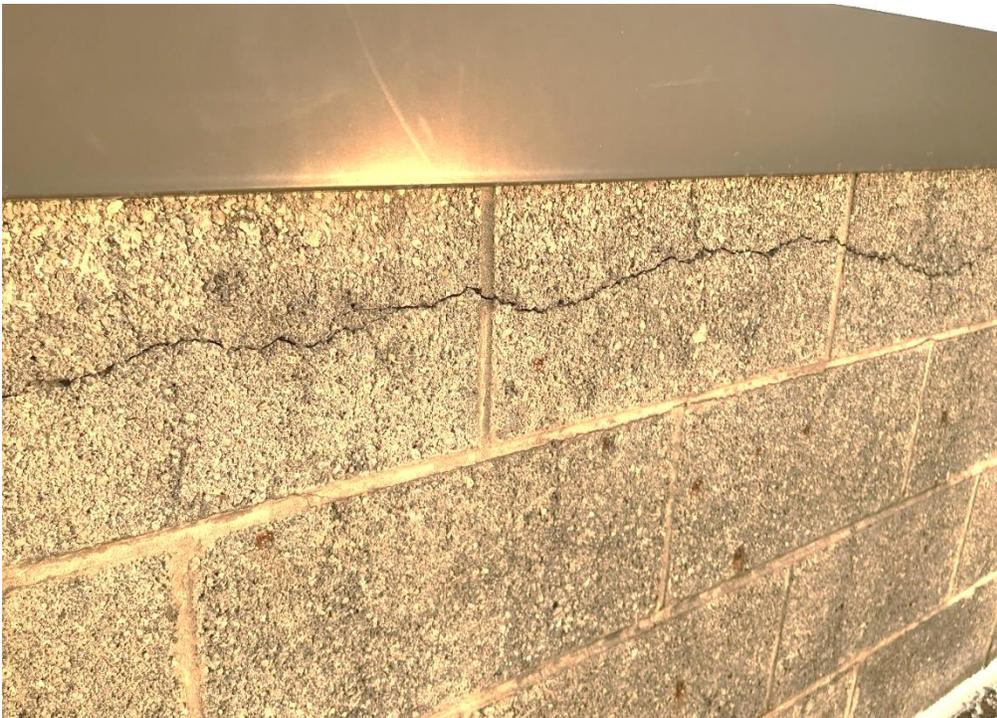
Figure 28. Cracking at CMU facade wall prior to recent coating of wall surface.

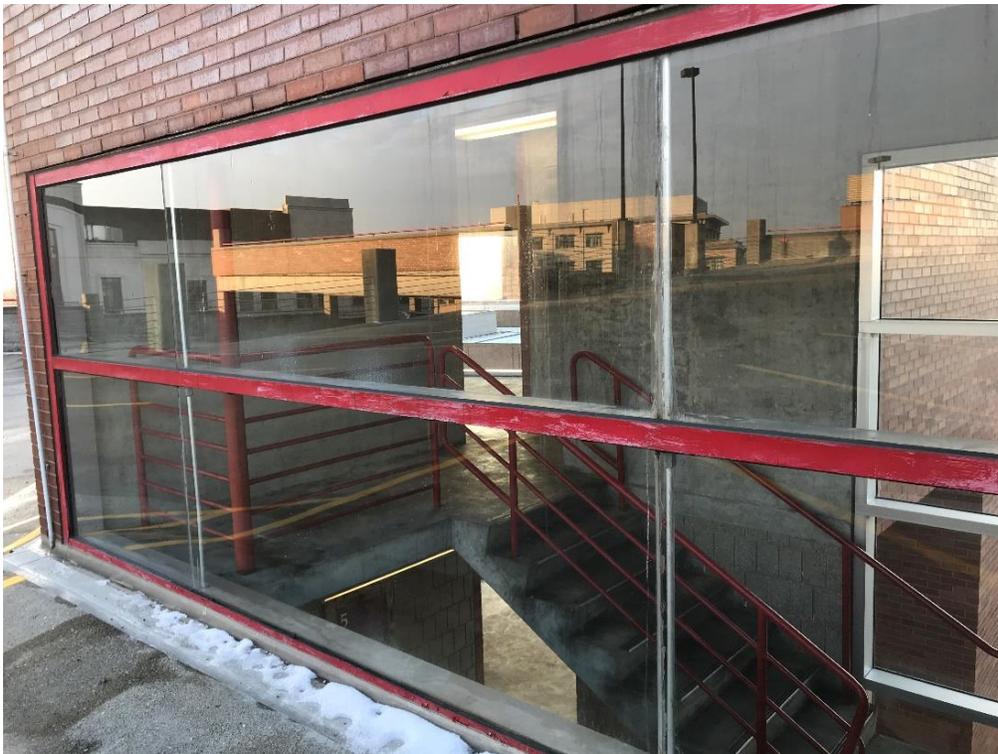
Figure 47. Deteriorated coating, perimeter sealant, and glazing at stairwell storefront.

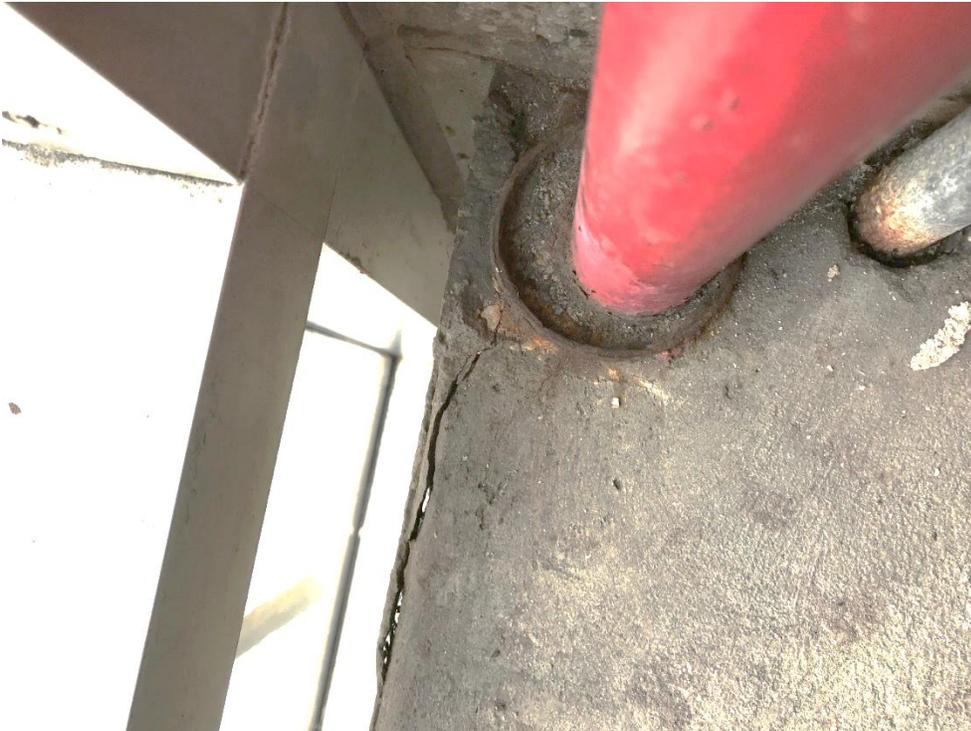
Figure 49. Spall at corroded stairwell handrail embed at landing.
