VIRTUAL MEETING OF THE ADVISORY PARKING COMMITTEE
WEDNESDAY, June 2, 2021 @ 7:30am
<https://zoom.us/j/98209276859> or dial: 877 853 5247 US Toll-free,
Meeting ID: 982 0927 6859

As requested, Wiss, Janney, Elstner Associates, Inc. (WJE) has completed limited condition assessments of the North Old Woodward, Park Street, Peabody, and Chester parking structures. These assessments were performed with the intent to determine the current and future infrastructure needs in support of a capital improvement plan; the intention of the plan is to extend the useful life of the structures and to maintain the structural integrity to ensure the structure can support the code-prescribed loadings. This report summarizes our observations at the Chester Parking Structure, located at 180 Chester Street in Birmingham, Michigan, and provides recommendations for your consideration.

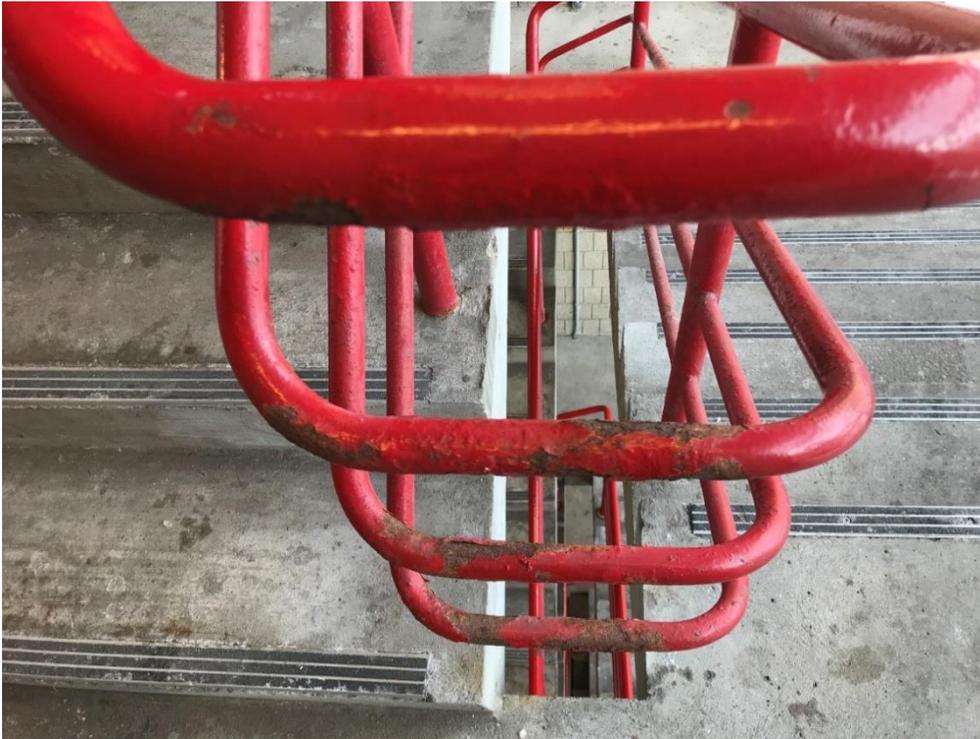
Figure 50. Chipped paint and corrosion at stairwell handrail.

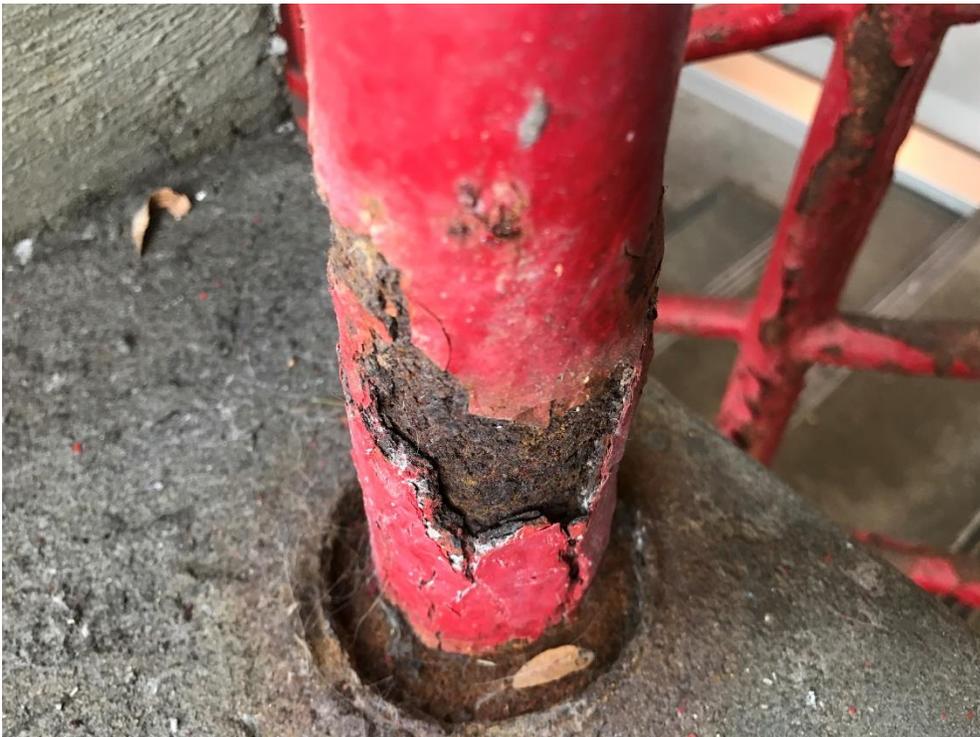
Figure 51. Corrosion at base of stairwell railing post.

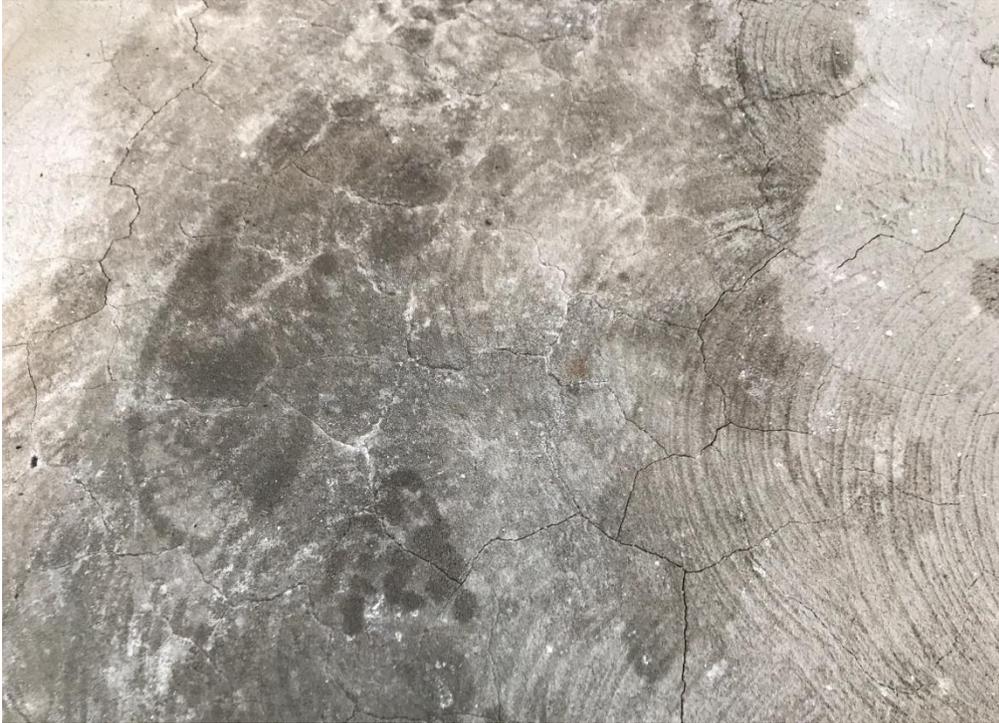
Figure 52. Crazing cracking at Level 7 stairwell landing surface.

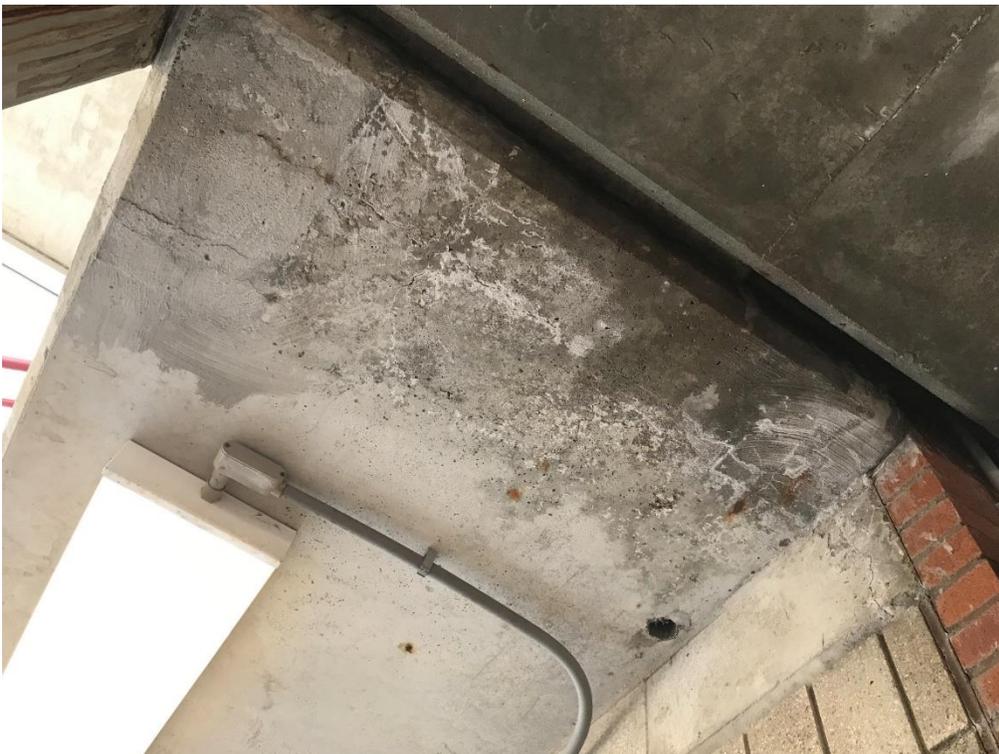
Figure 53. Cracking and efflorescence at underside of stair flight.

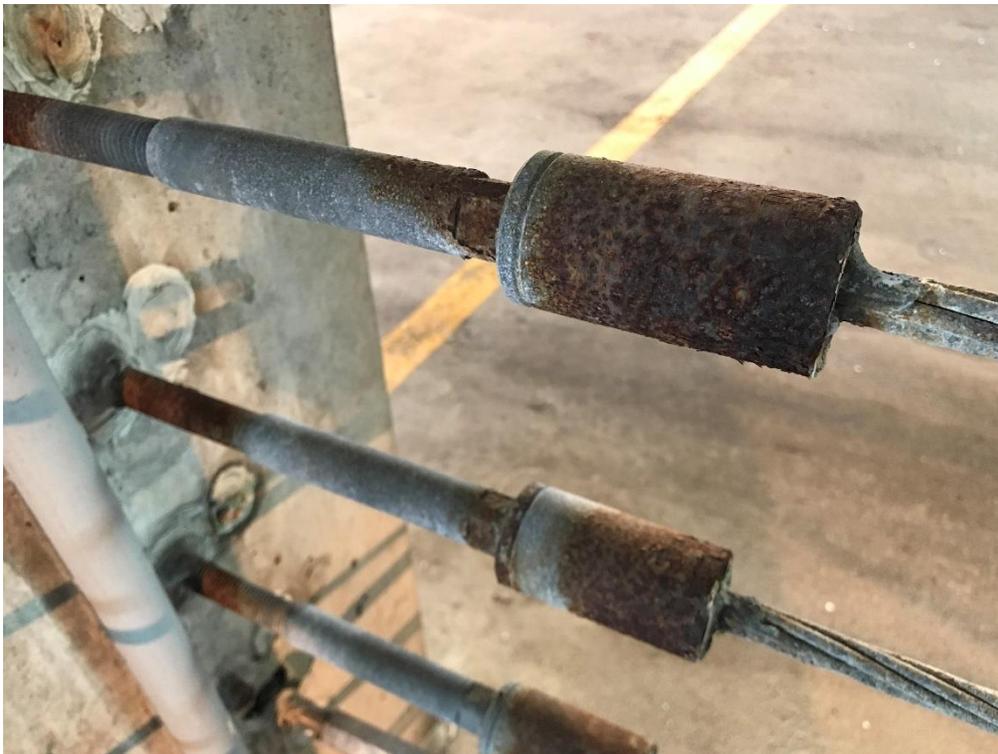
Figure 55. Corrosion of vehicle barriers and splice couplers.

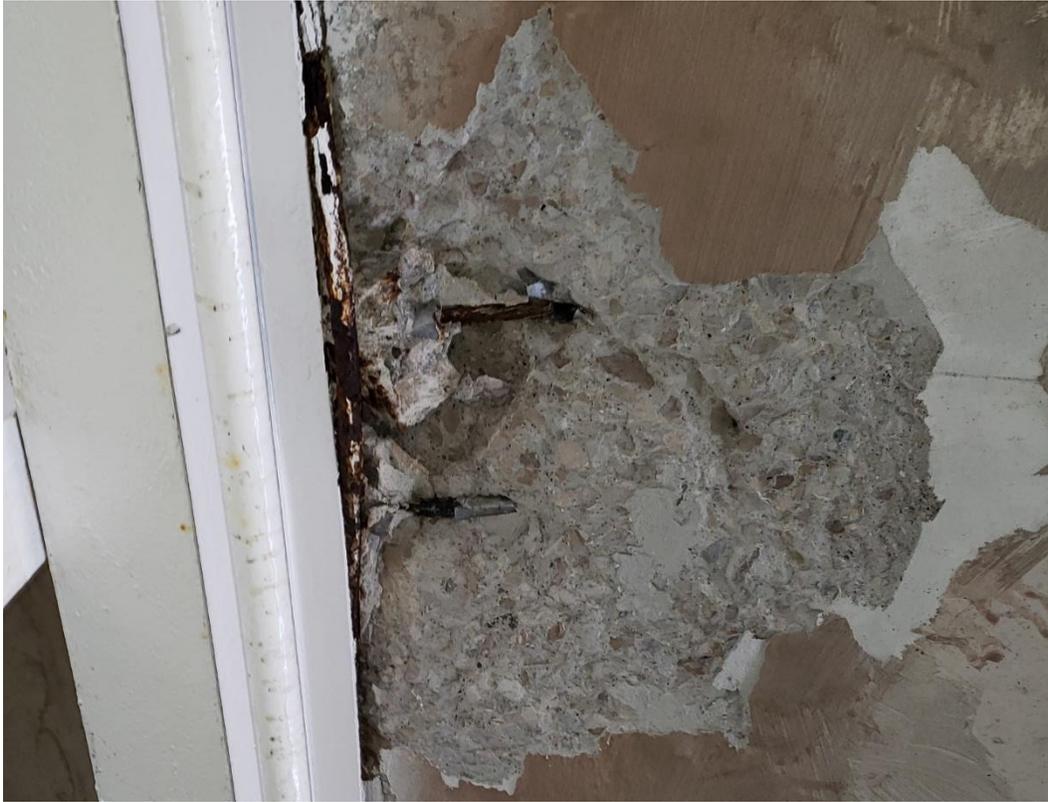
Figure 1. Spall at slab edge exposing PT temperature tendons

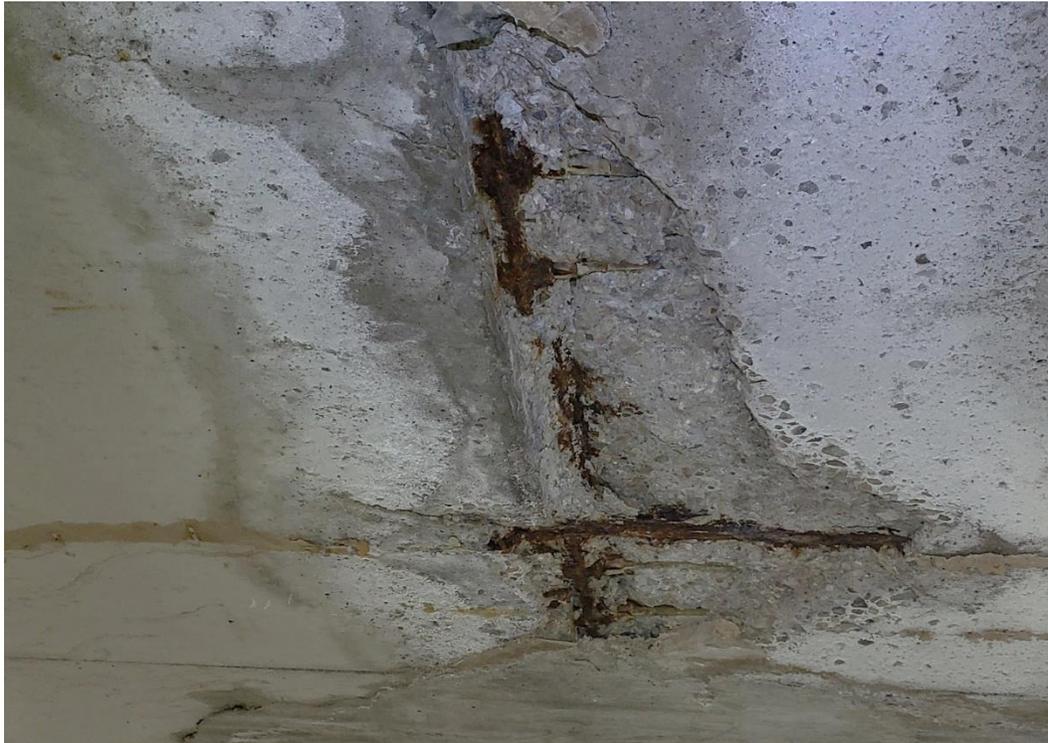
Figure 2. Spall at construction joint exposing PT tendon anchorages and an embedded conduit

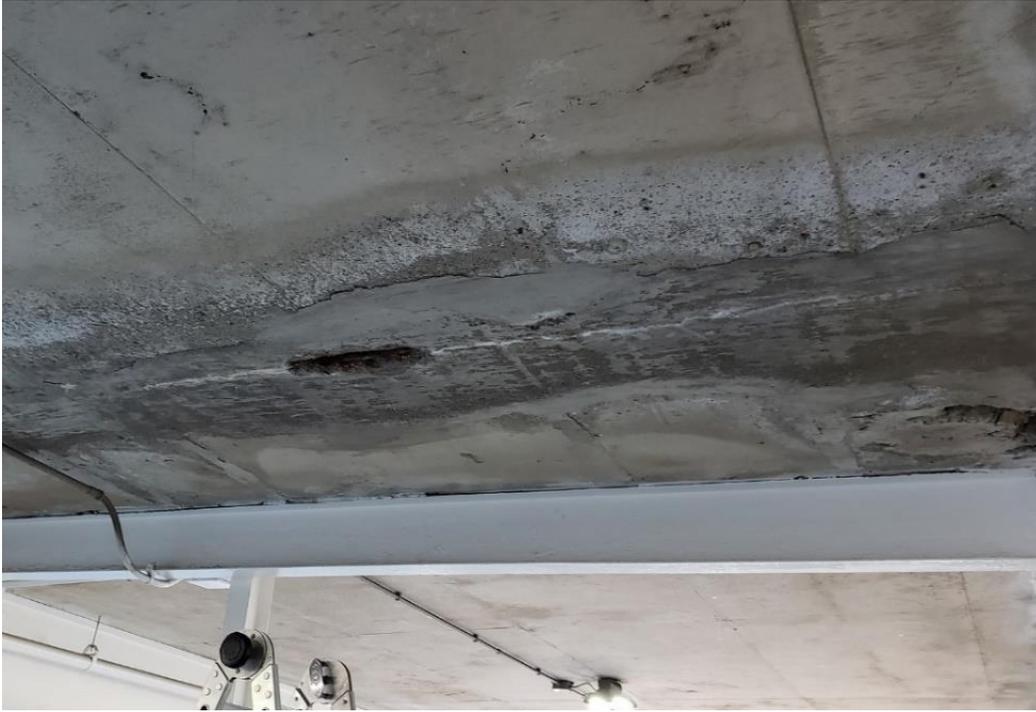
Figure 3. Spall at a previous repair exposing PT tendon

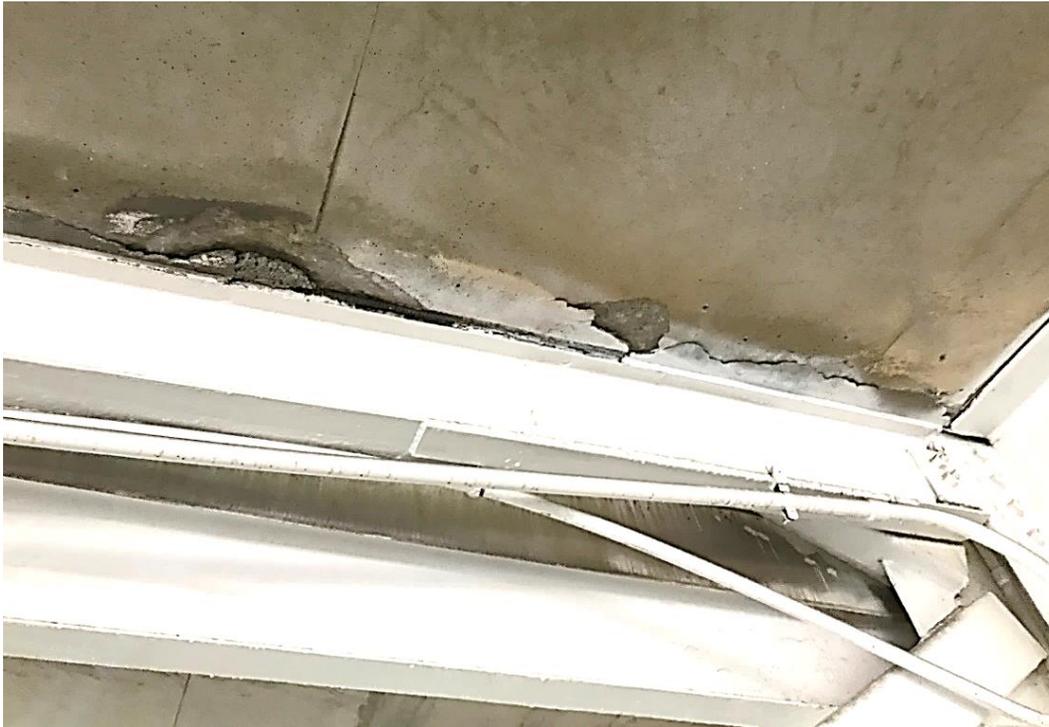
Figure 6. Progressive deterioration at slab edge repair. Note that mild steel and temperature and shrinkage PT anchorages are in this region.

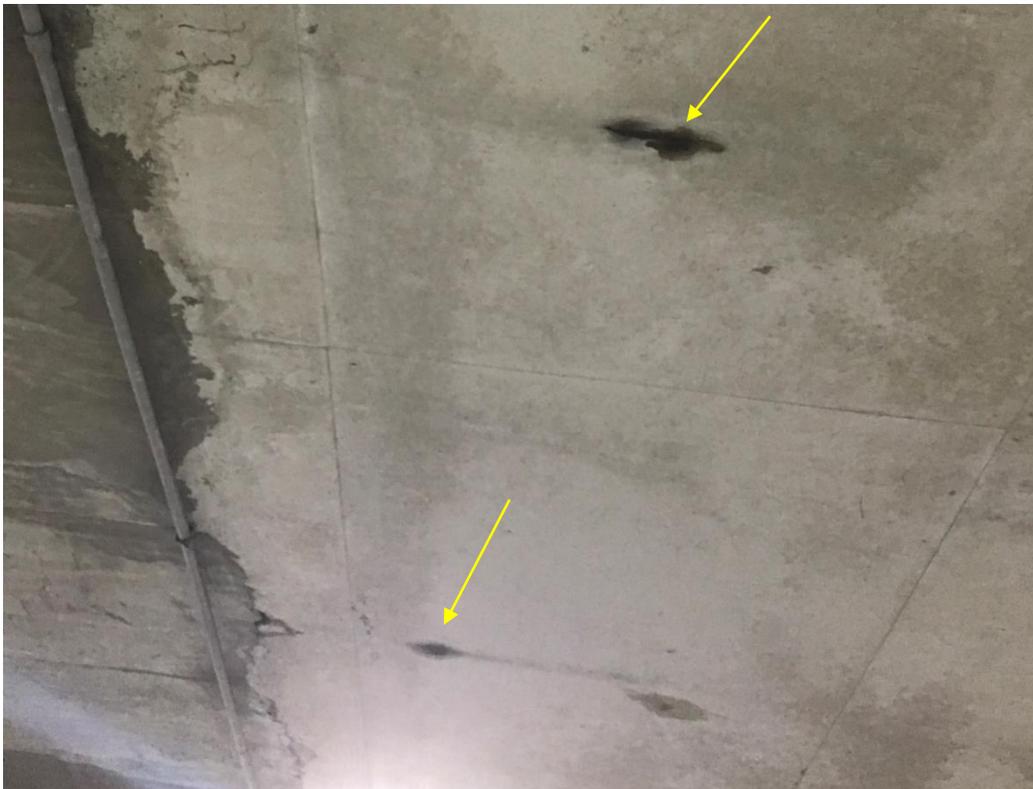
Figure 9. Grease stains near construction joint

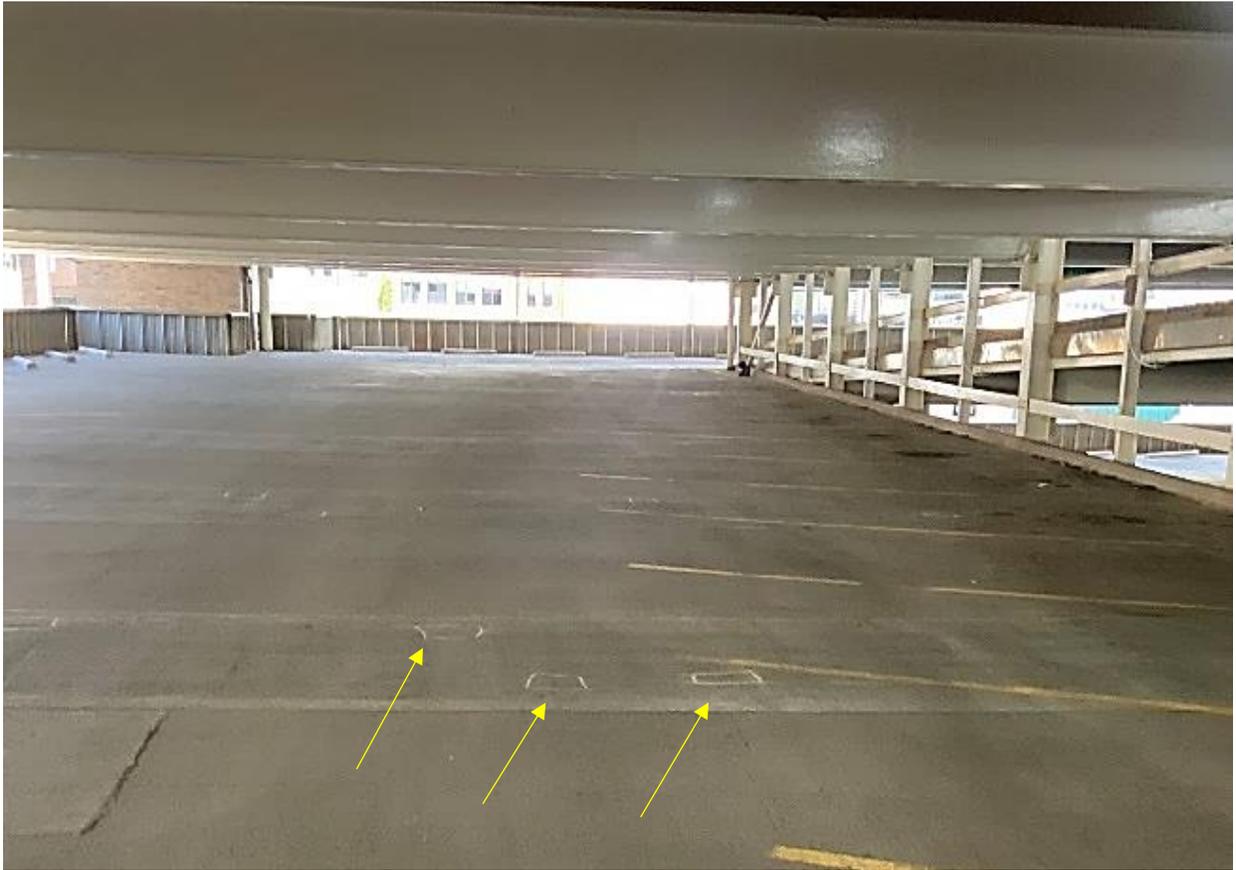
Figure 27. Delaminations near the beamlines marked in chalk

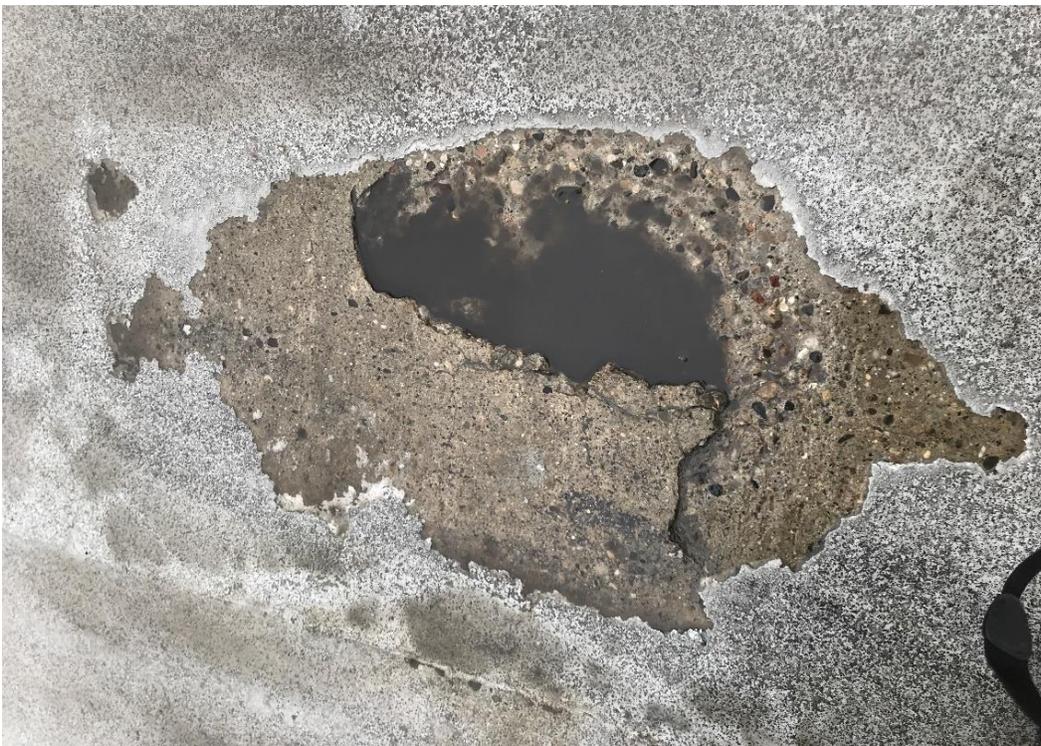
Figure 29. Spall at topside of roof level slab

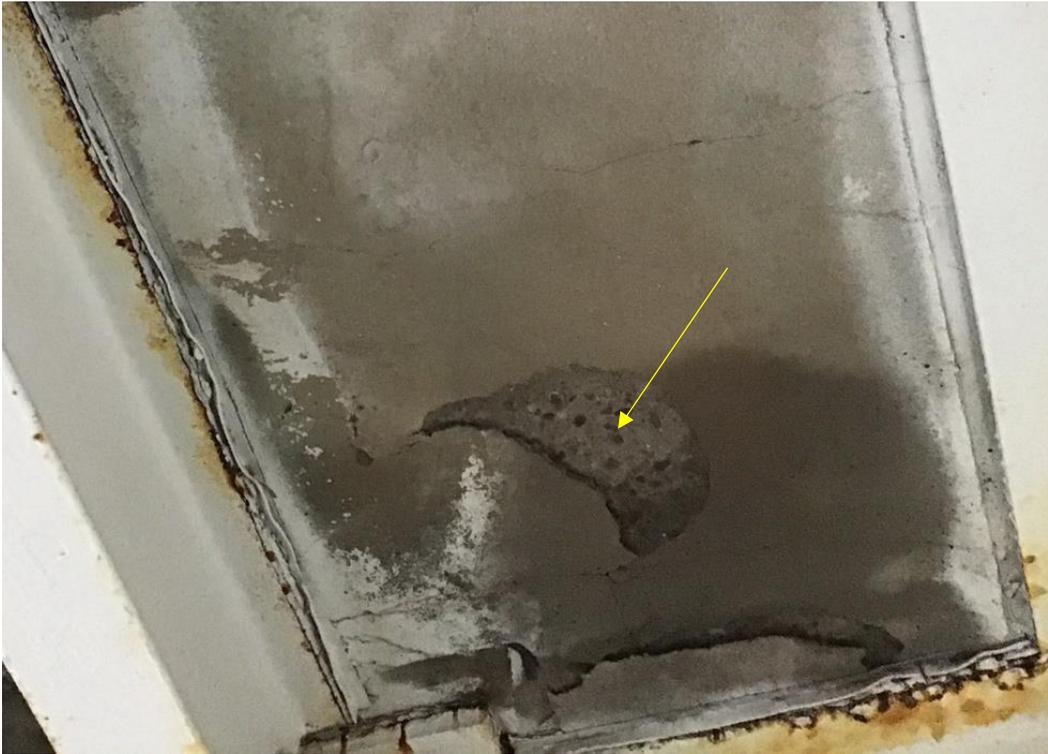
Figure 30. Spall at underside of slab

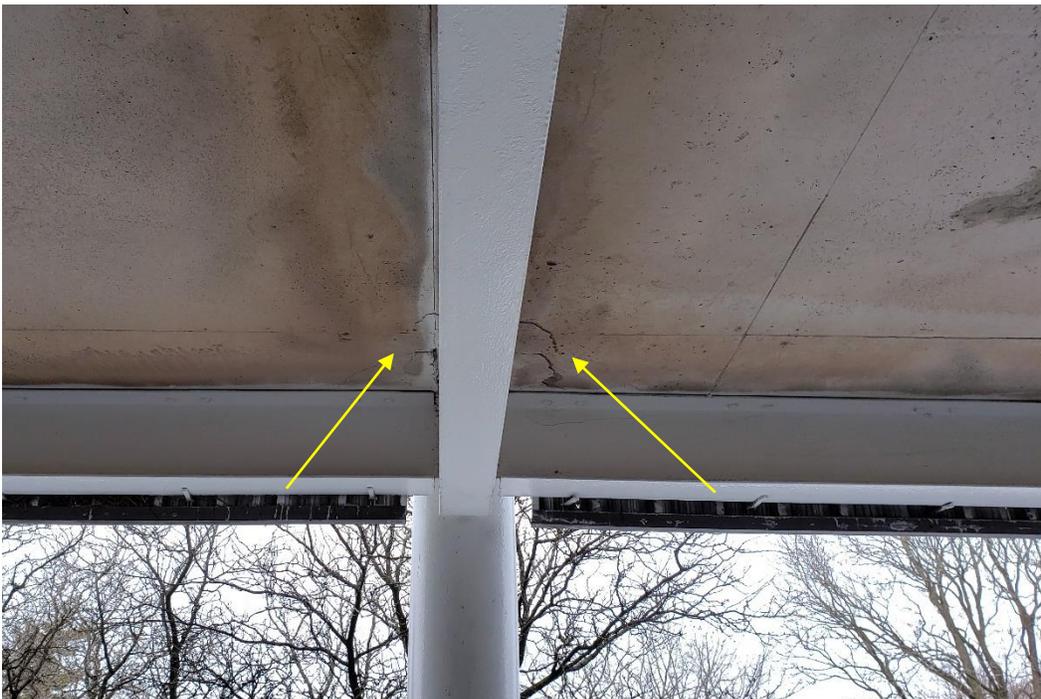
Figure 31. Cracks and incipient spalls adjacent to the exterior end of beam in unsloped bay

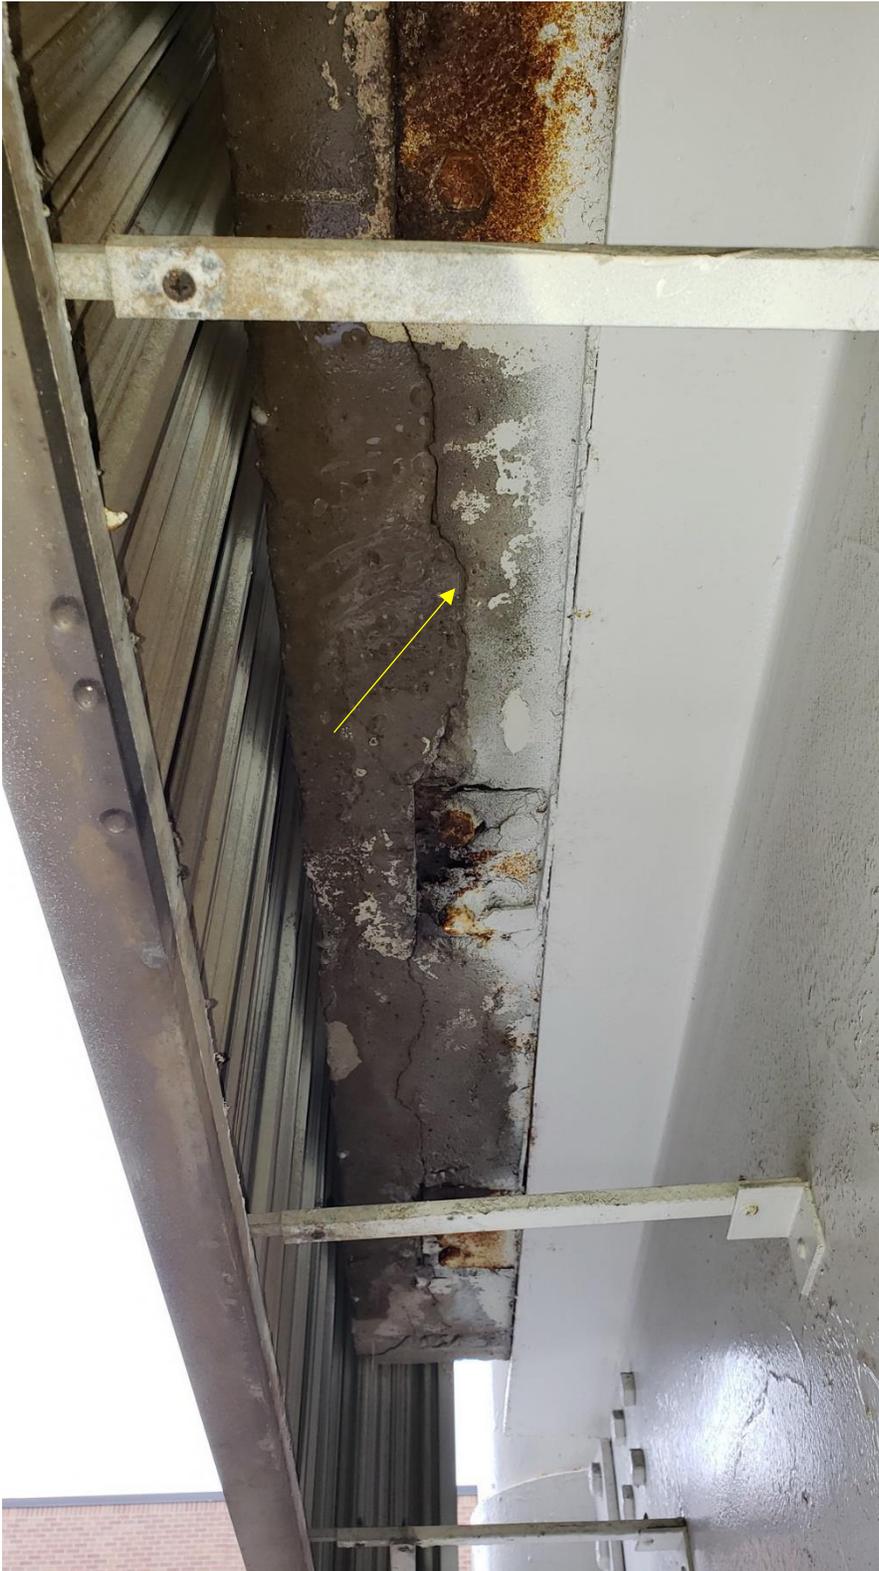
Figure 32. Cracked concrete at slab edge

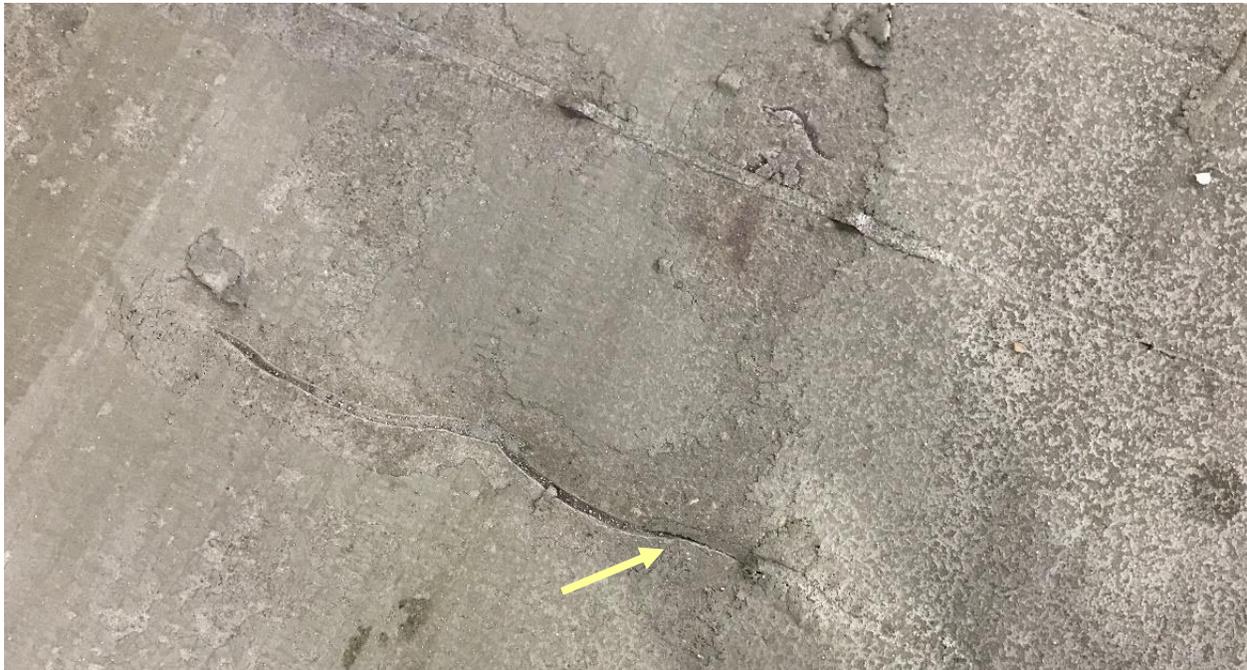
Figure 35. Failed sealant at crack

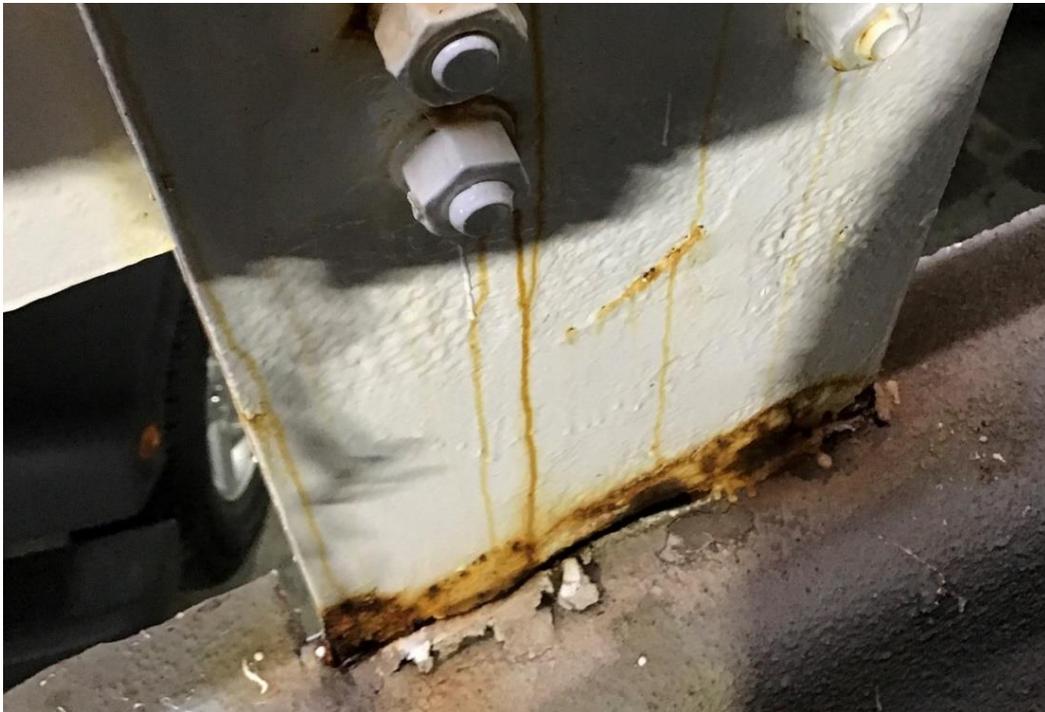
Figure 43. Corrosion where interior column contacts slab edge

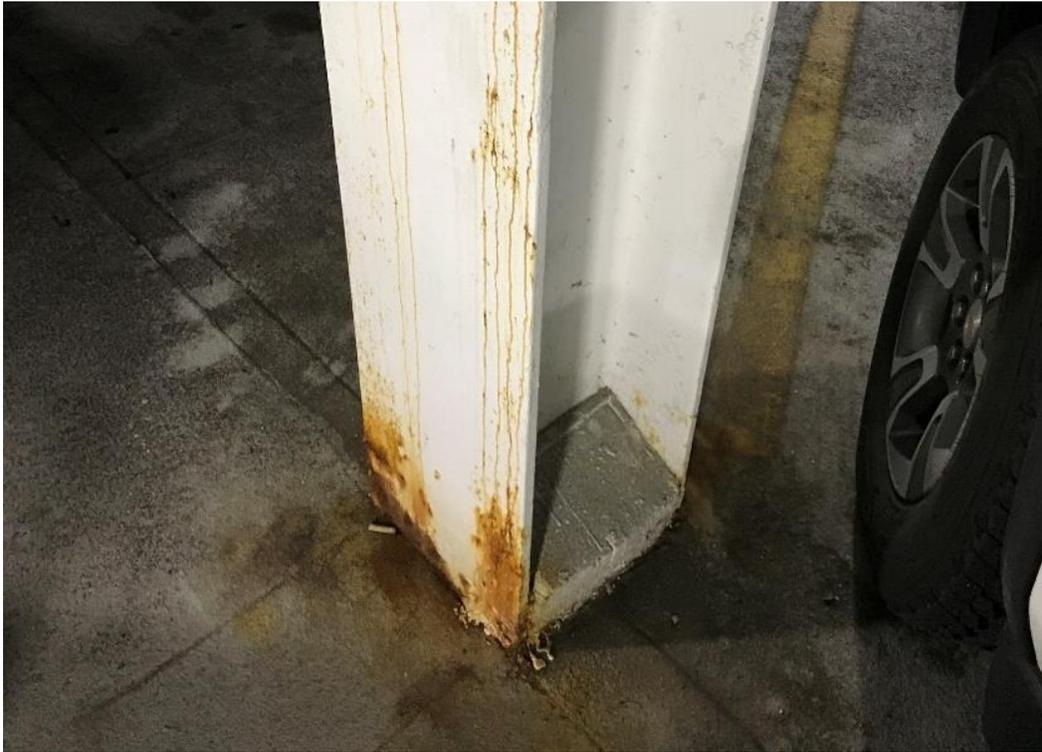
Figure 44. Corrosion at interior column base at elevated slab

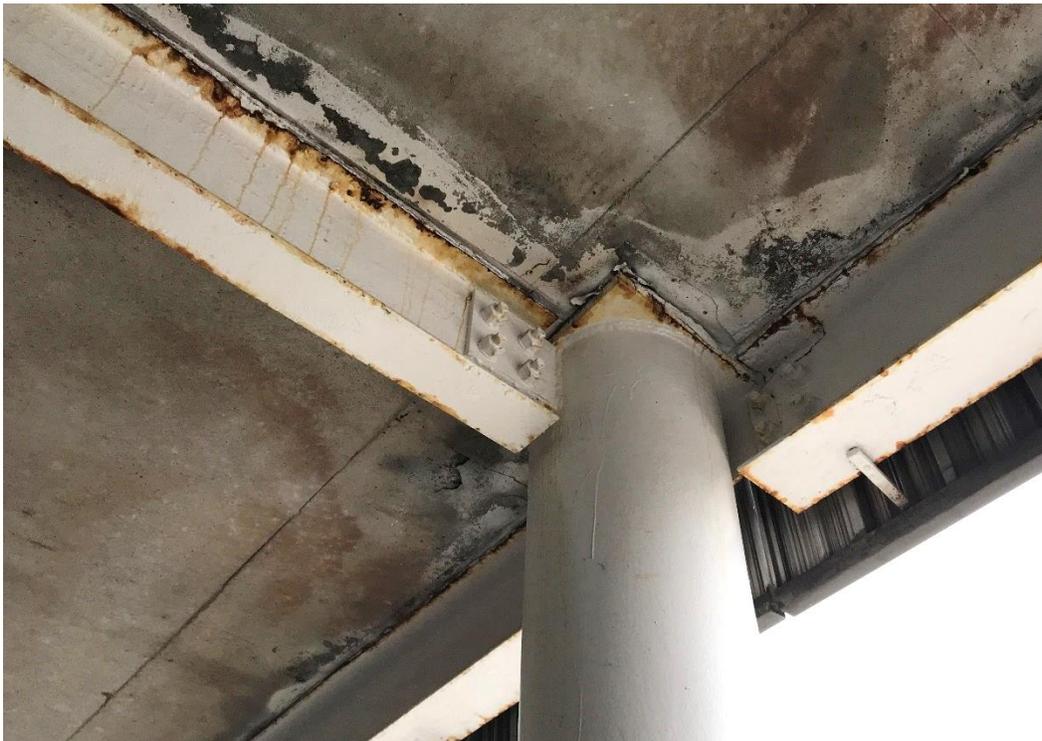
Figure 45. Corroded top of column and beam

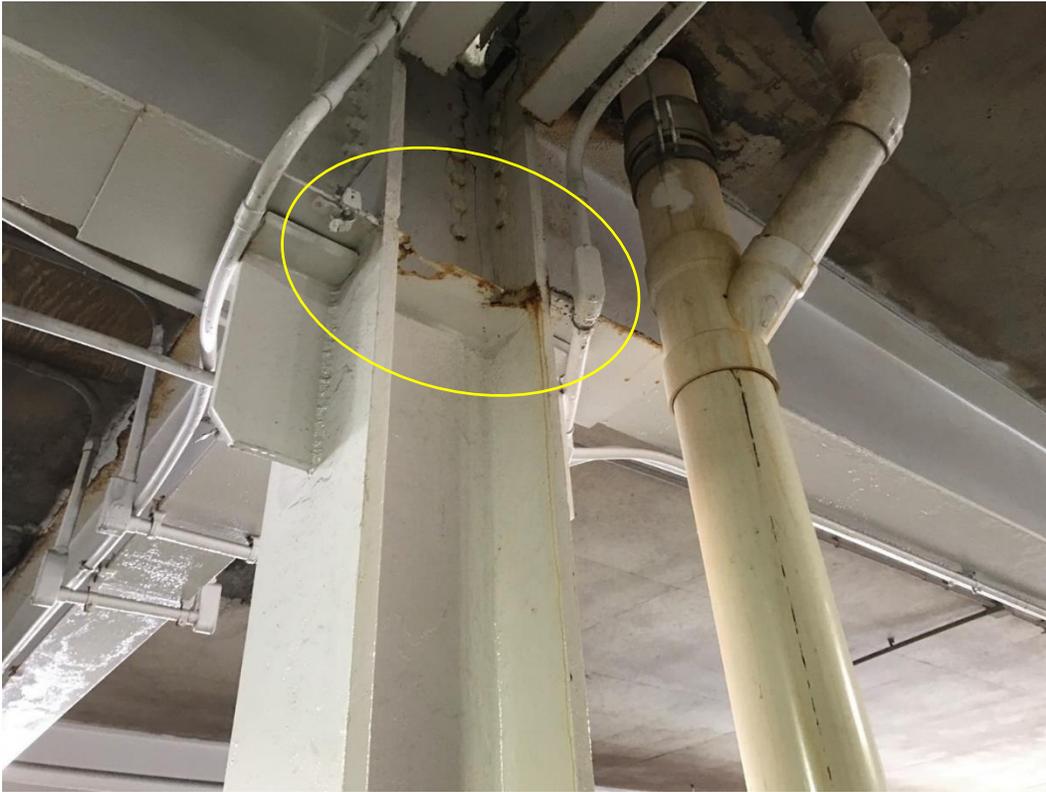
Figure 46. Section loss at column stiffener plate

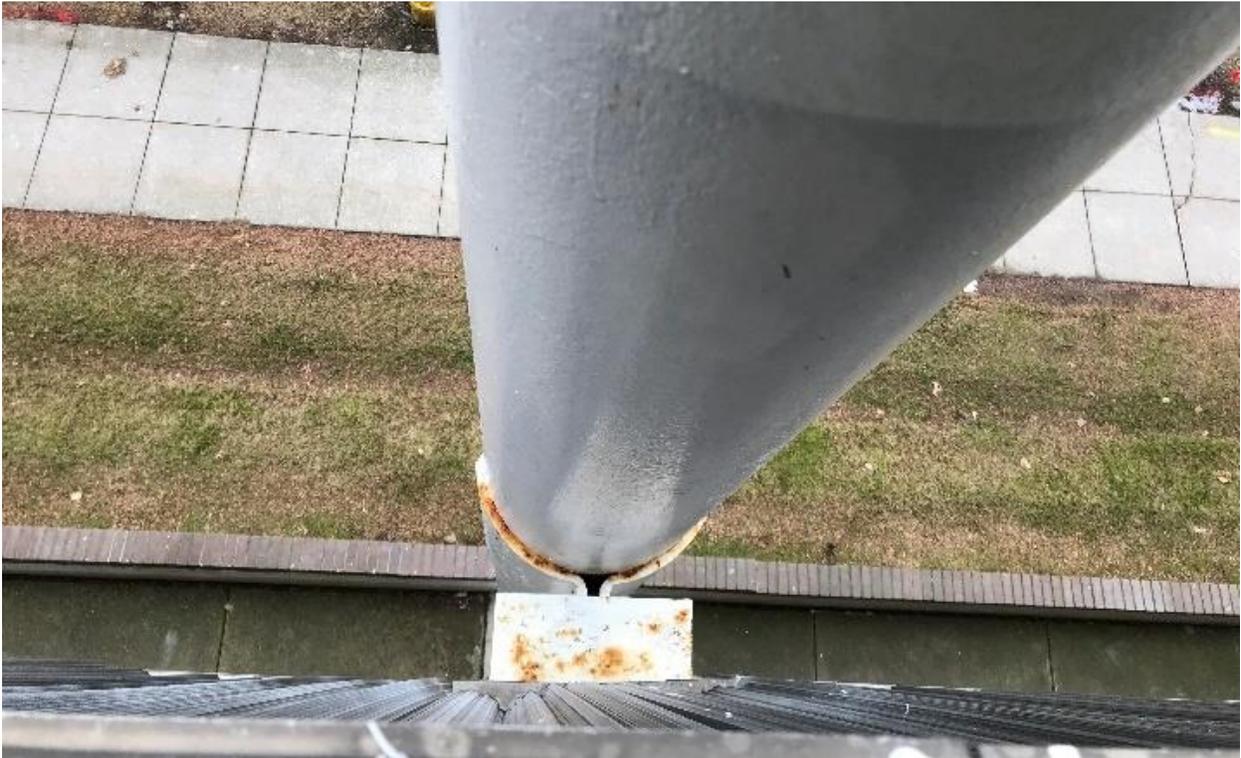
Figure 49. Corroded connection at exterior column

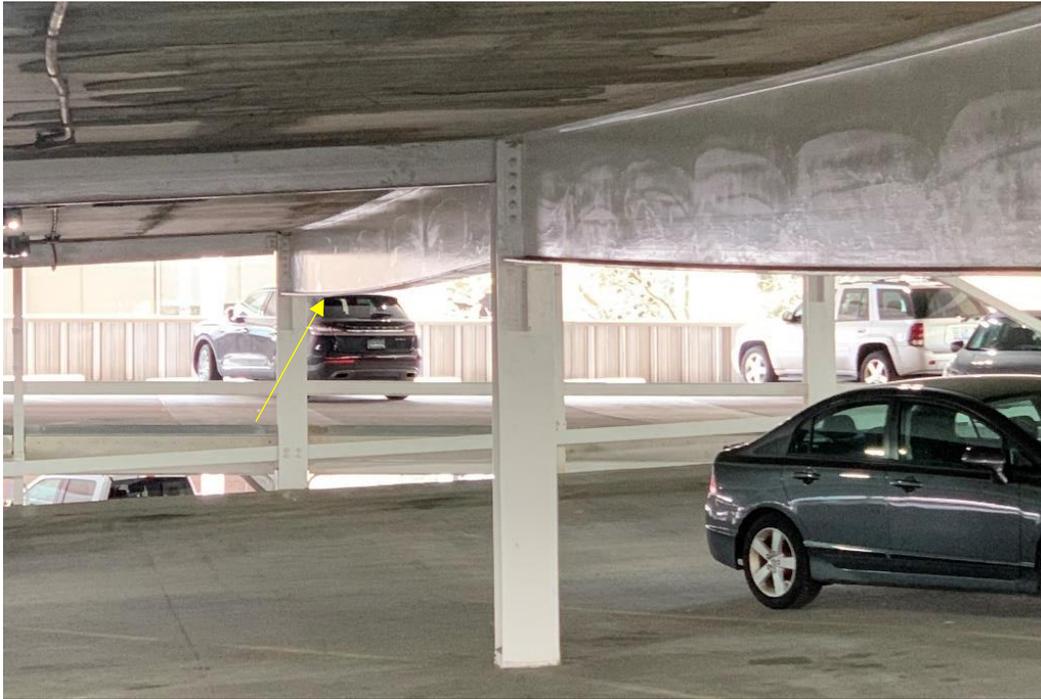
Figure 51. Deflected steel beams

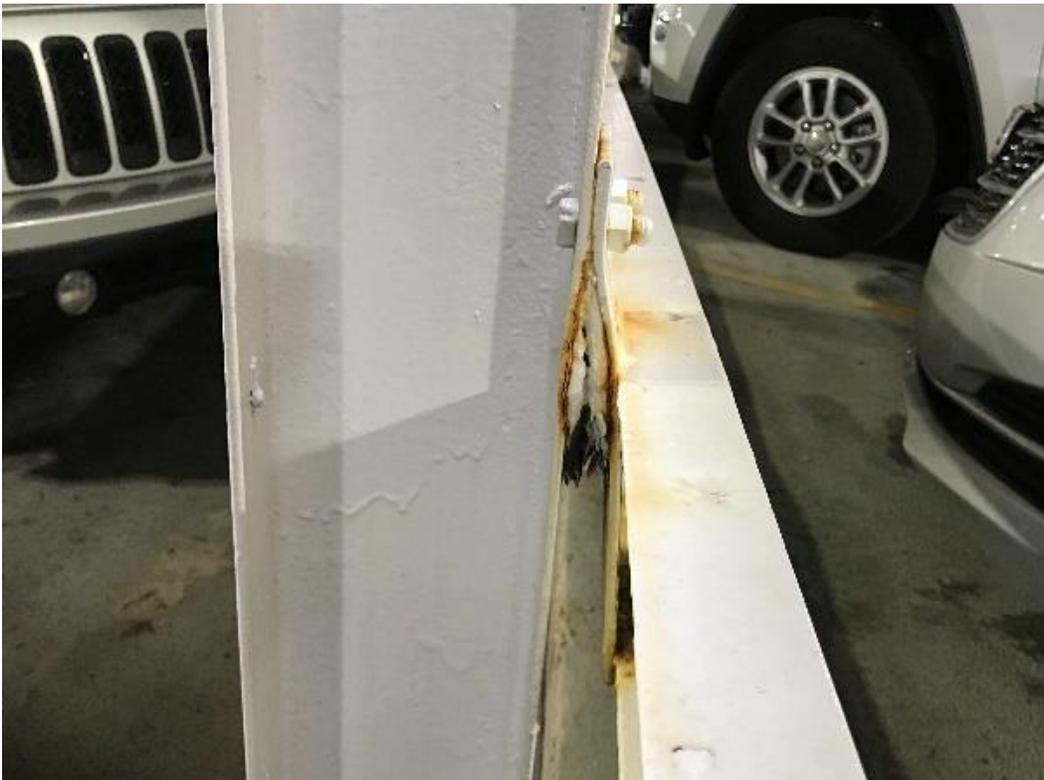
Figure 61. Corrosion byproduct buildup at channel to post connection

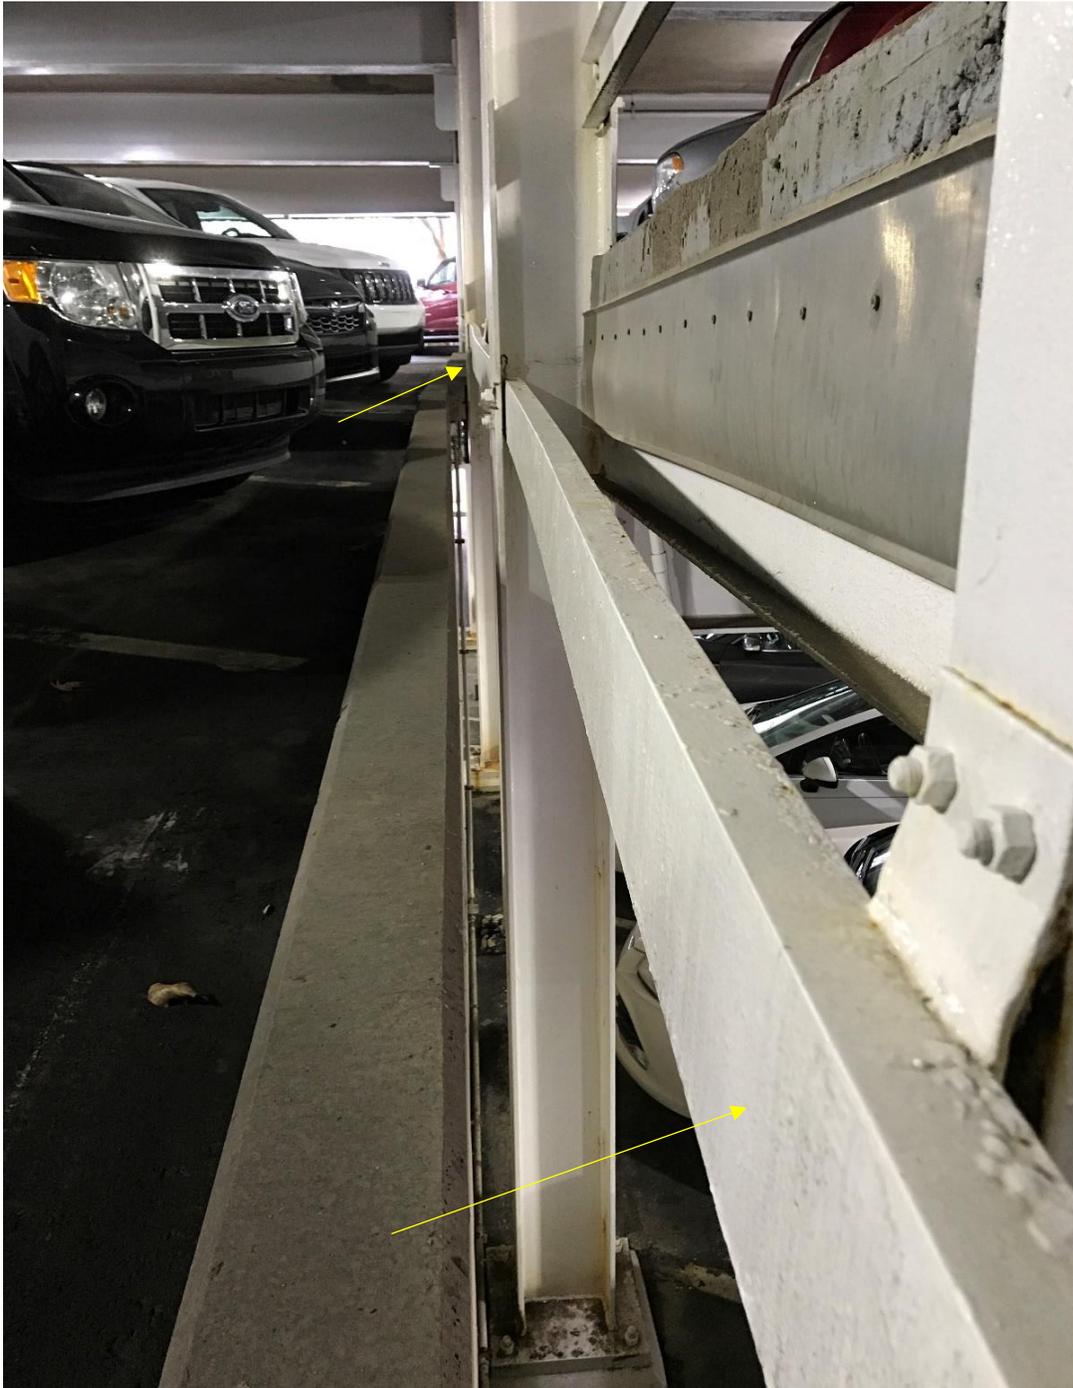
Figure 62. Lateral deformation of channels

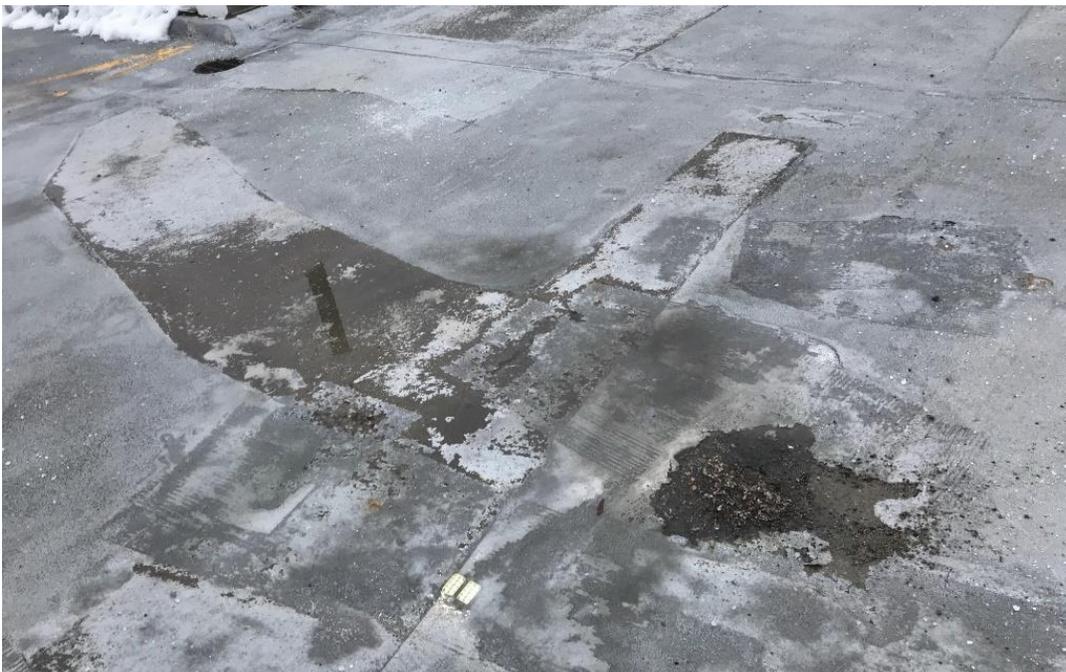
Figure 65. Traffic-bearing membrane failure at previous concrete repair

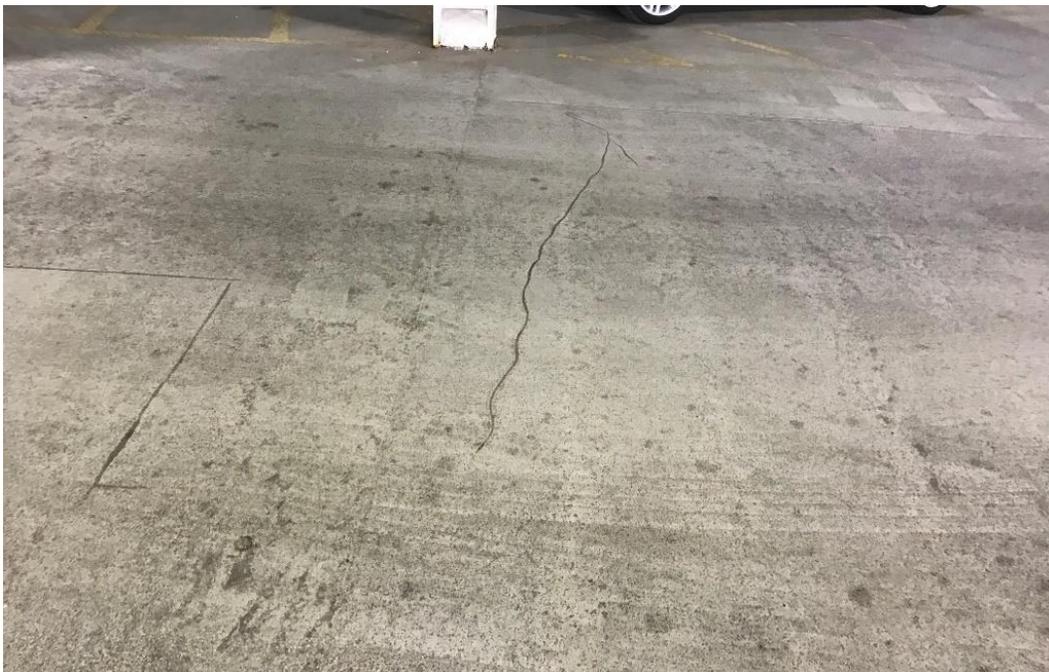
Figure 67. Sealed crack covered by traffic-bearing membrane

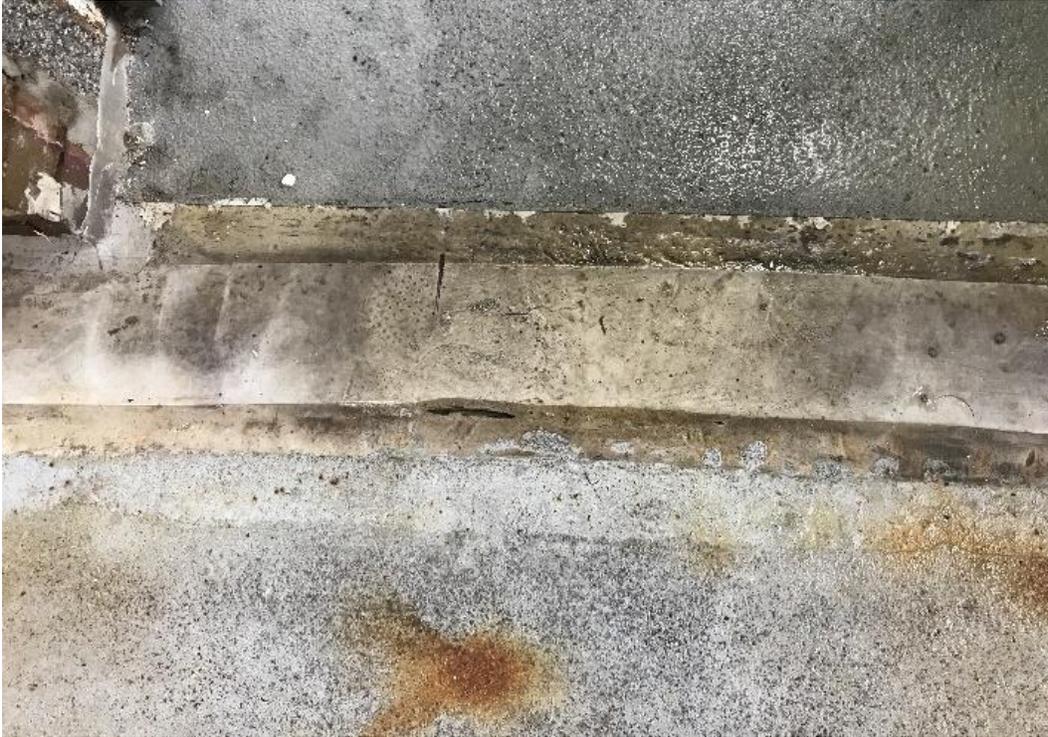
Figure 68. Failed stairwell expansion joint
