VIRTUAL MEETING OF THE ADVISORY PARKING COMMITTEE
WEDNESDAY, June 2, 2021 @ 7:30am
<https://zoom.us/j/98209276859> or dial: 877 853 5247 US Toll-free,
Meeting ID: 982 0927 6859

As requested, Wiss, Janney, Elstner Associates, Inc. (WJE) has completed limited condition assessments of the North Old Woodward, Park Street, Peabody, and Chester parking structures. These assessments were performed with the intent to determine the current and future infrastructure needs in support of a capital improvement plan; the intention of the plan is to extend the useful life of the structures and to maintain the structural integrity to ensure the structure can support the code-prescribed loadings. This report summarizes our observations at the Chester Parking Structure, located at 180 Chester Street in Birmingham, Michigan, and provides recommendations for your consideration.

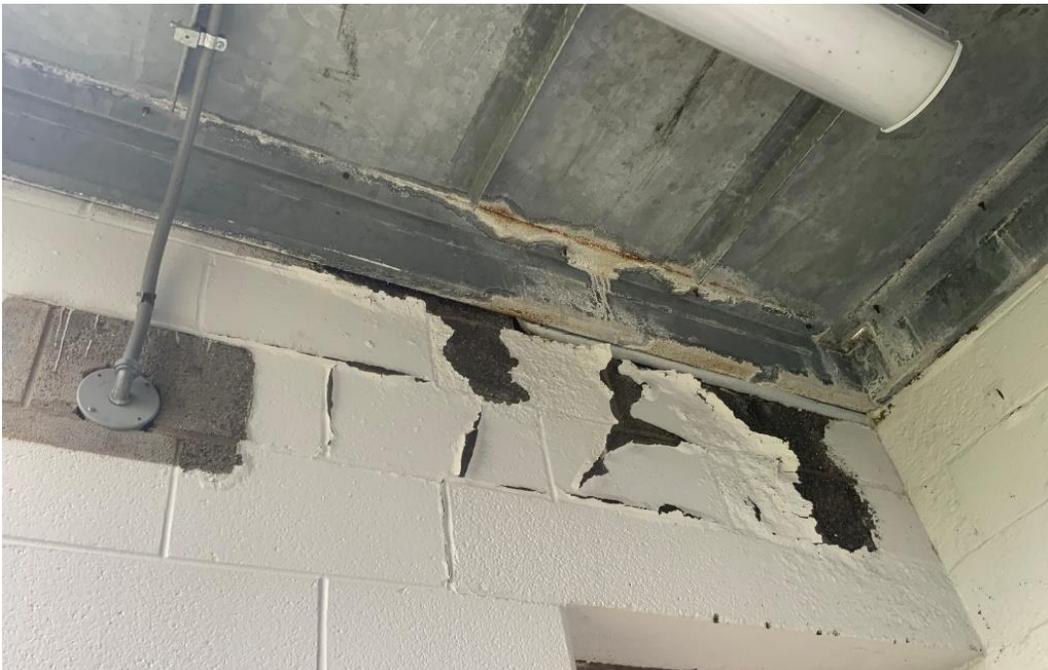
Figure 69. Failed coating at CMU stair tower wall below expansion joint seal

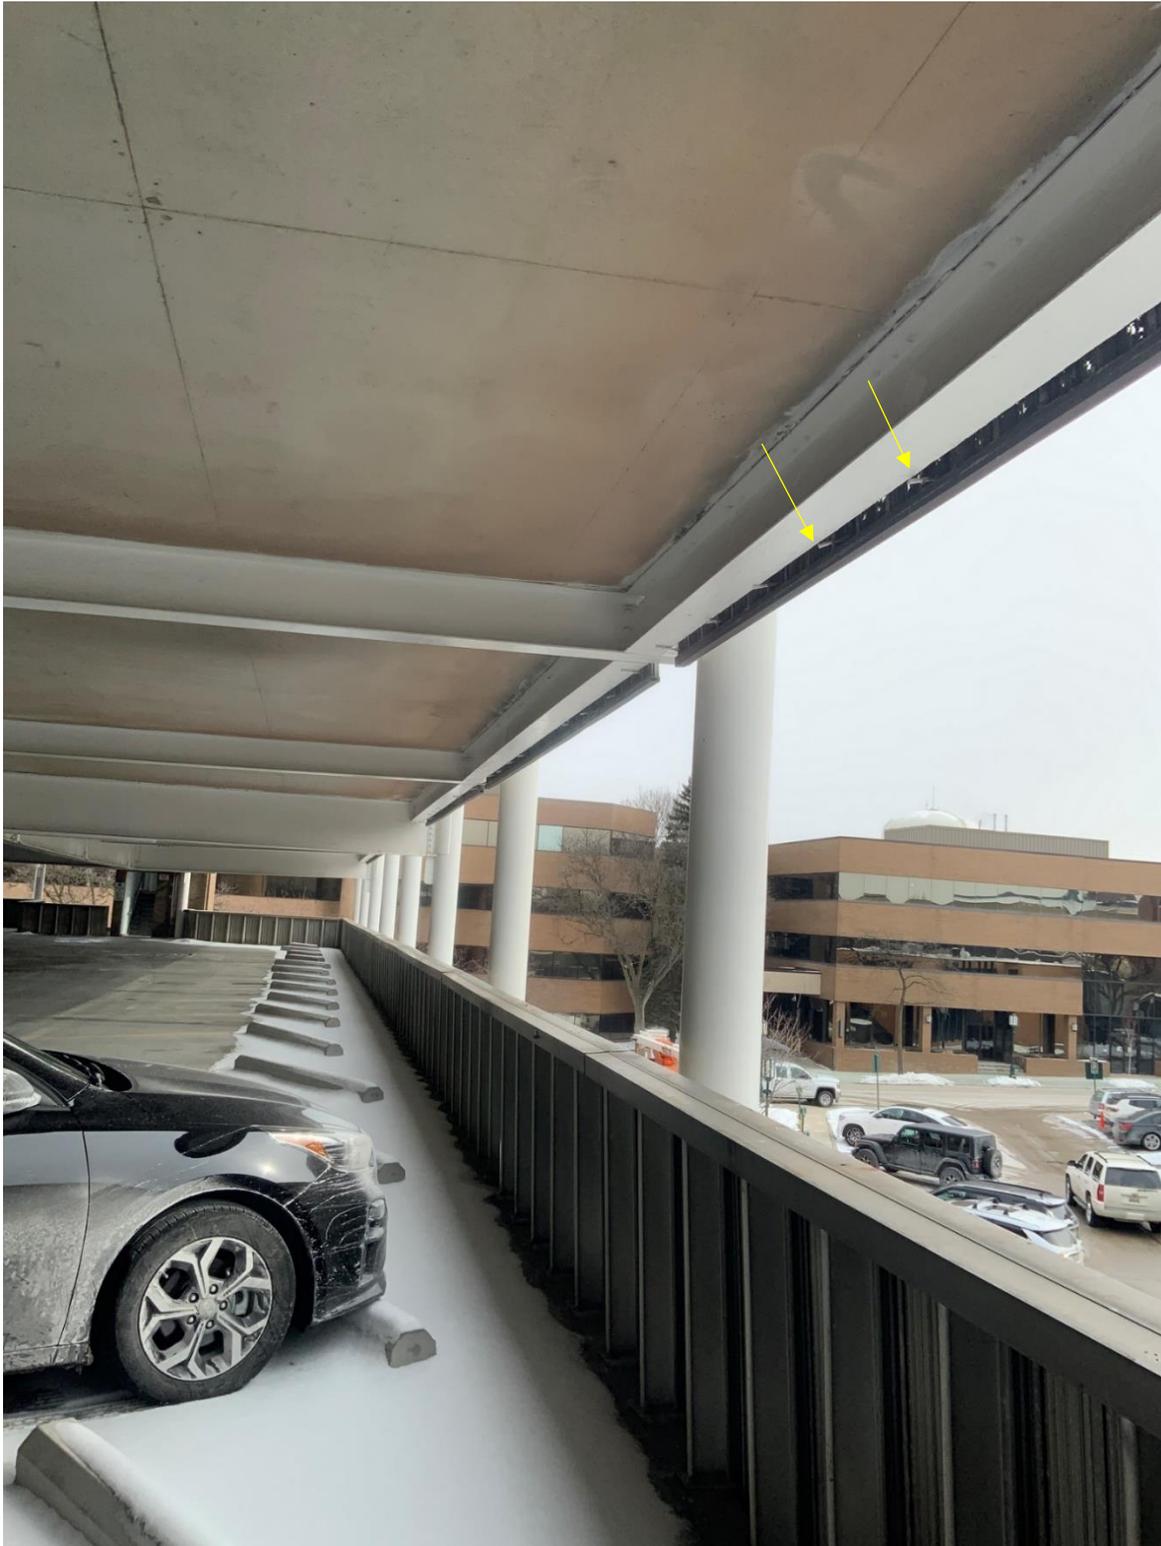
Figure 73. Facade panels tilted inward and failed tie-backs.

Reattach facade panel tie-backs ‡	1	LS	\$ 200,000	\$ 200,000
Miscellaneous				
Repair stair landings, tread/risers, CMU walls, and brick headers	1	LS	\$ 20,000	\$ 20,000
			Subtotal	\$ 550,250
			General Conditions, Overhead and Profit (15%)	\$ 82,538
			Project Contingency (15%)	\$ 82,538
			Engineering/Testing/Construction Period Services (10%)	\$ 55,025
			Long Term Recommendations Total	\$ 770,350
			Grand Total	\$ 3,649,310

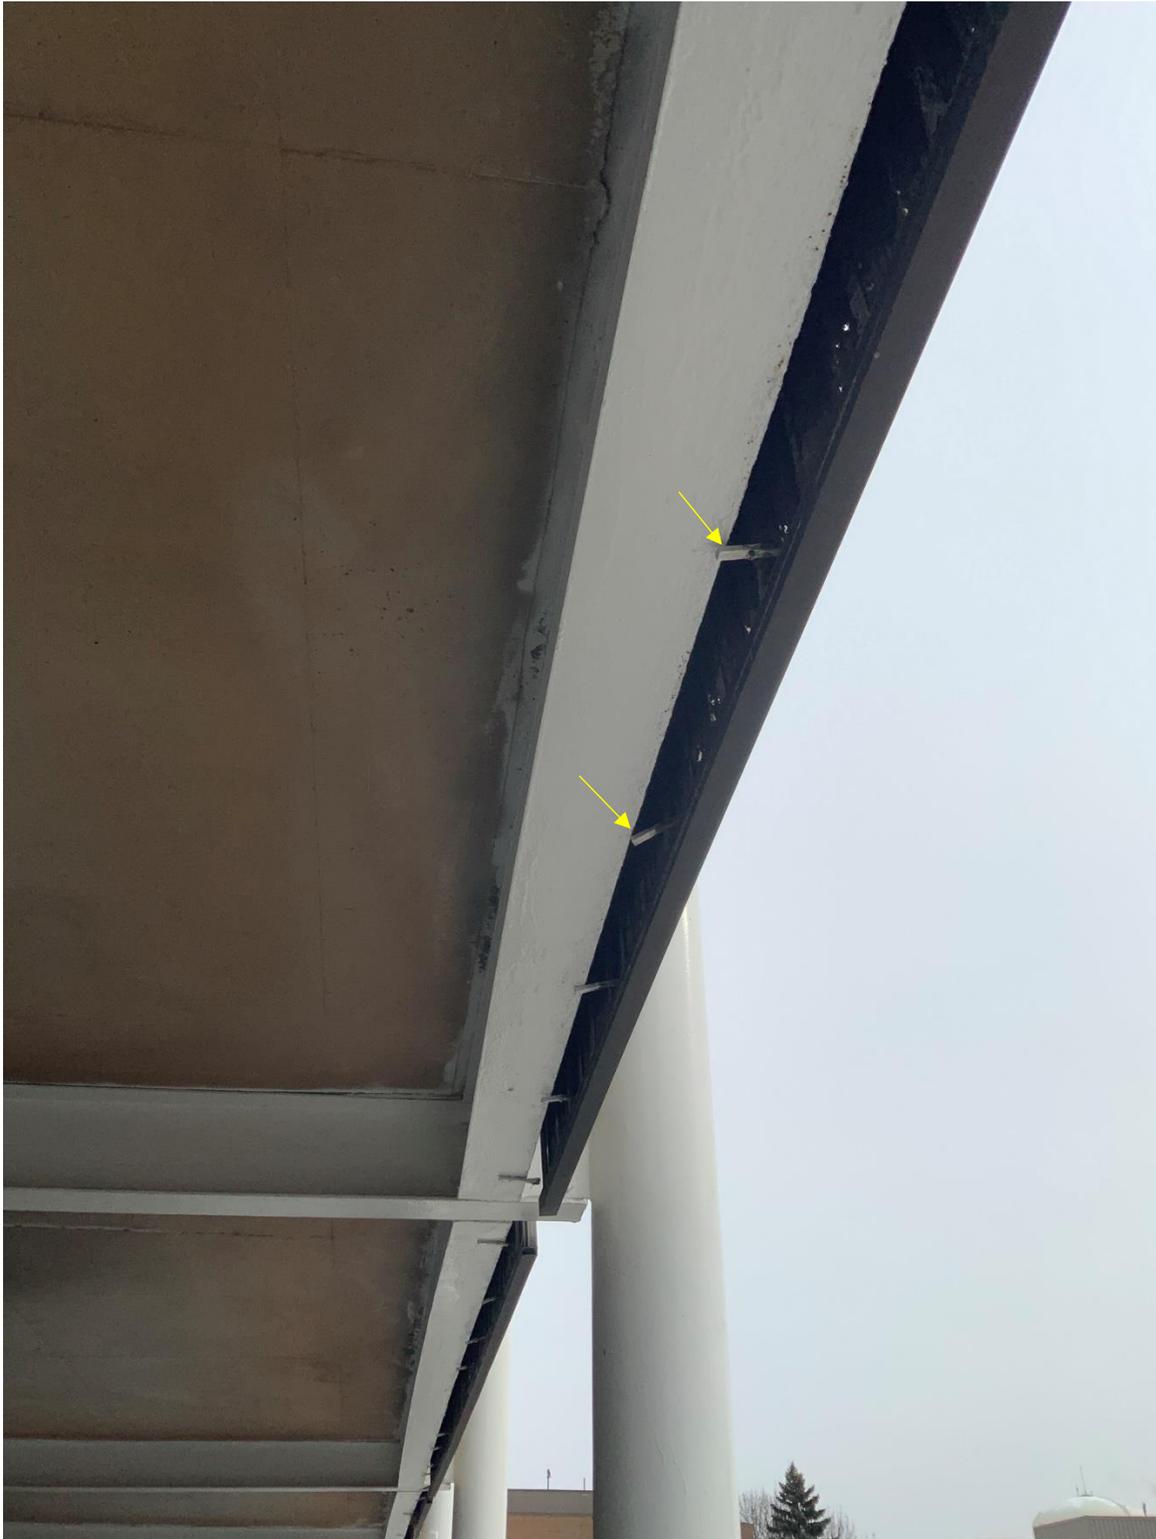
Figure 74. Failed welds and gaps at tie-backs

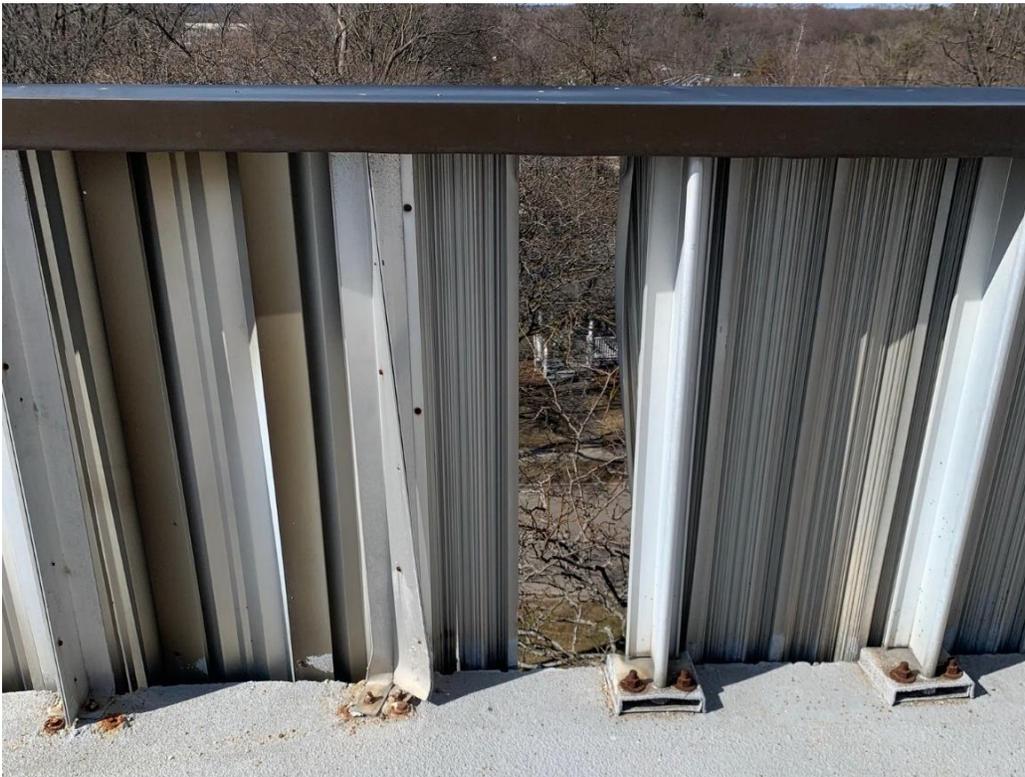
Figure 79. Opening in facade panels at roof level

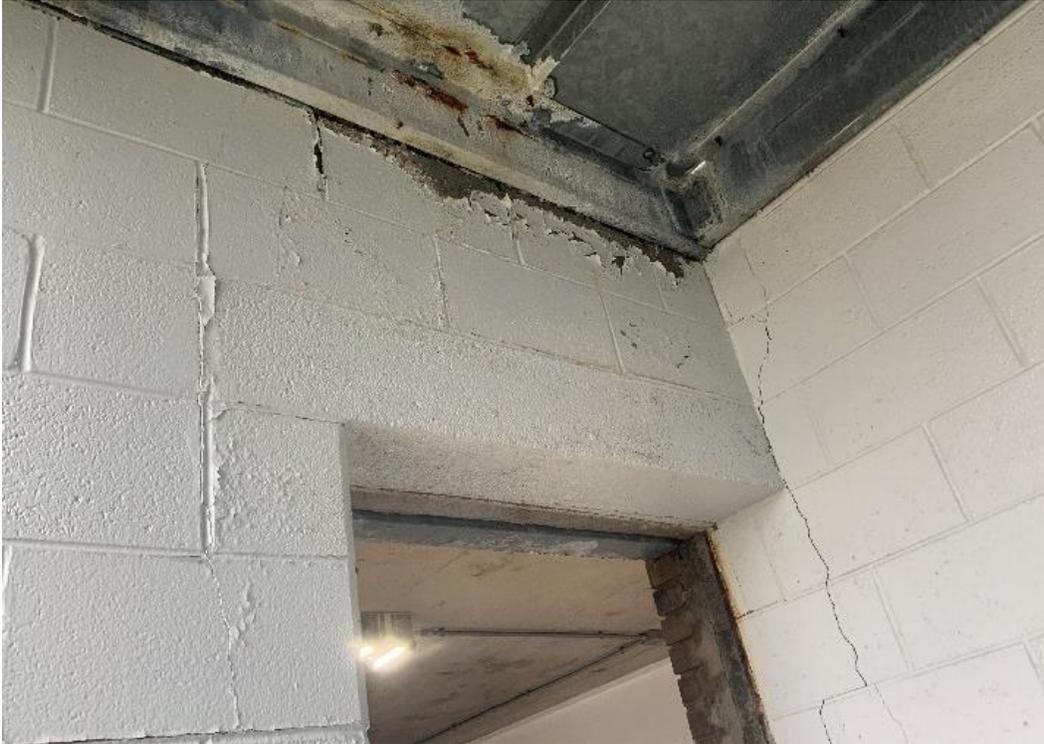
Figure 80. Cracks in CMU stair tower walls near corroded steel
