The Jeffrey 191 N Chester St Birmingham, MI

Community Impact Study (Combined C.I.S. and Site Plan Review)

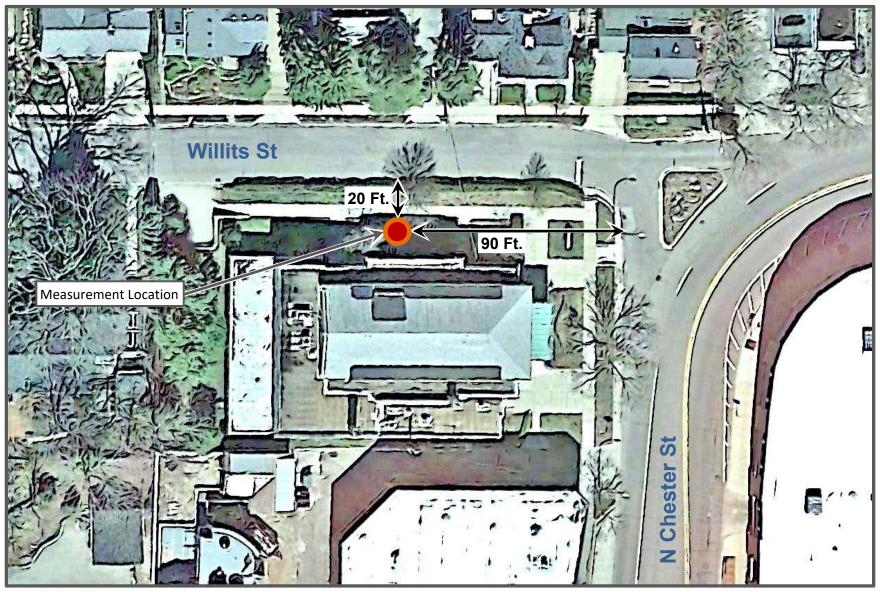
EXHIBIT 1

191 N CHESTER STREET AERIAL SITE VIEW DETAILING SOUND LEVEL MEASUREMENT LOCATION

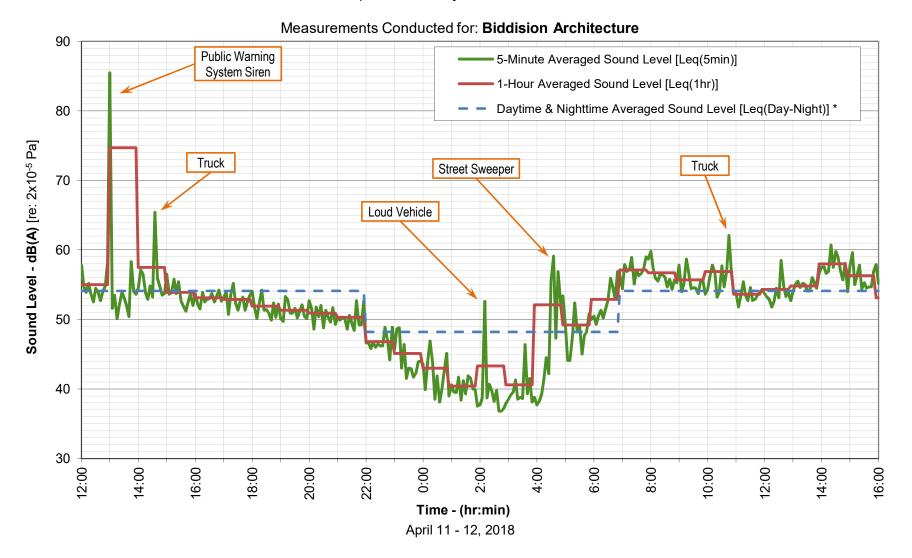
EXHIBIT 2

Ambient Sound Levels at 191 N Chester Street

Measured 20 Feet South of Willits Street and 90 Feet West of N Chester Street; Sound is predominantly from local vehicle traffic

^{*}The daytime average sound level does not include the public warning system siren.
