VIRTUAL MEETING OF THE ADVISORY PARKING COMMITTEE
WEDNESDAY, June 2, 2021 @ 7:30am
<https://zoom.us/j/98209276859> or dial: 877 853 5247 US Toll-free,
Meeting ID: 982 0927 6859

As requested, Wiss, Janney, Elstner Associates, Inc. (WJE) has completed limited condition assessments of the North Old Woodward, Park Street, Peabody, and Chester parking structures. These assessments were performed with the intent to determine the current and future infrastructure needs in support of a capital improvement plan; the intention of the plan is to extend the useful life of the structures and to maintain the structural integrity to ensure the structure can support the code-prescribed loadings. This report summarizes our observations at the Chester Parking Structure, located at 180 Chester Street in Birmingham, Michigan, and provides recommendations for your consideration.

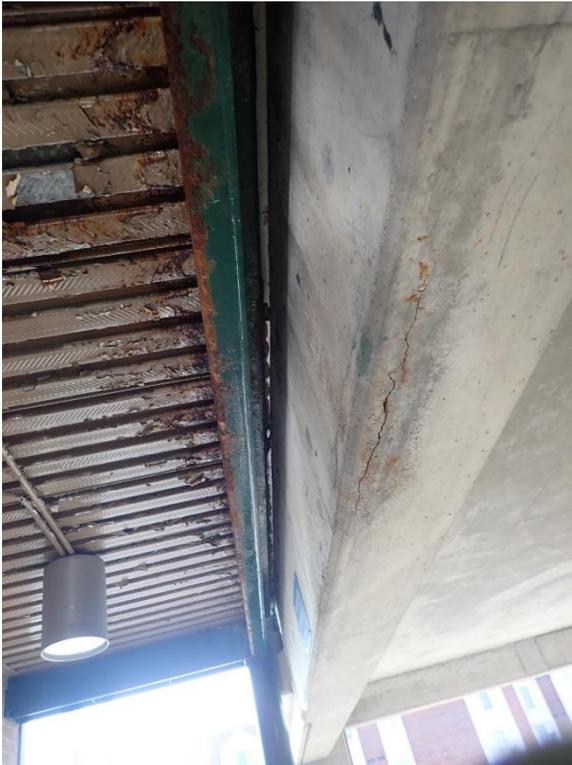
Figure 1. Peeling paint and corroded steel deck on underside of slab at elevator entryway, Tier 2. Note concrete beam distress near region of water penetration.

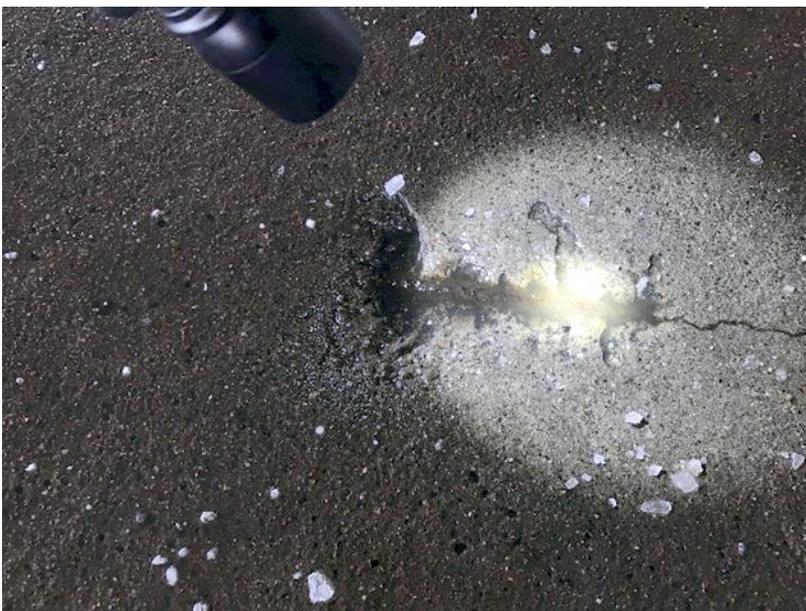
Figure 2. Spall exposing corroded mild reinforcing steel.

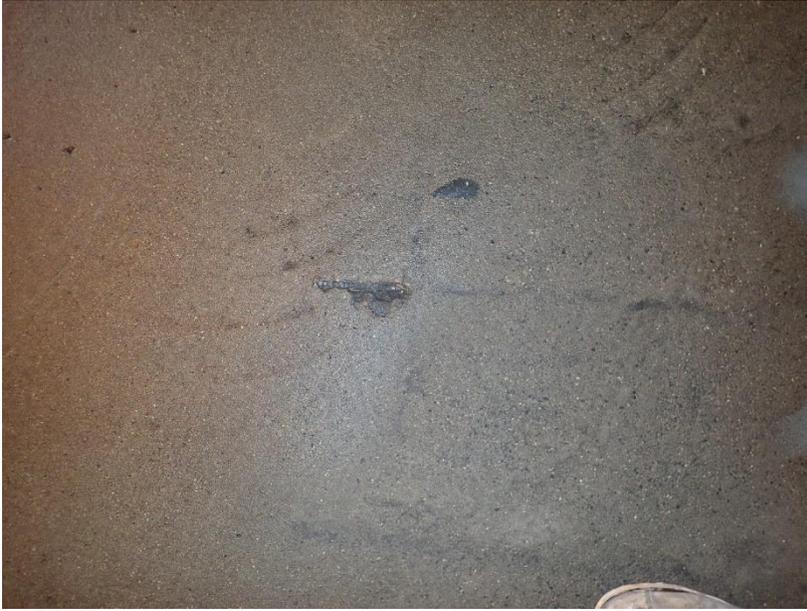
Figure 3. Spall exposing corroded mild reinforcing steel.

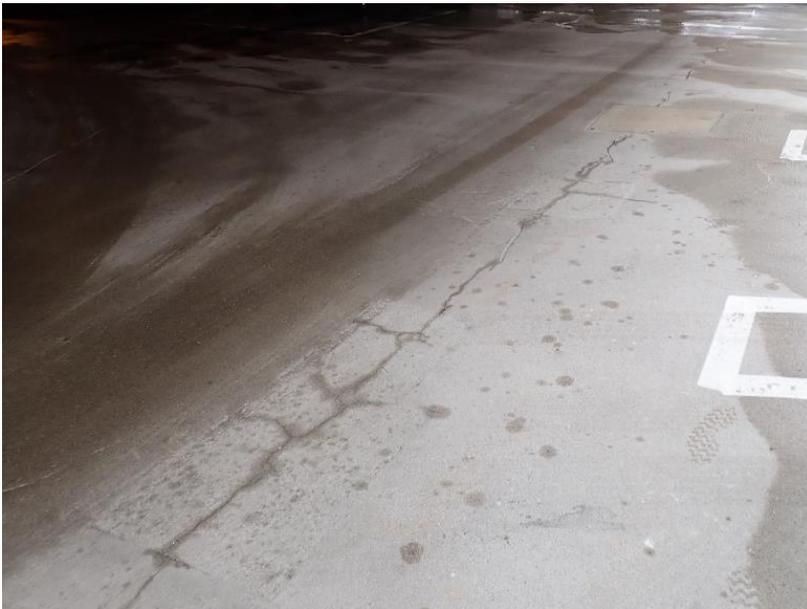
Figure 4. Isolated cracks in line with transverse temperature and shrinkage reinforcing steel, and penetrate previous repair areas.

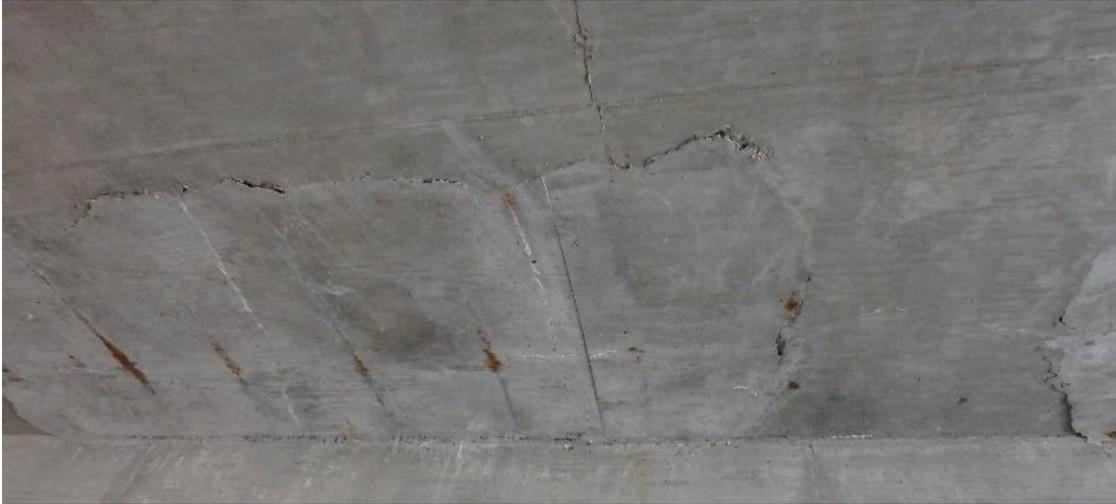
Figure 5. Isolated cracks, efflorescence, and corrosion staining at PT tendon anchorage repairs.

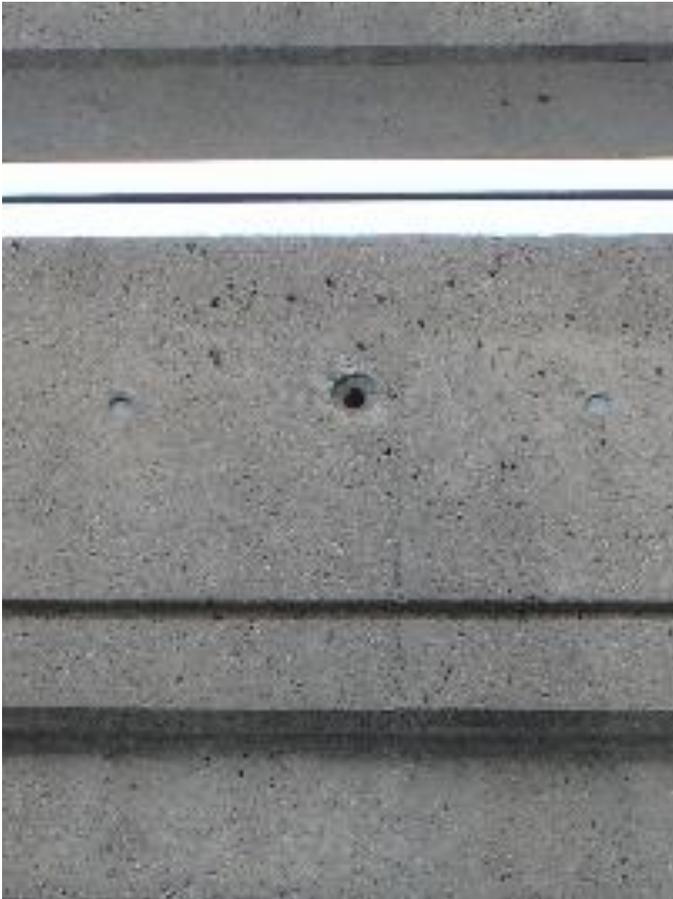
Figure 6. Isolated missing grout from grout pocket for slab PT anchorage.

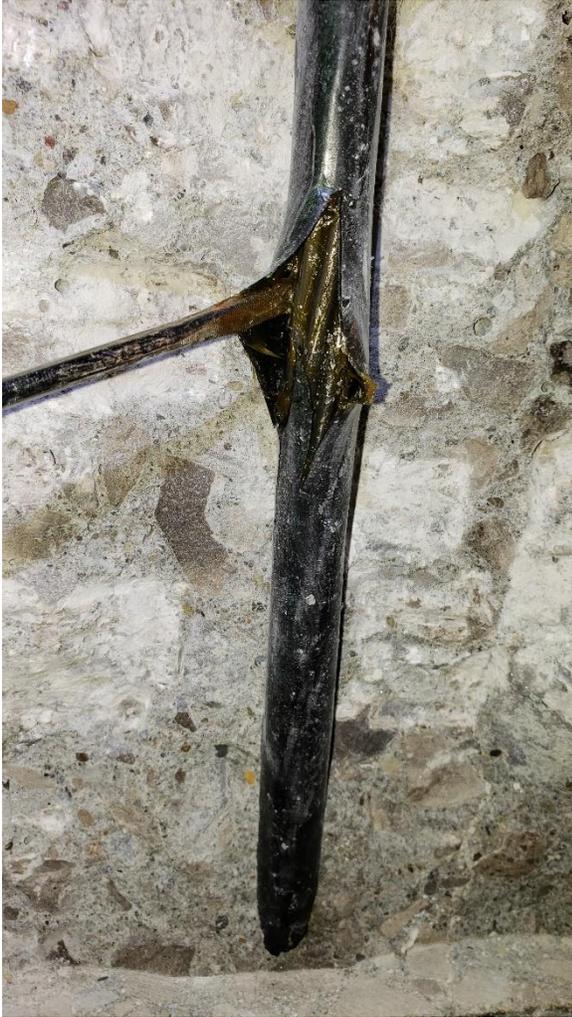
Figure 8. Typical good tendon condition at Inspection Openings 1, 2, and 4.

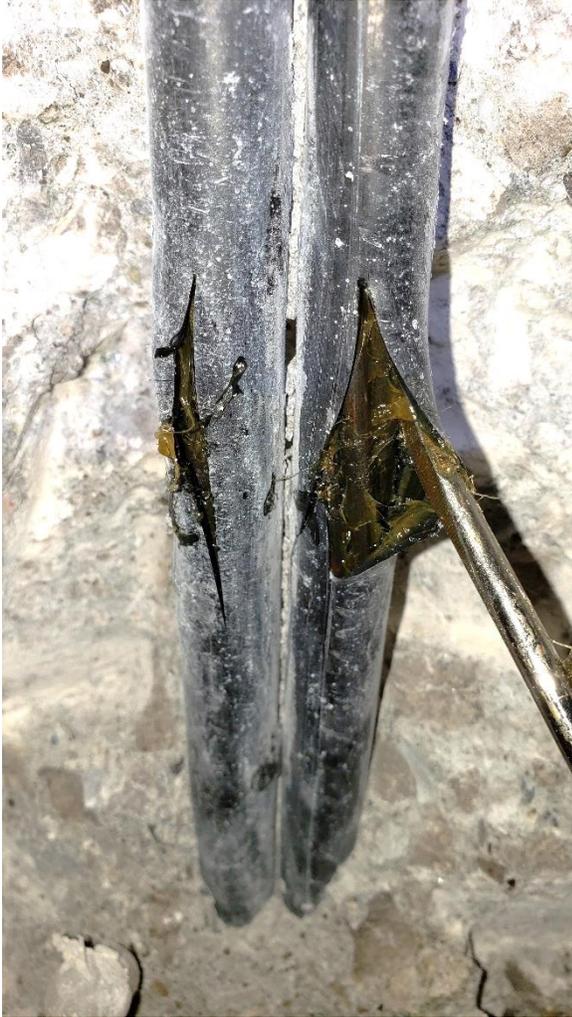
Figure 9. Exposed tendons at Inspection Opening 3.

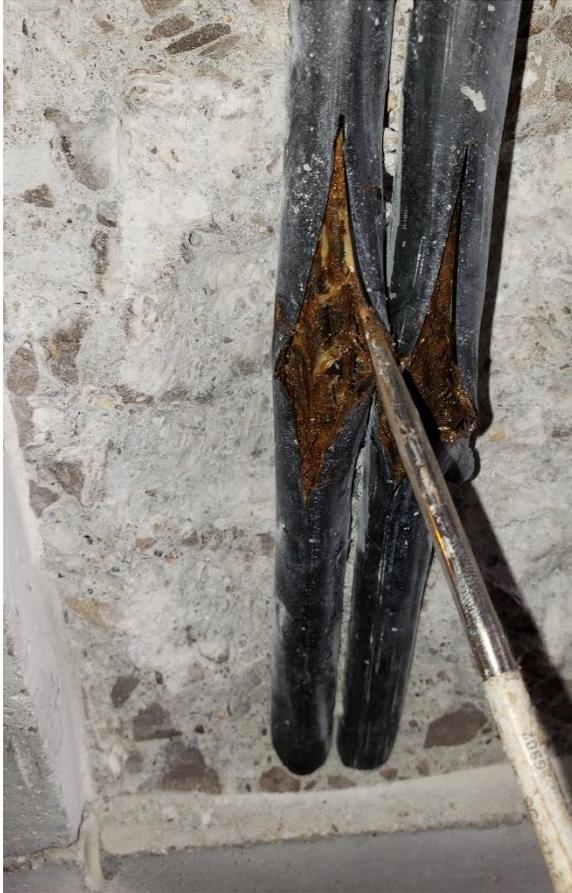
Figure 10. Exposed tendons at Inspection Opening 5 with corrosion byproducts and emulsified grease.

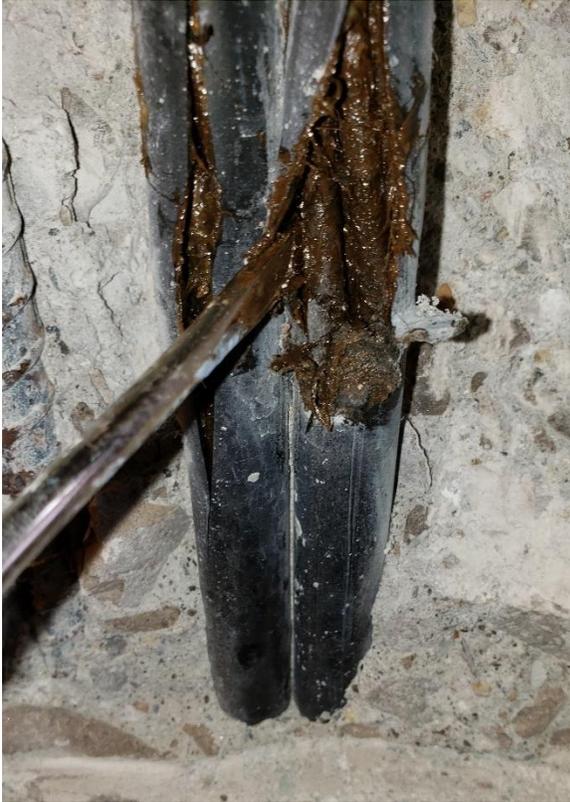
- c. **Inspection Opening 6:** Two tendons were exposed in a sound concrete area adjacent to a previous PT repair. The tendon sheathings were intact, and the tendons were holding tension. Corrosion byproducts and moisture had emulsified the grease (Figure 11). Section loss and pitting of the individual wires were not observed.

Figure 11. Exposed tendons at Inspection Opening 6 with corrosion byproducts emulsified in the grease.

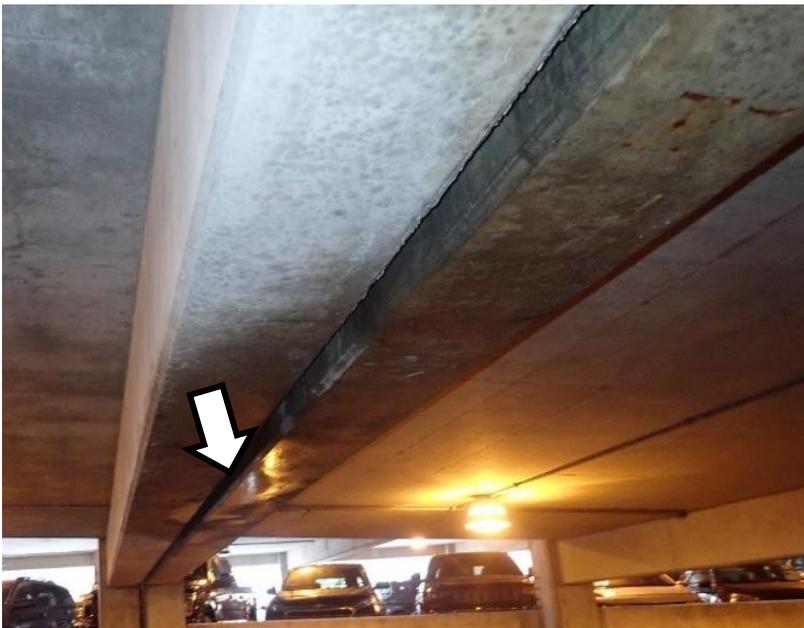
1. Evidence of water infiltration is present on the majority of beams at the expansion joints (Figure 12).
2. Localized areas of delaminated concrete and cracking are present within PT beams at each level (Figure 13). At approximately 20 locations, the locations of unsound concrete range in size from approximately 5 to 40 square feet.
 - a. The observed beam distress is concentrated at expansion joints and stair towers at each level of elevated slab, with more severe distress concentrated at Tier 1 and Tier 3.

Figure 12. Water infiltration and corrosion staining at the underside of a deteriorated expansion joint.

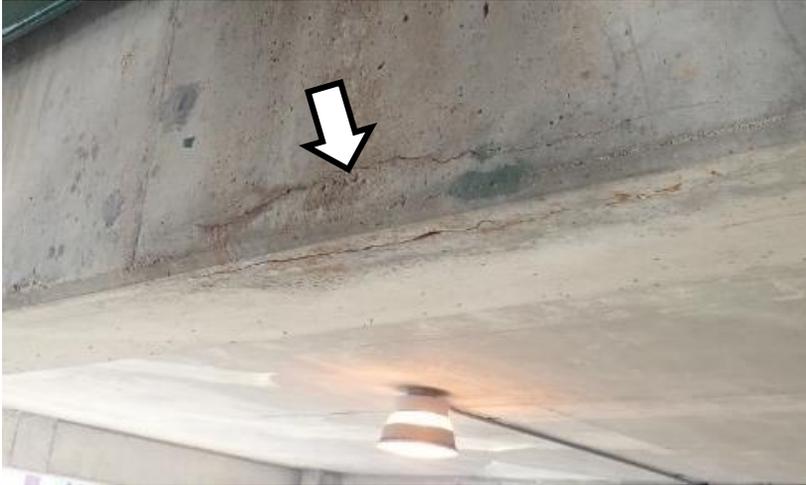
Figure 13. Arrow indicates delamination on beam.

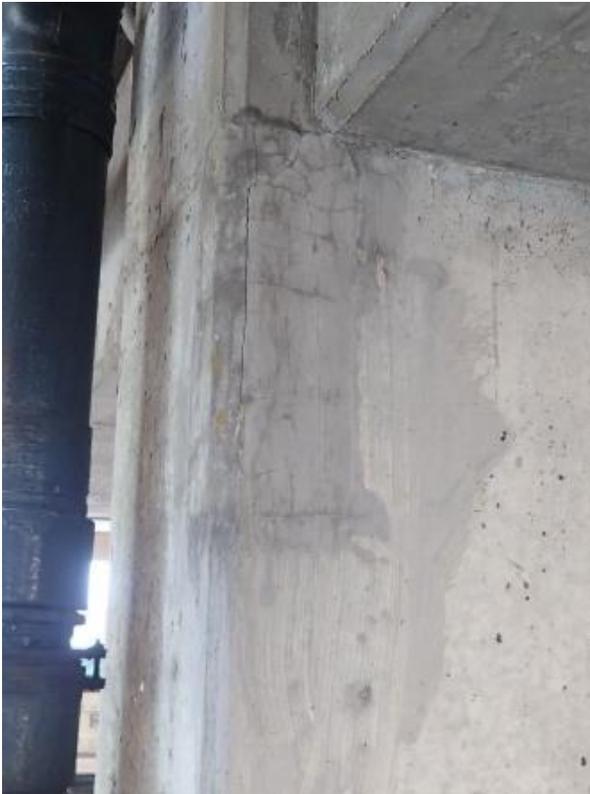
-
- b. A majority of the previous concrete beam and column repairs are unsound on Tier 1 and Tier 4 (Figure 14). Previous concrete repairs at other levels are generally serviceable.

Figure 14. Unsound concrete patch at top of column, Tier 3.

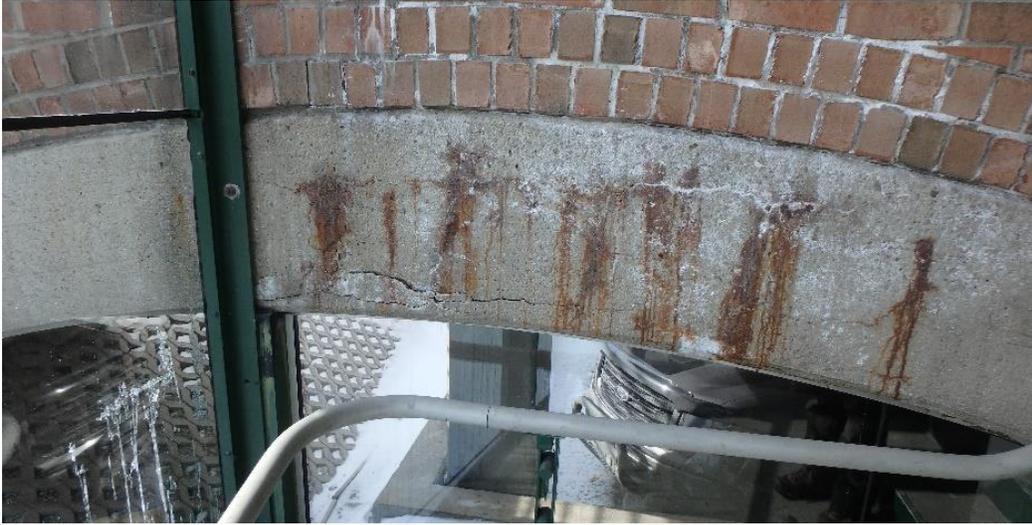
4. Arched beams supporting the pedestrian bridges exhibit areas of unsound concrete, corroded exposed reinforcement, cracking, and corrosion and efflorescence staining (Figure 15).

Figure 15. Typical area of unsound concrete, cracking, and corrosion and efflorescence staining on arched beam supporting pedestrian bridge.

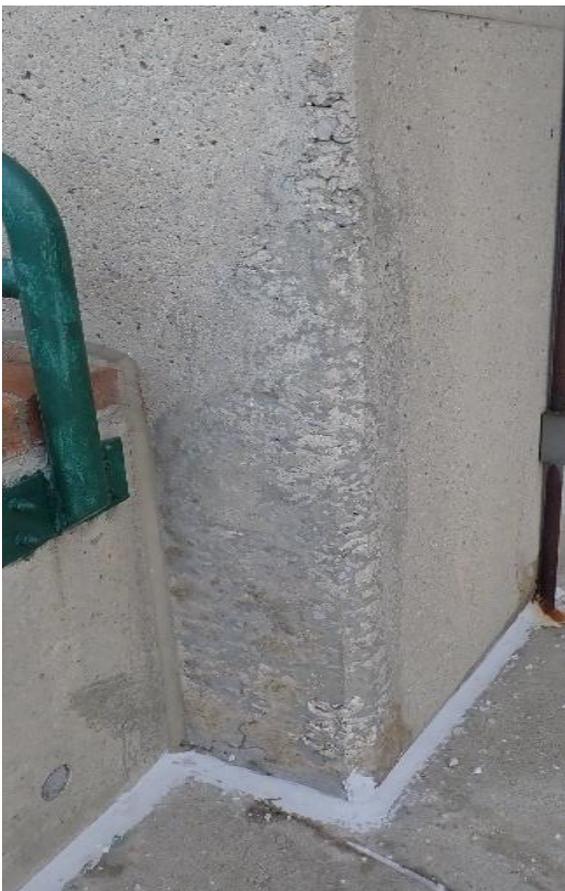
5. Honeycombing in the concrete surface was noted at isolated columns, though these areas were found to be sound (Figure 16).
 6. Approximately 30 columns across the structure, particularly on columns supporting Tier 2 and Tier 4, have localized areas of delaminated concrete that are primarily near the bottom of the columns, which are an average size of 2 to 4 square feet each (Figure 17). This includes some of the inclined columns (Figure 18). Other areas of concrete distress were observed at columns located below failed expansion joint seals, pedestrian bridges, and at some beam-to-column intersections.

Figure 16. Isolated concrete honeycombing in concrete column.

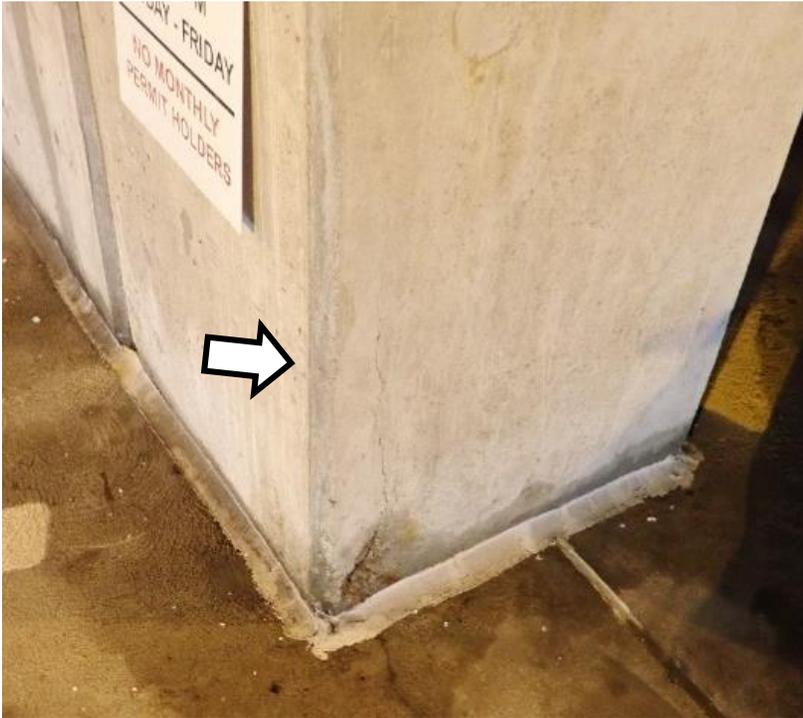
Figure 17. Arrow indicates crack with adjacent unsound concrete near column bottom.

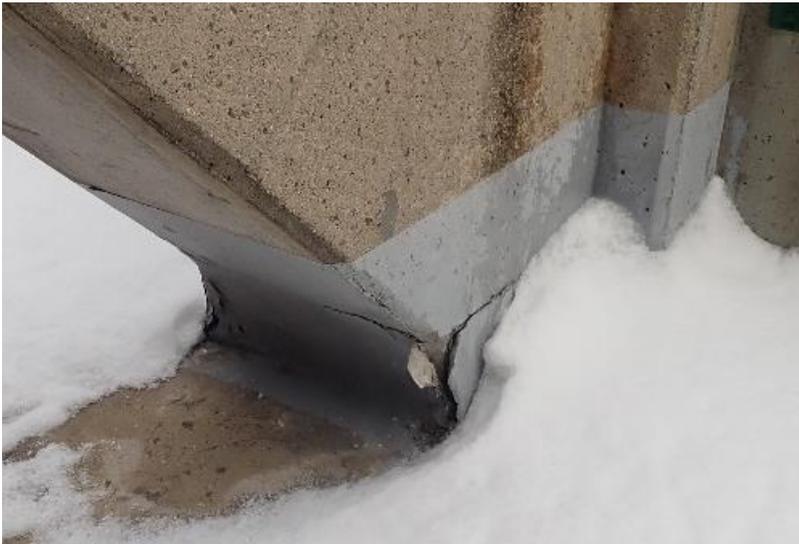
Figure 18. Delaminated coating and unsound concrete at base of inclined column supporting Tier 4.

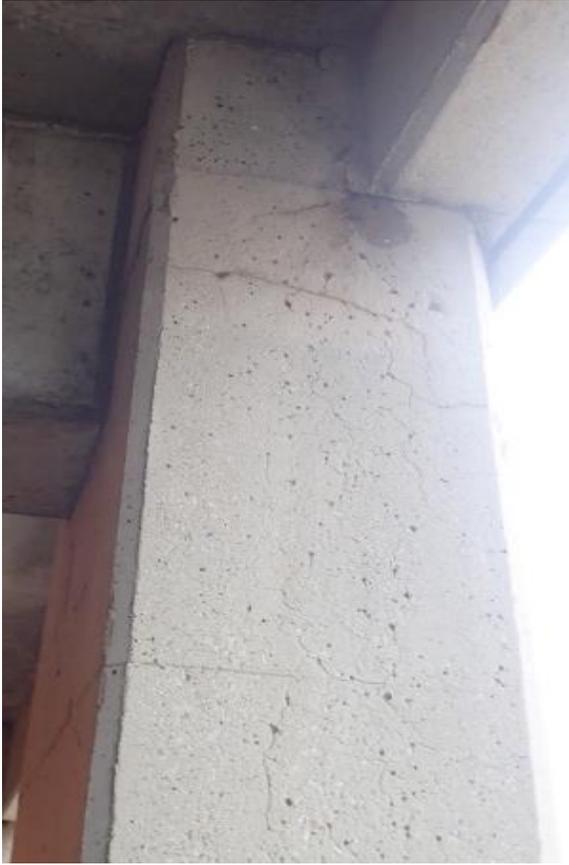
7. Several of the columns and spandrel beams have narrow cracks, which primarily align with stirrup reinforcement, and are particularly concentrated on the exterior facing surfaces (Figure 19). Corrosion staining was generally not observed, except in isolated regions where reinforcing bars were exposed due to low concrete cover (less than 1/8 inch to 1/4 inch).

Figure 19. Shrinkage cracks on exterior column, Tier 2.

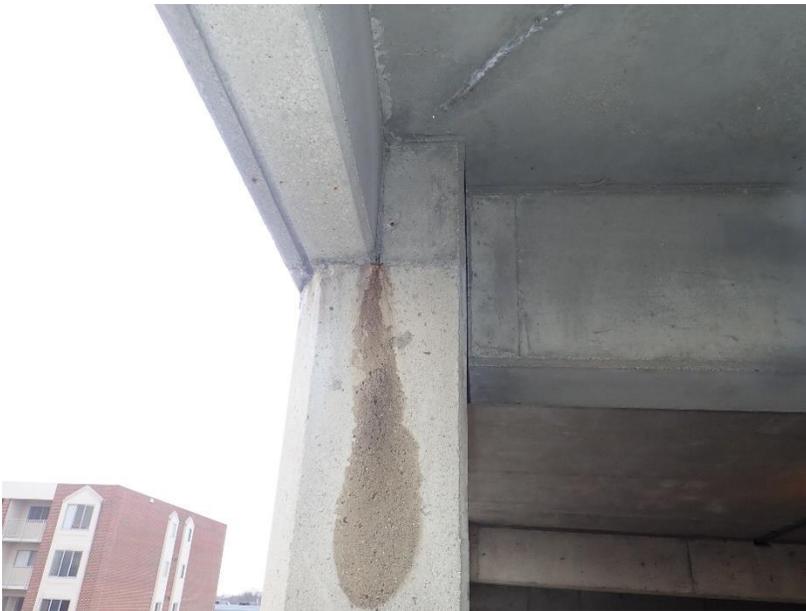
8. Evidence of water infiltration and restraint cracking is present at several locations where the spandrel beams bear on the columns (Figure 20). Water staining, corrosion staining and/or efflorescence were observed during WJE's site visit. The cracked concrete areas were generally sound.

Figure 20. Active water infiltration where spandrel beam bears on column.

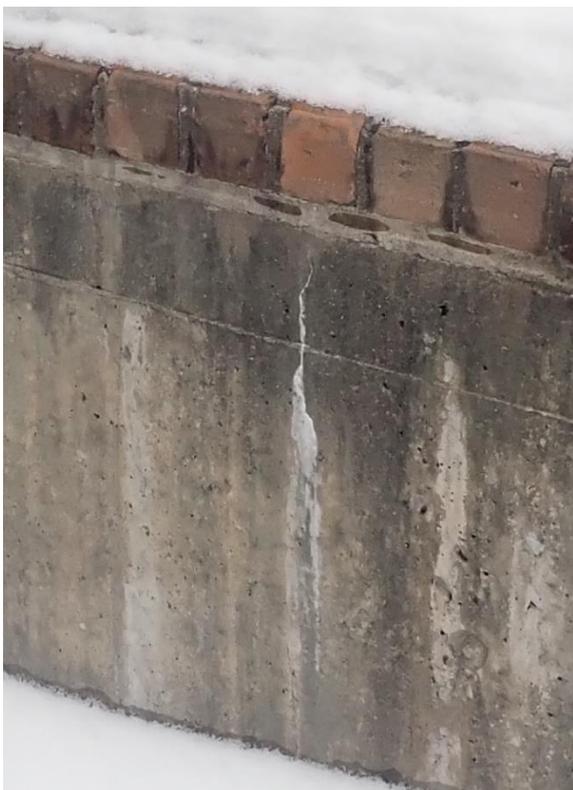
Figure 22. Crack with efflorescence staining on perimeter wall.

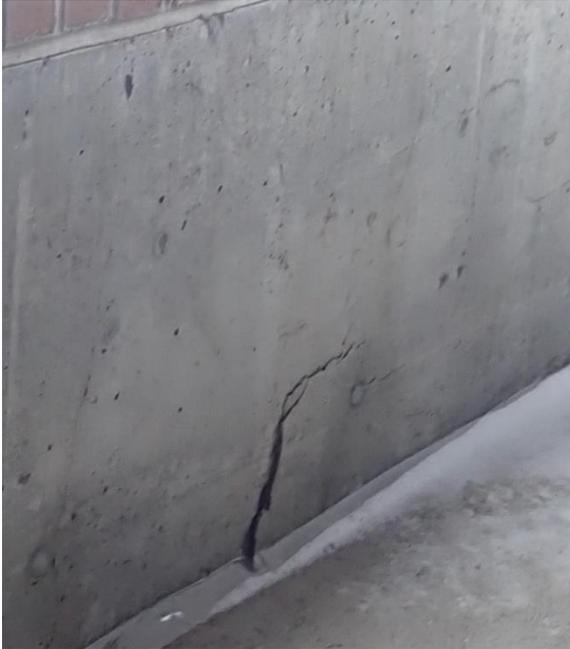
Figure 23. Crack and unsound concrete on perimeter wall, north bay of Tier 1.

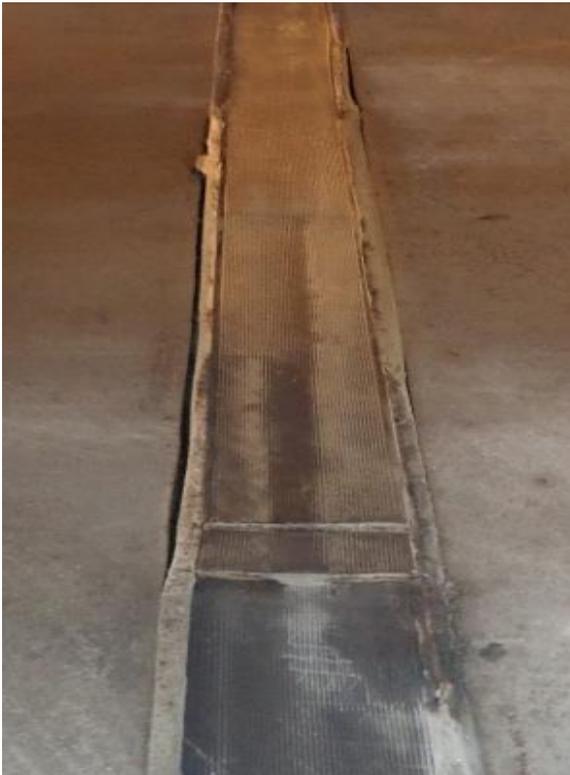
1. Most of the pre-molded seals for expansion joints have tears in the sealant or adhesion failures of the sealant to the concrete substrate (Figure 24). Active water penetration was noted at a majority of these locations during WJE's assessment. The expansion joint seals between the composite slab outside the elevators, pedestrian bridges, and adjacent post tensioned concrete slab exhibit similar distress (Figure 25).

Figure 24. Adhesively failed edges of pre-molded expansion joint seal.

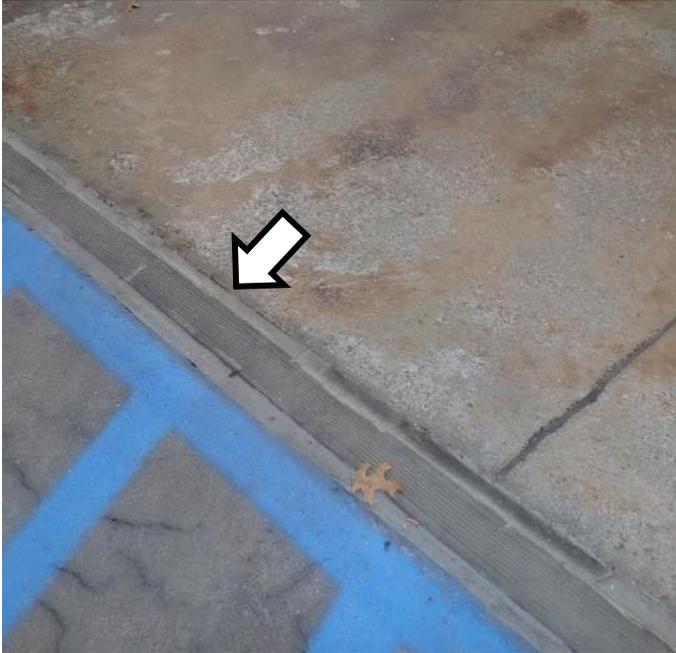
Figure 25. Arrow indicates adhesively failed pre-molded expansion joint seal near elevator shaft.

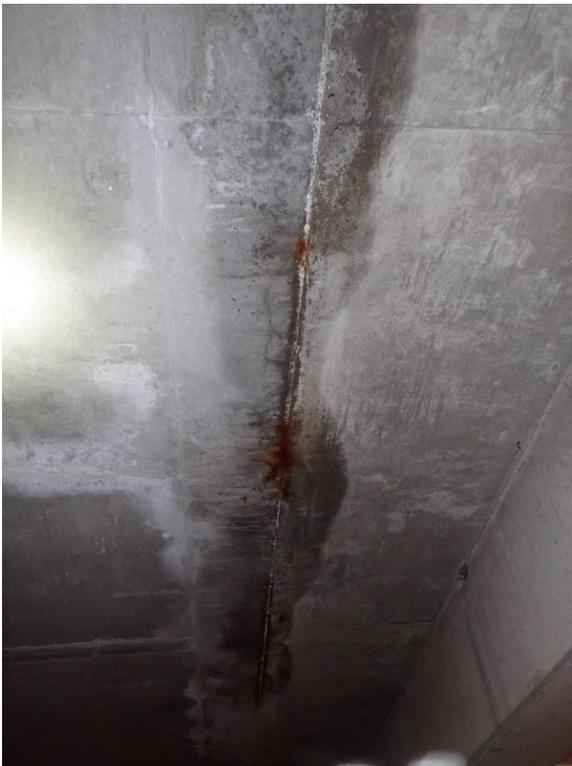
4. Efflorescence and water staining are present at the bottom of the slab at approximately 10 percent of the construction joints, indicating prolonged moisture exposure in these regions (Figure 26).

Figure 26. Efflorescence, moisture, and corrosion staining on the underside of a construction joint.

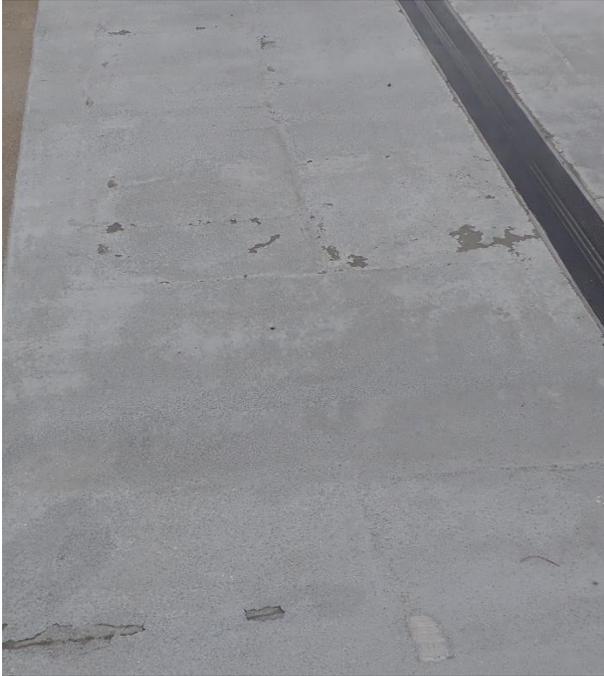
6. Much of the traffic coating that exists at the Tier 3 and Tier 4 expansion joints is worn or delaminated (Figure 27).
7. The traffic coating at the pedestrian bridges is delaminated (Figure 28).

Figure 27. Worn and delaminated coating at Tier 4 expansion joint.

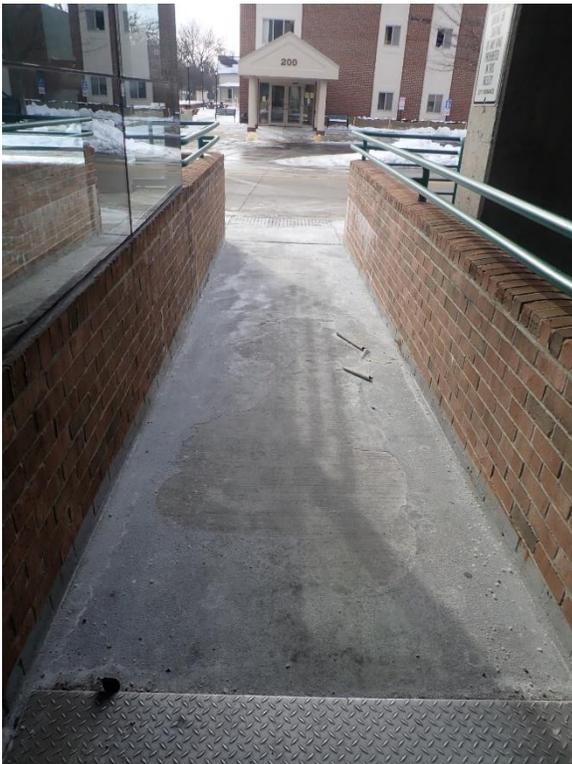
Figure 28. Delaminated coating at pedestrian bridge.

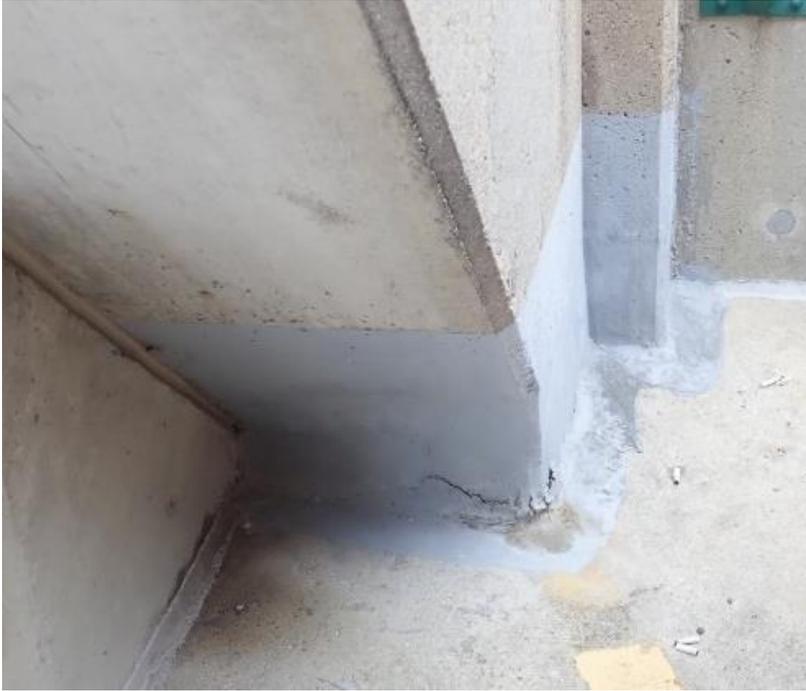
8. The traffic coating around the bases of inclined columns at Tier 3 has tears and areas of delamination (Figure 29).
9. One area of standing water was noted on the northeast end of Tier 1 (Figure 30). The area of standing water encompasses approximately 1,000 square feet. Smaller isolated areas of standing water are present within Tier 3, which are approximately less than 100 square feet each.

Figure 29. Delaminated coating at inclined column base, Tier 3.

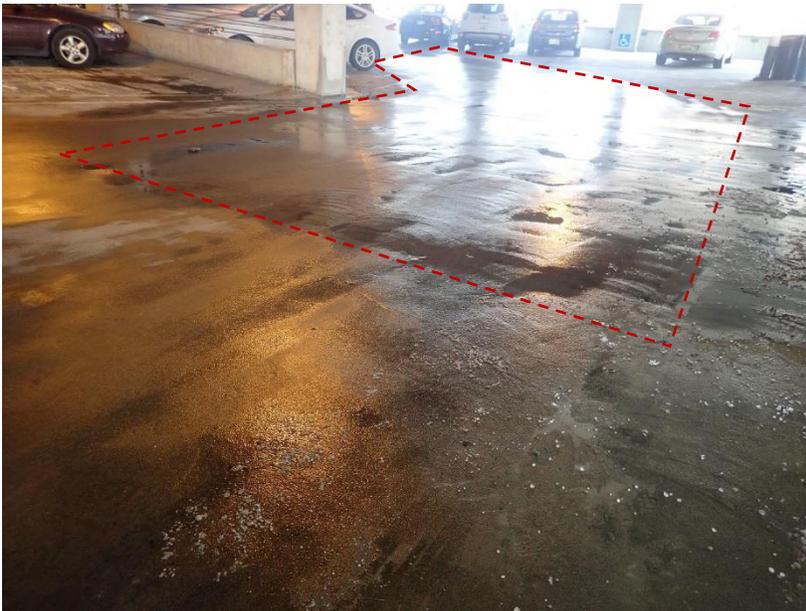
Figure 30. Dashed line indicates standing water observed at Tier 2.

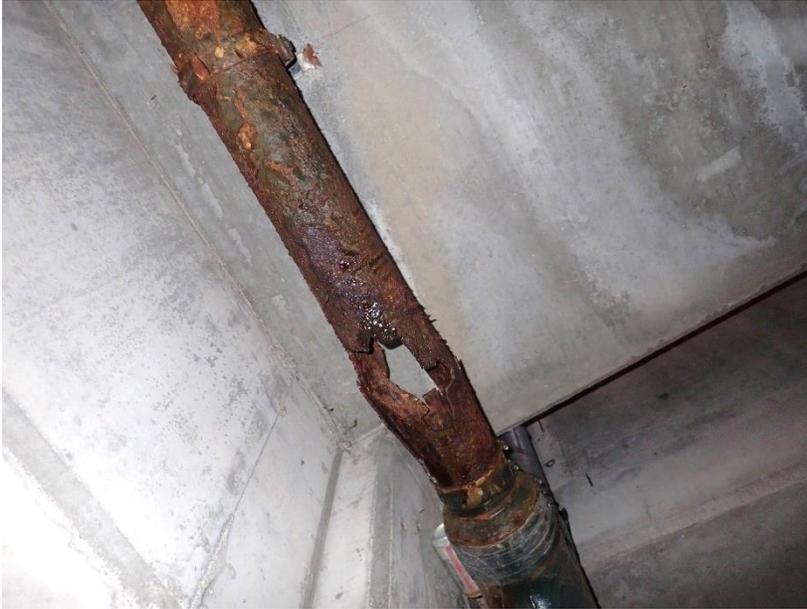
Figure 31. Through-corroded floor drainage pipe.

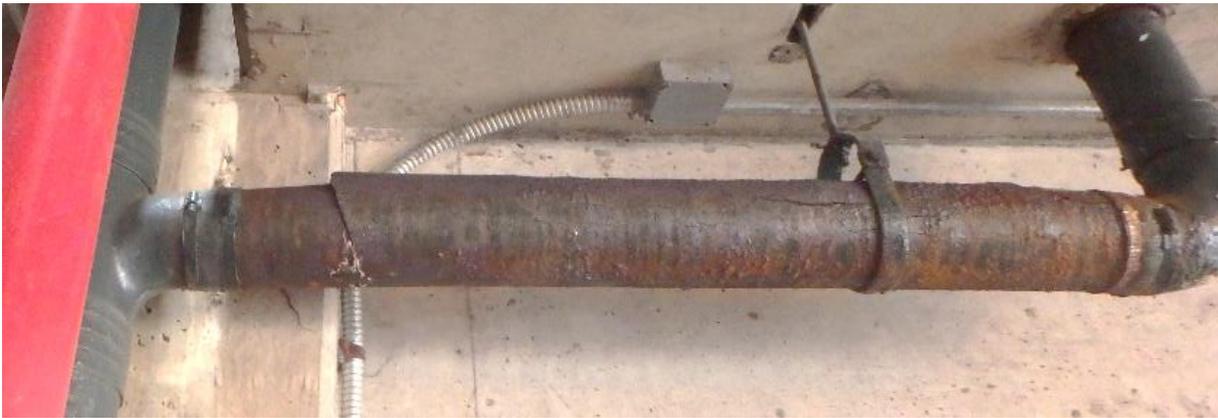
Figure 32. Cracked floor drainage pipe with corrosion product.

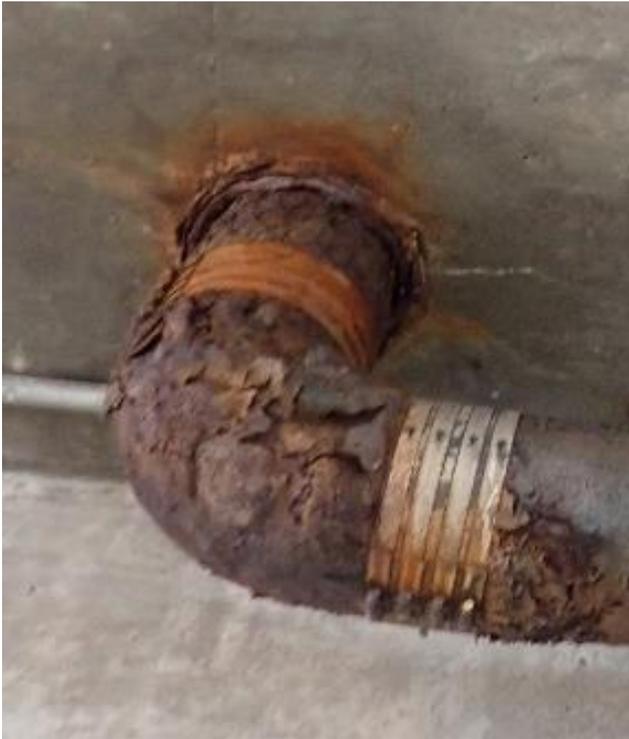
Figure 33. Corrosion product from floor drain bowl above.

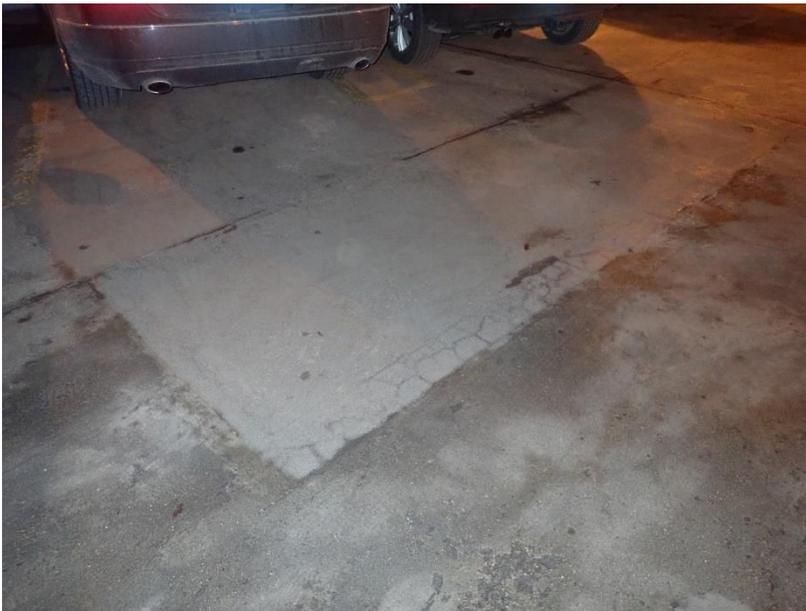
1. A partial-depth repair at the slab on ground, encompassing approximately 125 square feet in the north bay, is unsound and cracked (Figure 34).

Figure 34. Unsound and cracked partial-depth concrete repair at Tier B.

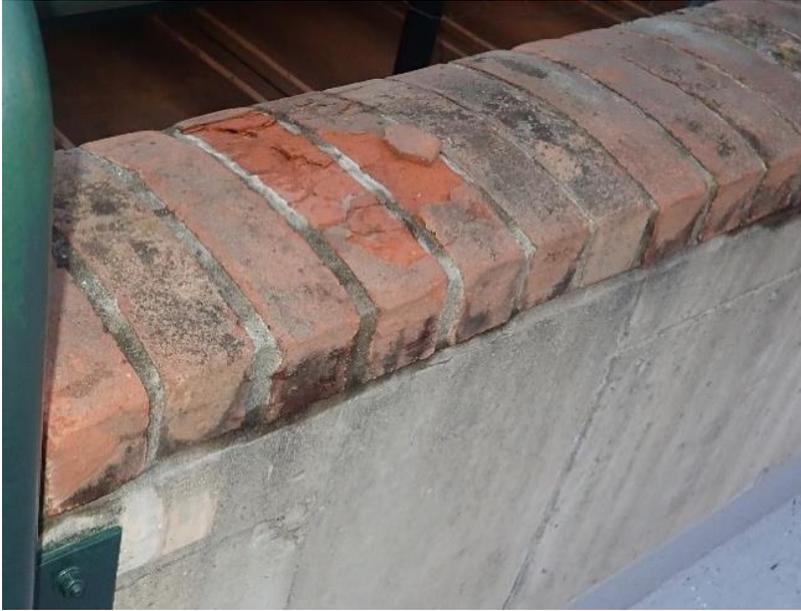
Figure 35. Cracked and spalled brick coping on concrete spandrel beam, Tier 2.

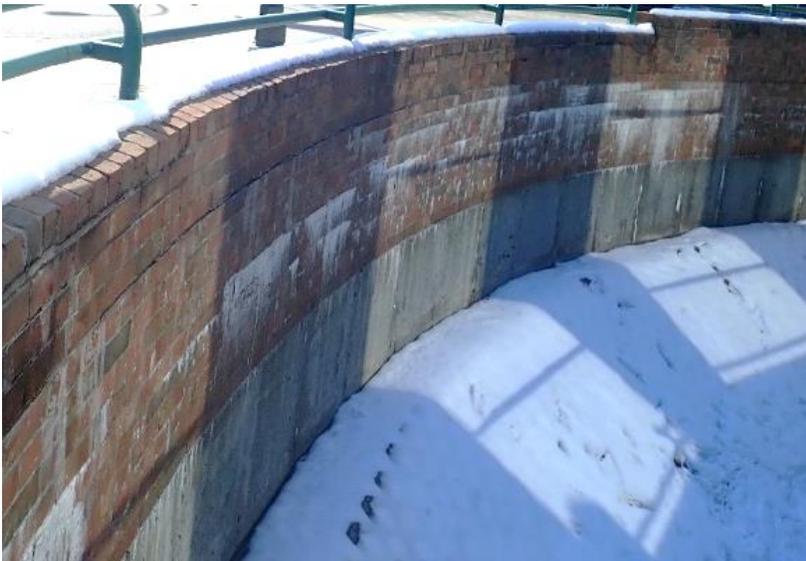
Figure 36. Efflorescence staining and eroded mortar joints at site wall.

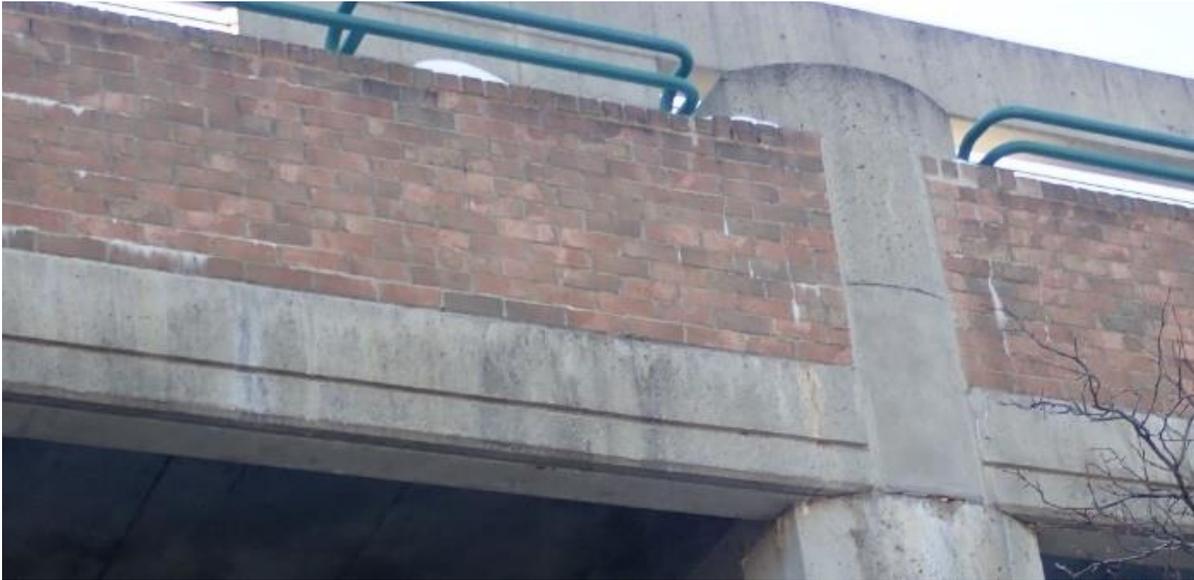
Figure 37. Efflorescence, staining and eroded mortar joints, west elevation.

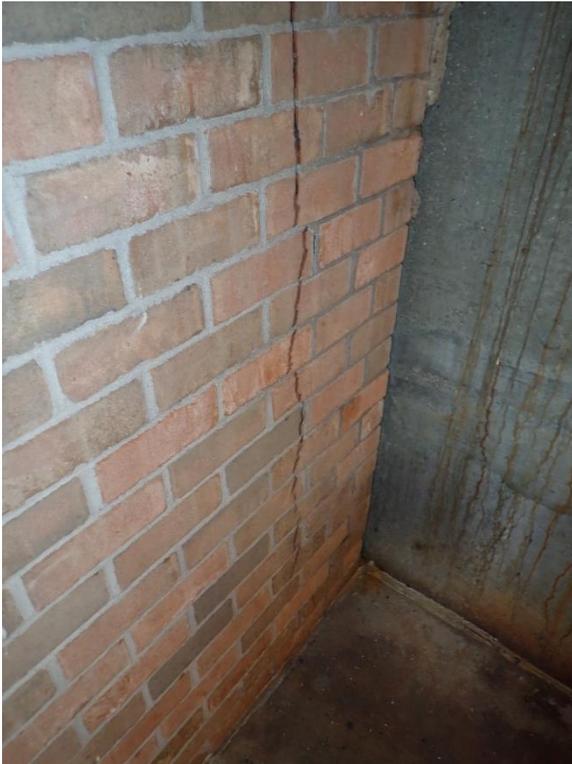
Figure 38. Vertical crack between southeast stairwell common wall and deck, Tier A.

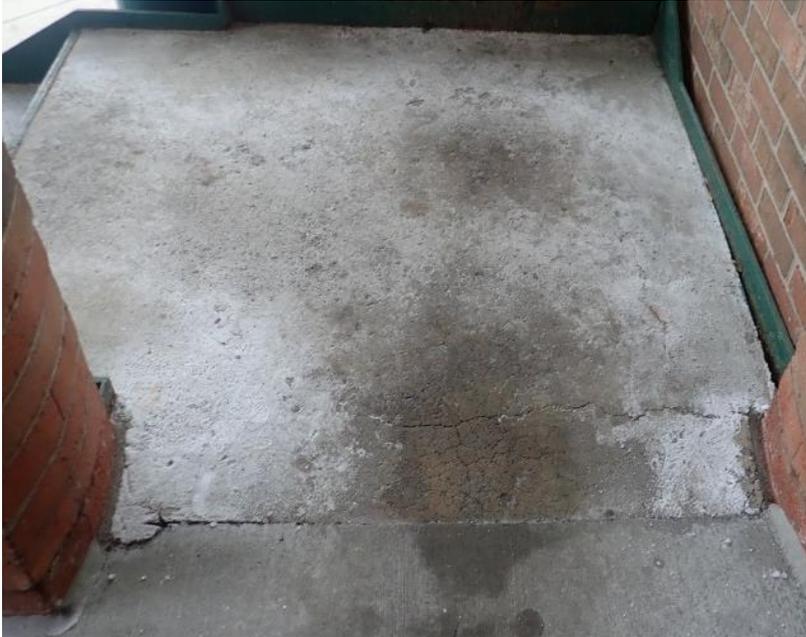
Figure 39. Cracked and eroded concrete stair landing.

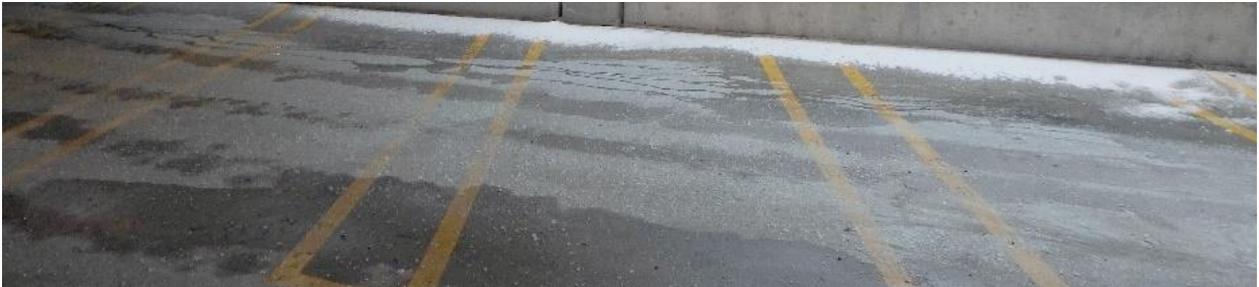
Figure 40. Typical de-icing salt placement noted during WJE's assessment.

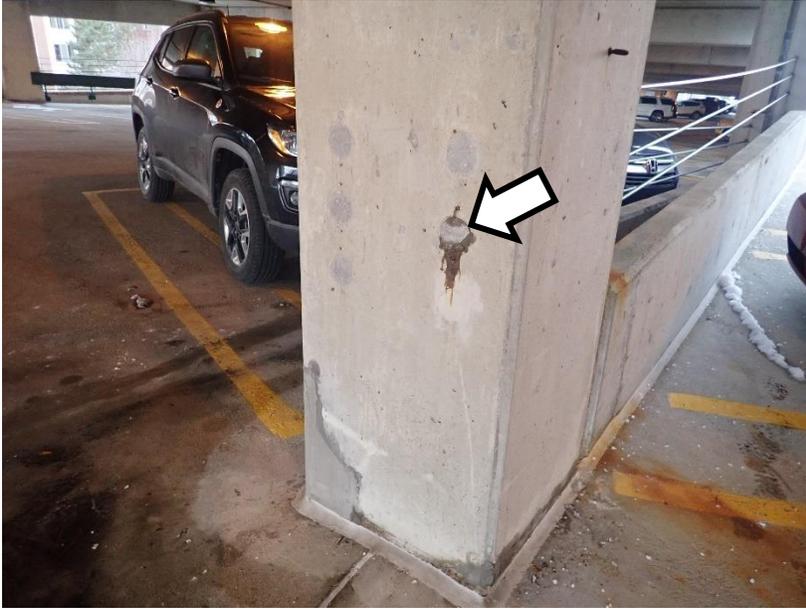
Figure 41. Arrow indicates grease staining from grout pocket for vehicle barrier cable.

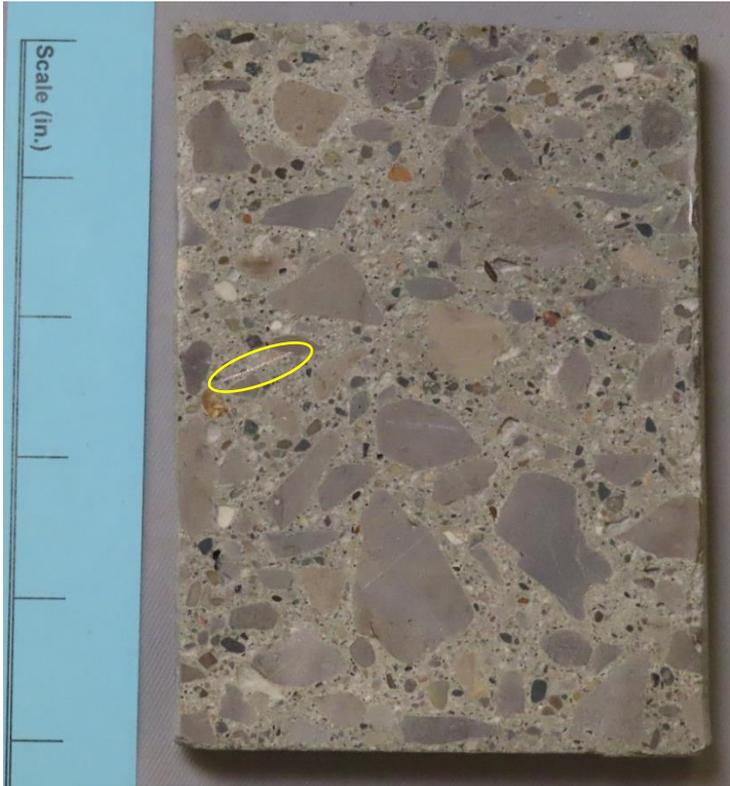
Figure 2. Lapped surface of Core 2. Residual copper left from a paste scratch hardness test is circled on the image.

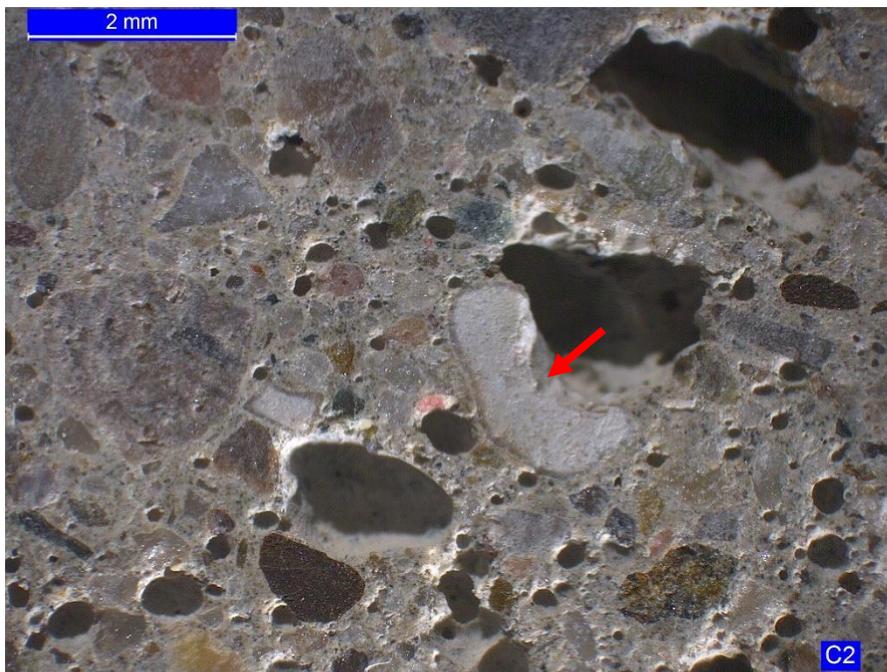
Figure 3. A chert fine aggregate contains a discontinuous reaction rim adjacent the void (arrow).

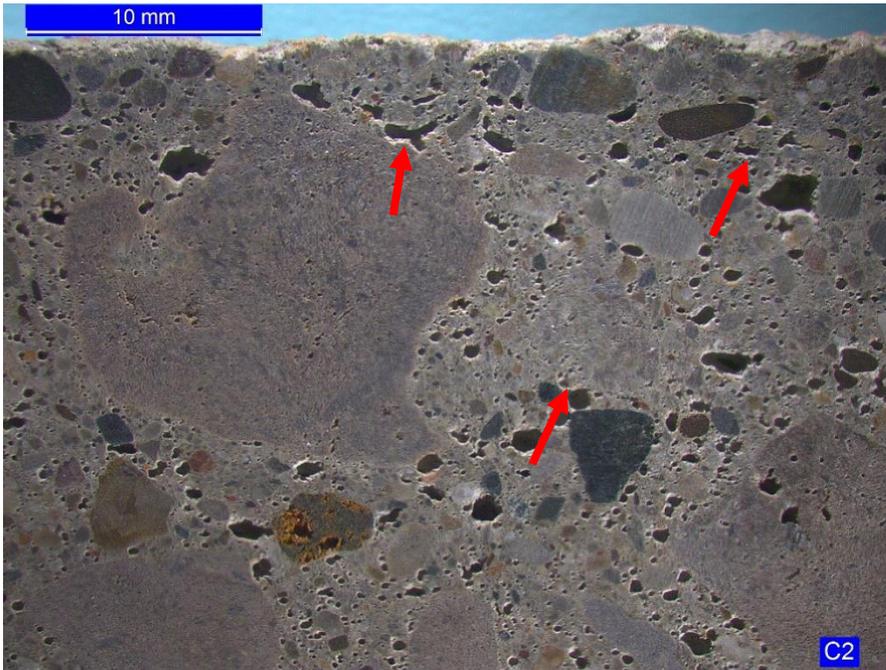
Figure 6. Irregularly-shaped bleed water voids (arrows) near the surface of Core 2. No distress is associated with the presence of these voids near-surface.
