VIRTUAL MEETING OF THE ADVISORY PARKING COMMITTEE
WEDNESDAY, June 2, 2021 @ 7:30am
<https://zoom.us/j/98209276859> or dial: 877 853 5247 US Toll-free,
Meeting ID: 982 0927 6859

As requested, Wiss, Janney, Elstner Associates, Inc. (WJE) has completed limited condition assessments of the North Old Woodward, Park Street, Peabody, and Chester parking structures. These assessments were performed with the intent to determine the current and future infrastructure needs in support of a capital improvement plan; the intention of the plan is to extend the useful life of the structures and to maintain the structural integrity to ensure the structure can support the code-prescribed loadings. This report summarizes our observations at the Chester Parking Structure, located at 180 Chester Street in Birmingham, Michigan, and provides recommendations for your consideration.

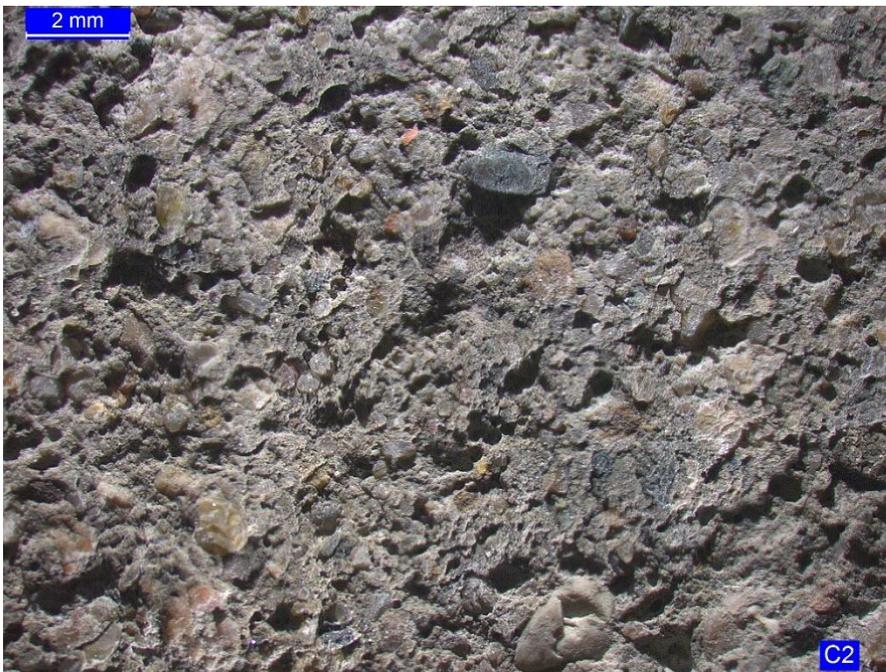
Figure 7. Thin, elongate voids on the top surface of Core 2.

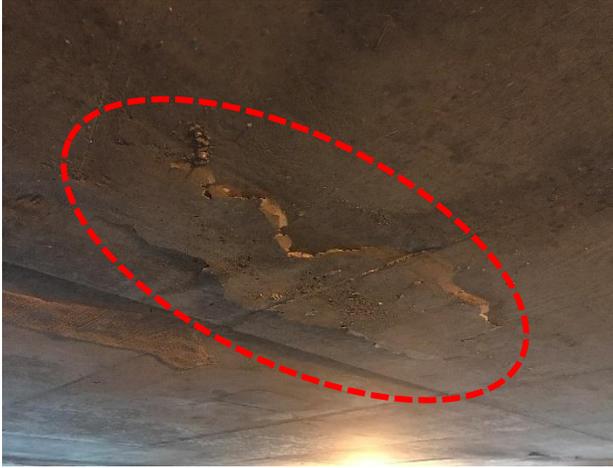
Figure 1. Unsound (delaminated) concrete on a slab underside.

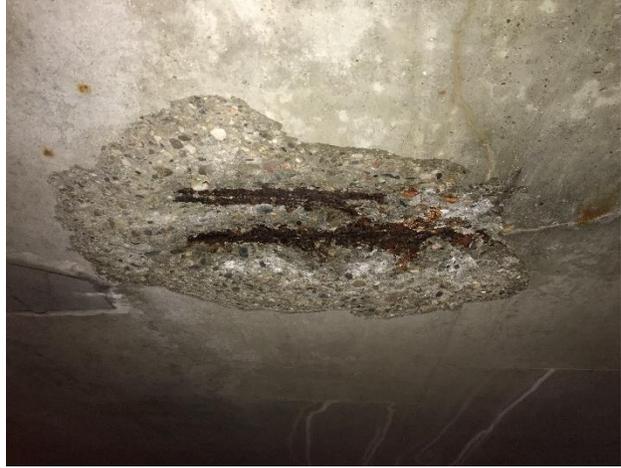
Figure 2. Spalled concrete with exposed corroded reinforcing bars.

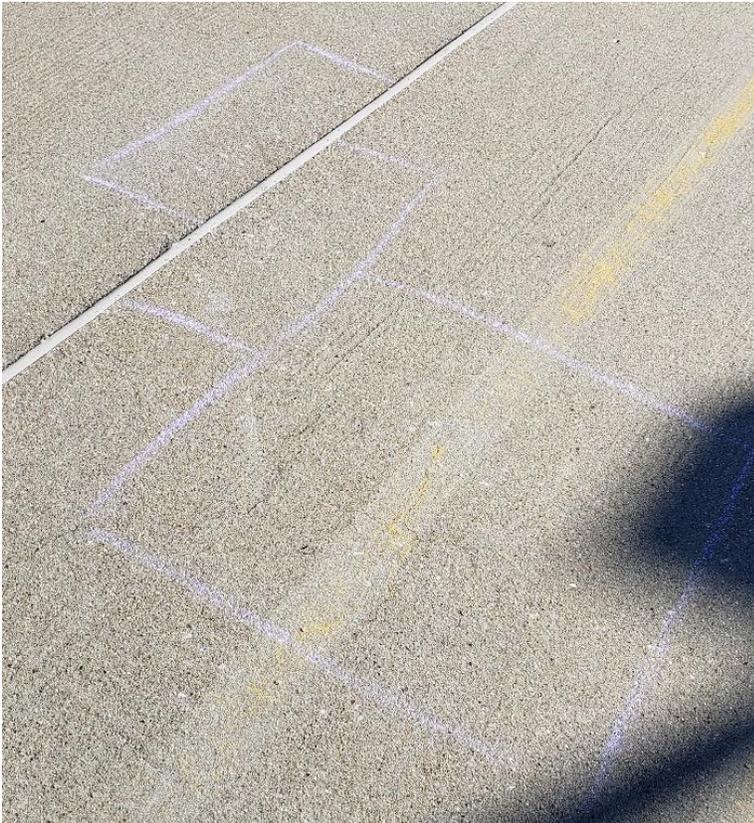
Figure 3. Unsound (delaminated) concrete outlined in chalk. Note that there are no visible indications of concrete deterioration.

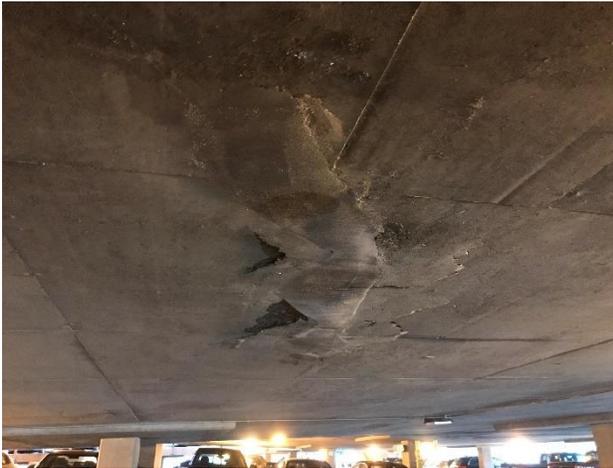
Figure 10. Unsound (delaminated) previous repair.

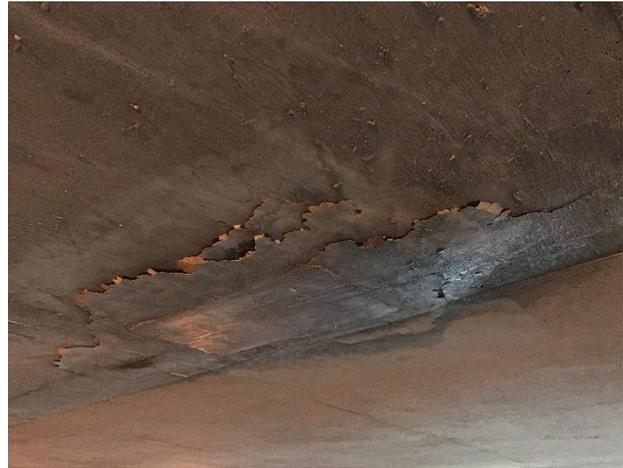
repairs on the underside typically consist of shallow, partial depth, trowel-applied mortar. Unsound concrete also extends beyond the repair areas at some locations (Figure 11).

Figure 11. Unsound (delaminated) previous repair with unsound concrete extending beyond the previous repair area.

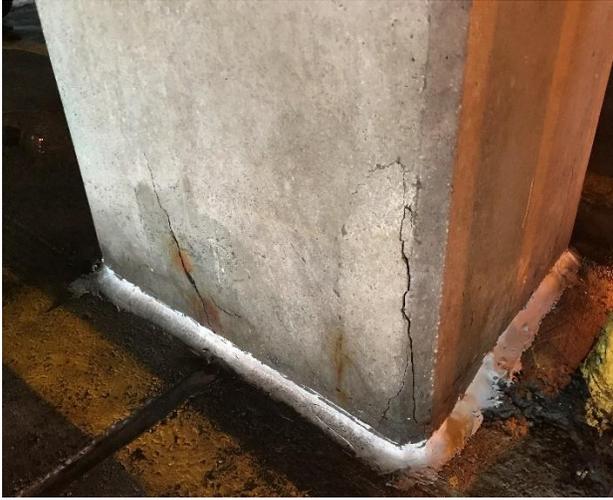
1. Localized areas of unsound and cracked concrete exist on approximately 35 percent of the columns, typically occurring at the bottom corners at locations of shallow concrete cover (Figure 13). The areas of unsound concrete are typically less than two square feet each.
2. Previous repairs were found at several columns. Many of the column repairs are unsound or deteriorated (Figure 14).

Figure 13. Unsound concrete at column corners.

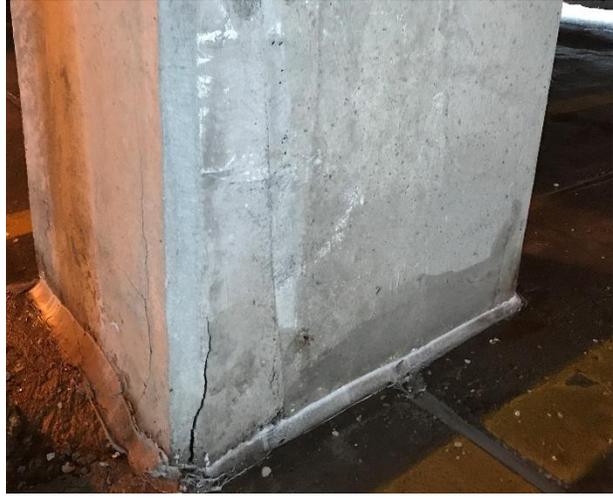
Figure 14. Cracked previous repair.

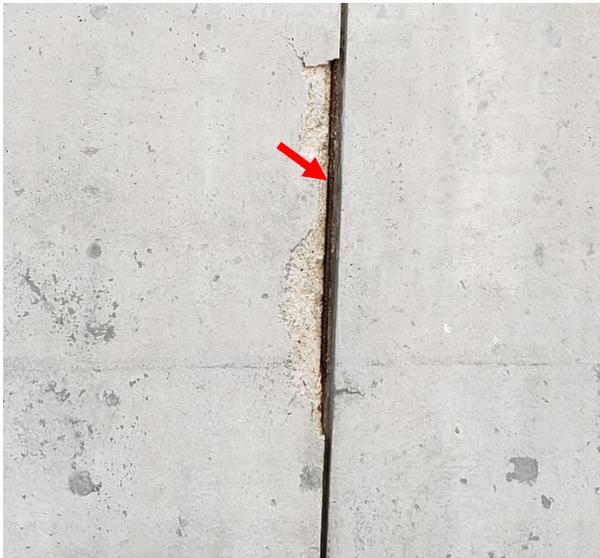
1. Limited, localized areas of spalled concrete and failed previous repairs exist in several locations. Corroded reinforcing steel was typically exposed at the spalled locations (Figure 15).
2. At approximately 30 locations on Level 5, exposed reinforcing steel exists at areas where there is low concrete cover (Figure 16).
3. Cracking with efflorescence exists at the wall above the ramp on Level 5 (Figure 17).

Figure 15. Spall at an exterior wall joint with an exposed corroded reinforcing bar indicated by the arrow.

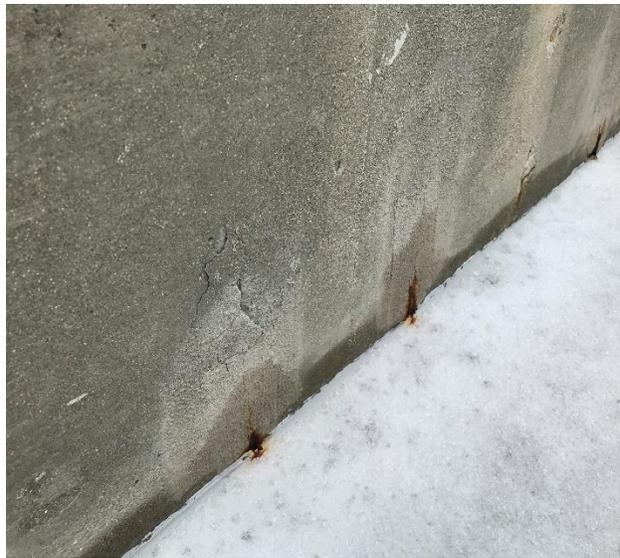
Figure 16. Corrosion stains and exposed corroded reinforcing bars at areas of low concrete cover.

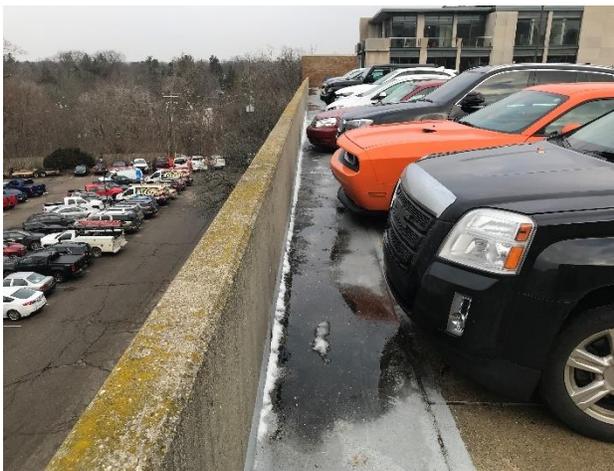
WJE was on site during a rain event and documented active water leaks and water ponding (Figure 18, Figure 19, and Figure 20). Additionally, the following distress to waterproofing components were noted:

Figure 18. Ponding water on roof slab at a concrete curb.

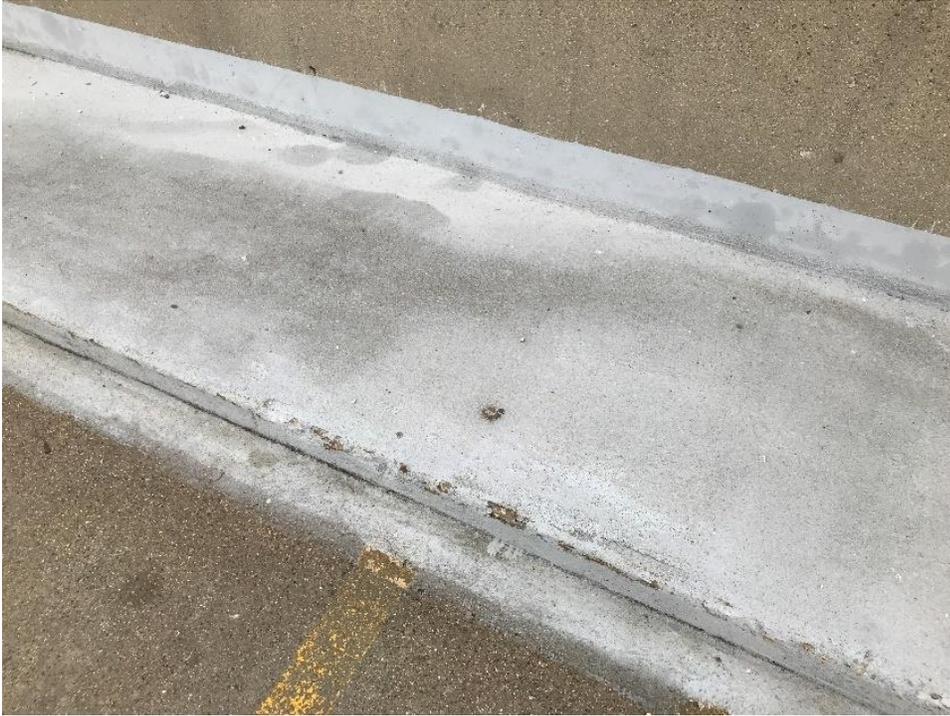
1. A traffic-bearing membrane is present on the curbs on level 5. The coating appears to be well bonded to the concrete, but there are localized tears and abrasions (Figure 21).
2. Sealant is present at the joints of the concrete slab topping and at previous crack repairs. Most of sealant exhibits adhesive failure (Figure 22).

Figure 21. Area of membrane scrapes at a concrete curb on Level 5.

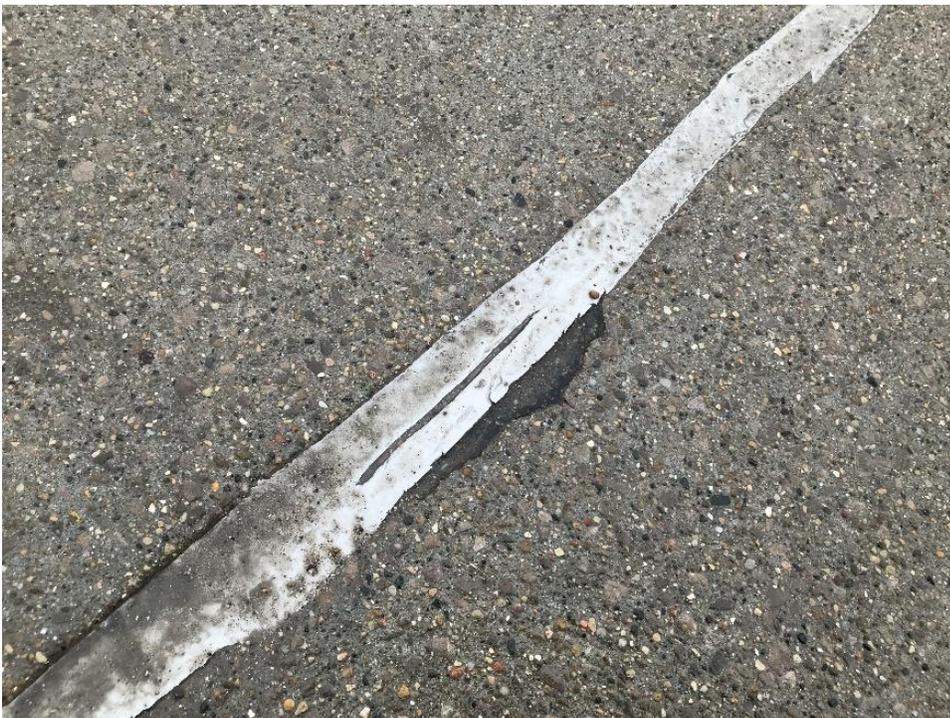
Figure 22. Joint seal adhesive failure in a topping slab joint.

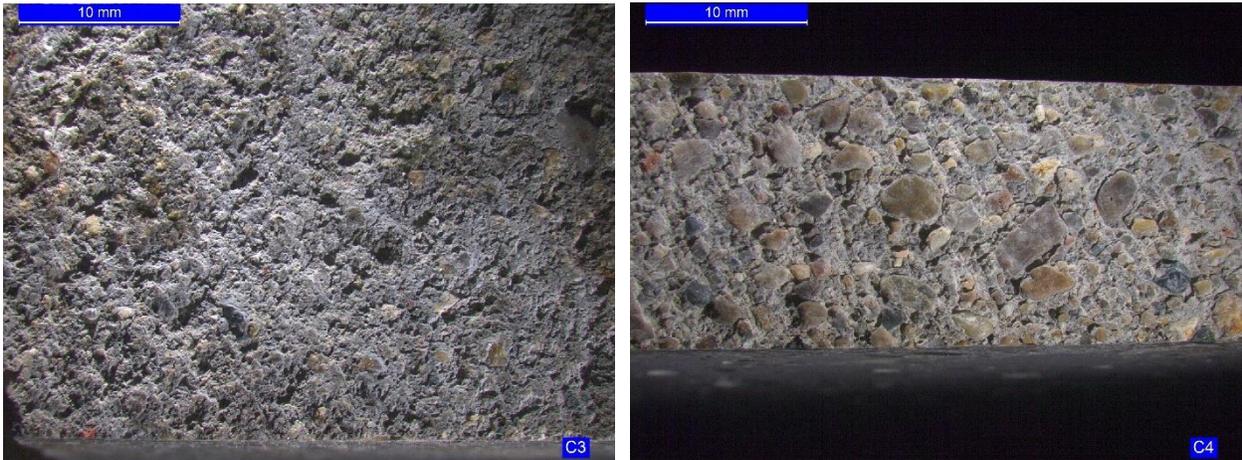
Figure 9. The eroded top surfaces of the toppings in Core 3 (left) and Core 4 (right). A greater number of aggregates are exposed on the surface of Core 4. Note that the topping is compositionally dissimilar in Core 4 compared to Cores 1, 2, and 3.

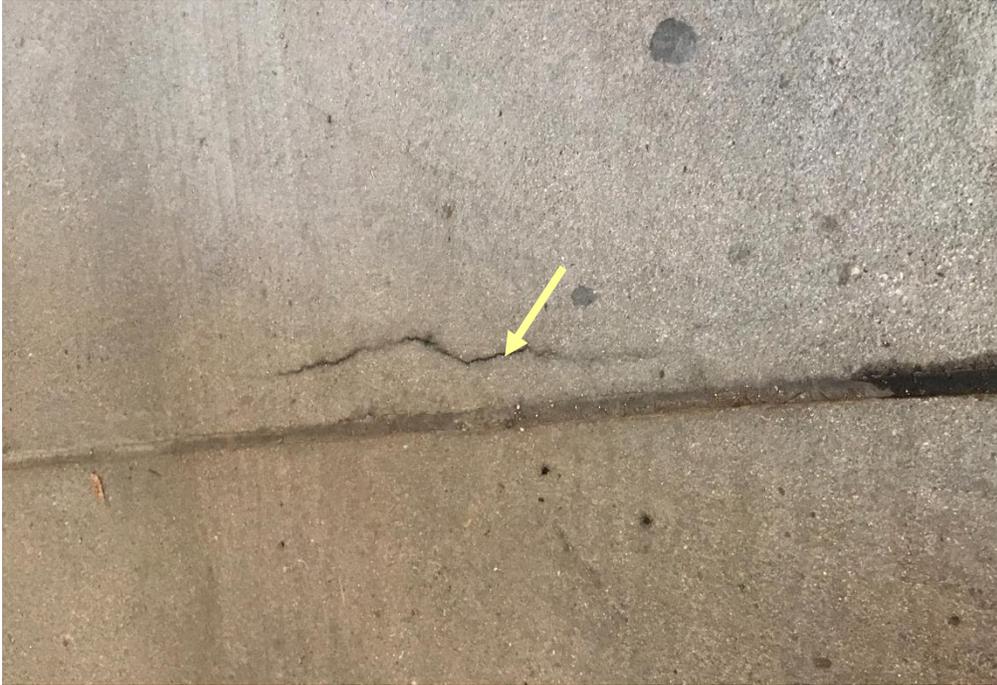
Figure 1. Area of unsound concrete along construction joint.

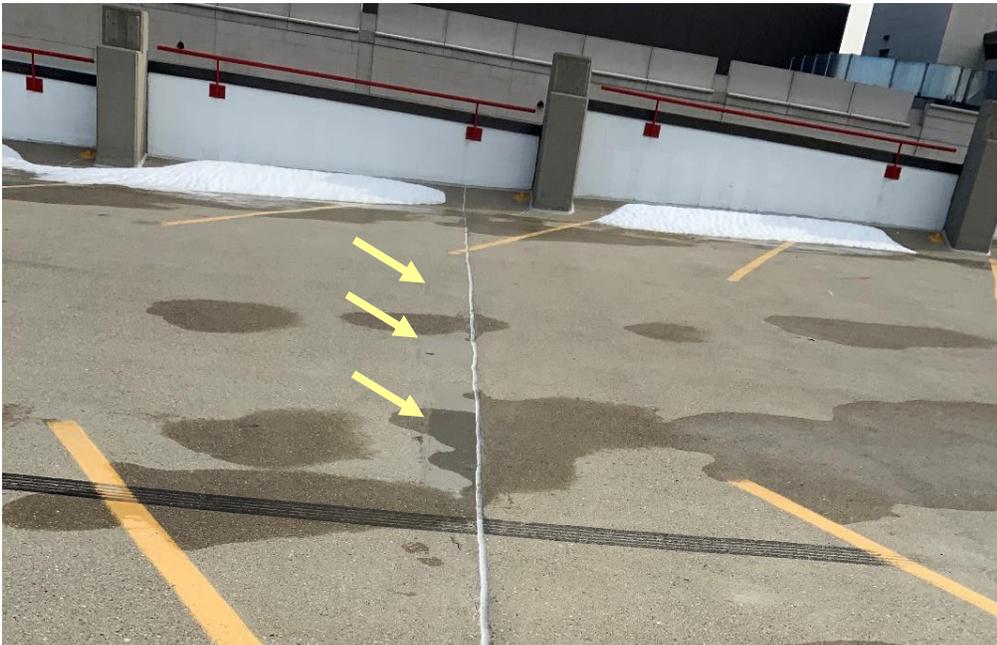
Figure 2. Previous partial-depth concrete repairs at topside of Level 7 construction joint.

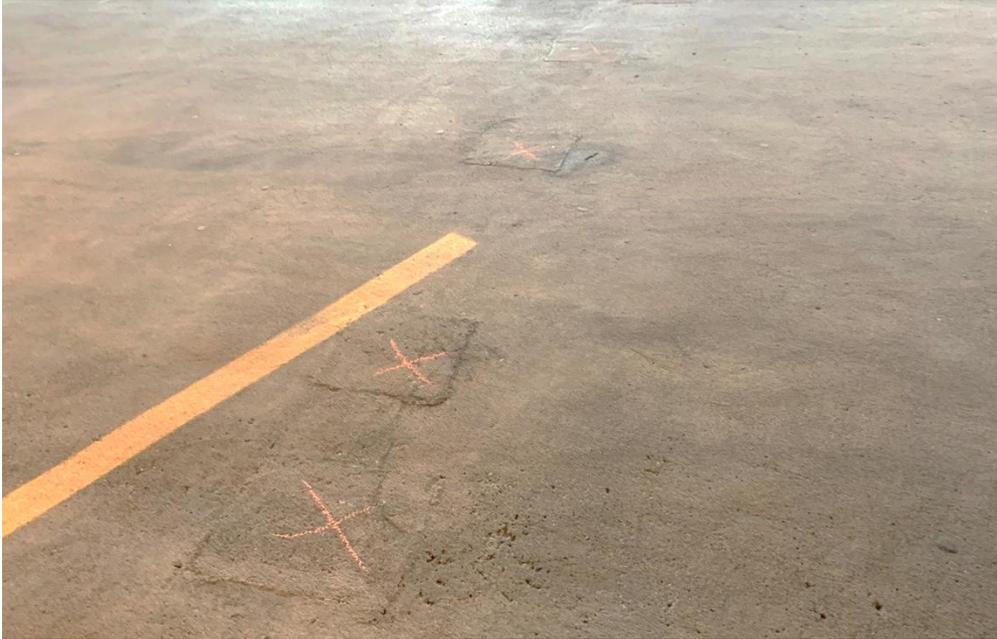
Figure 3. Unsound previous repairs along the top of a beamline.

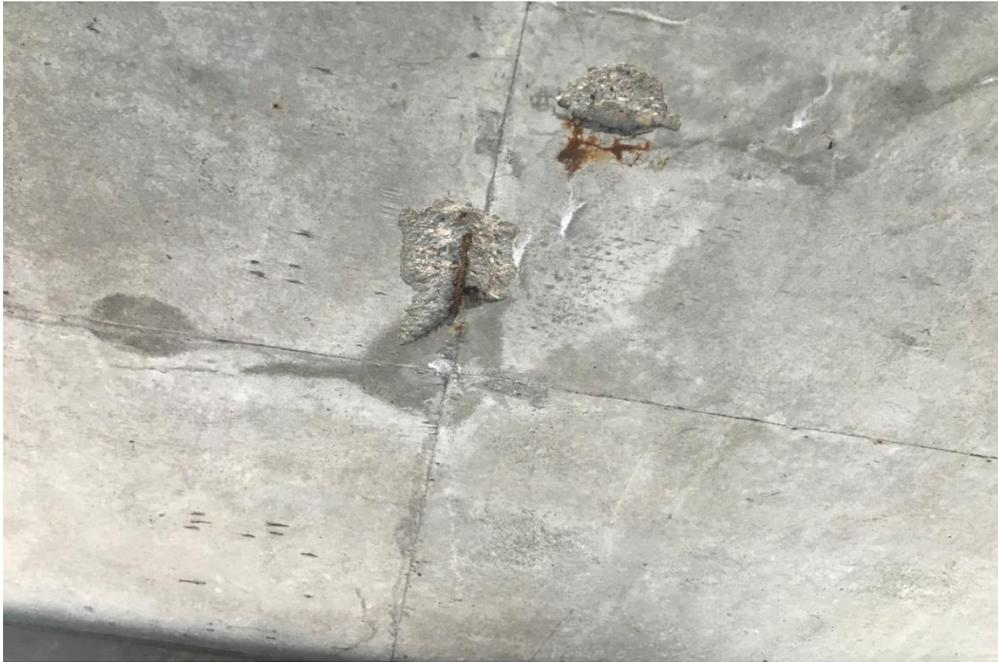
Figure 5. Exposed, corroded mild reinforcement at spall in underside of slab between beams.

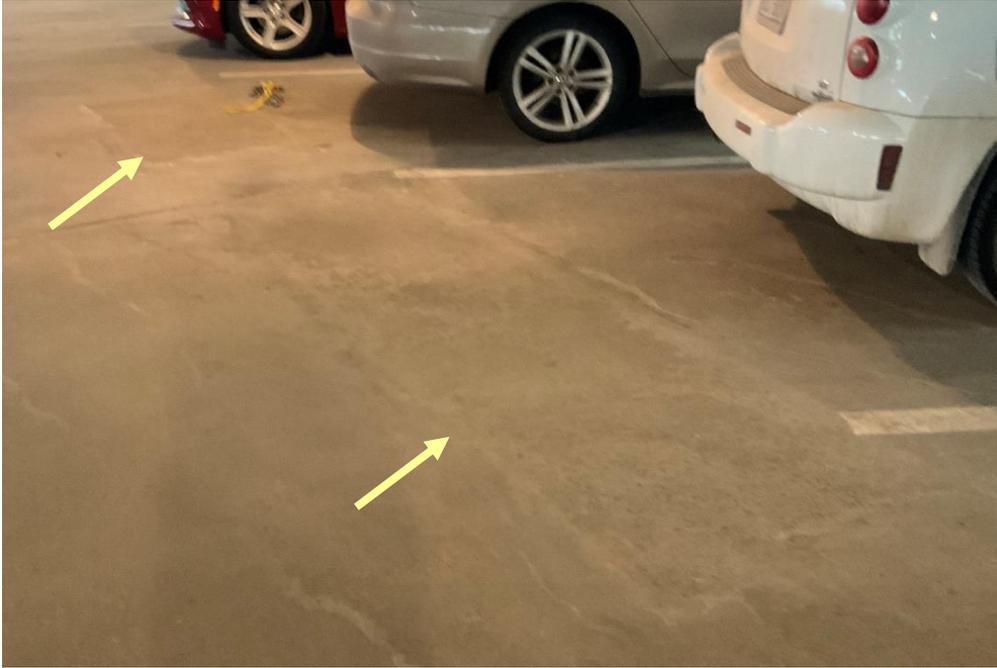
Figure 10. Previous PT tendon repair at Level 1.

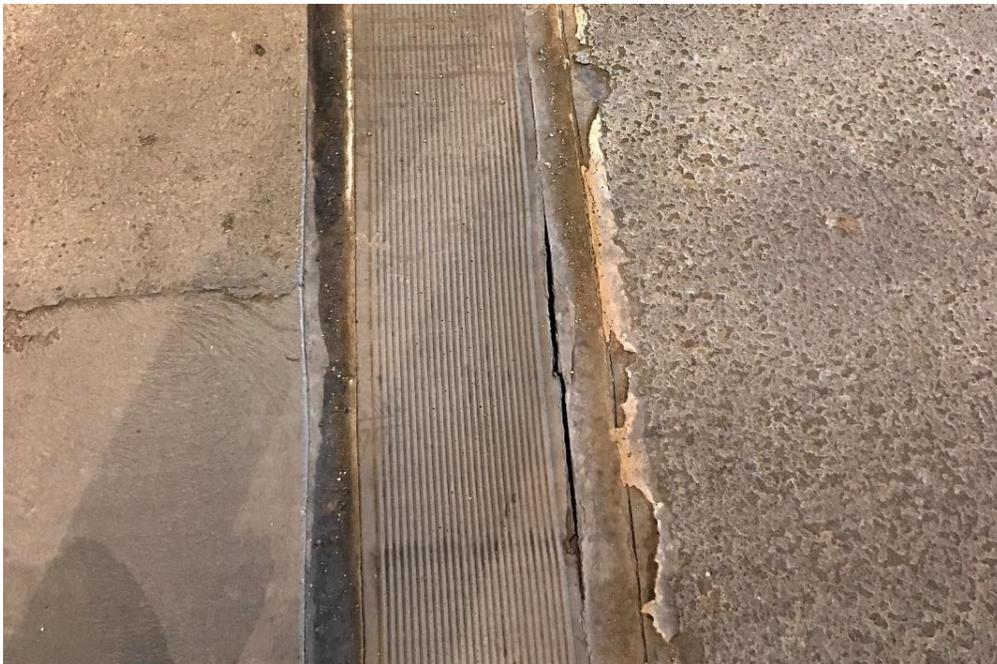
Figure 18. Failed expansion joint seal at the transition between the slab on grade and the elevated PT structural slab.

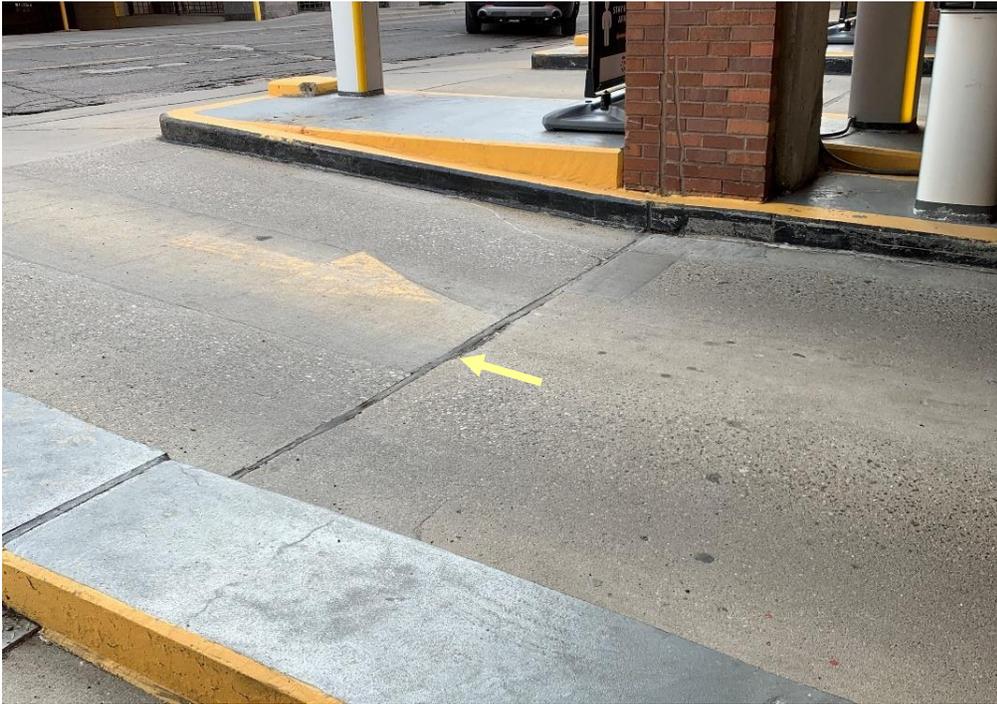
Figure 19. Joint sealant at vehicle entry between vaulted sidewalk region (plenum) and garage interior.

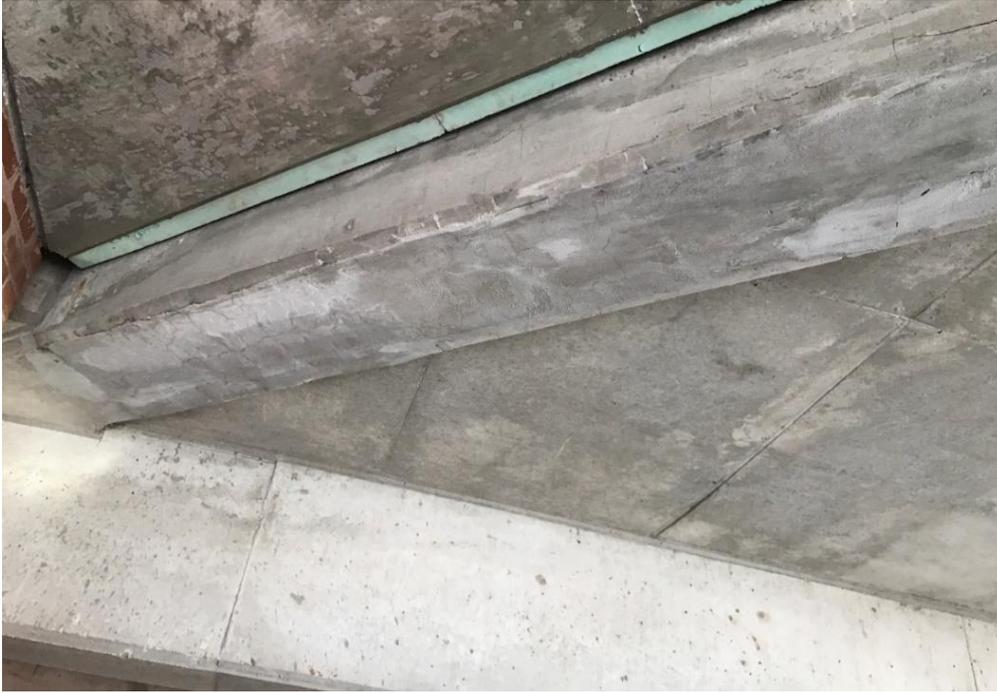
Figure 21. Deterioration at edge beam near southwest stairwell.

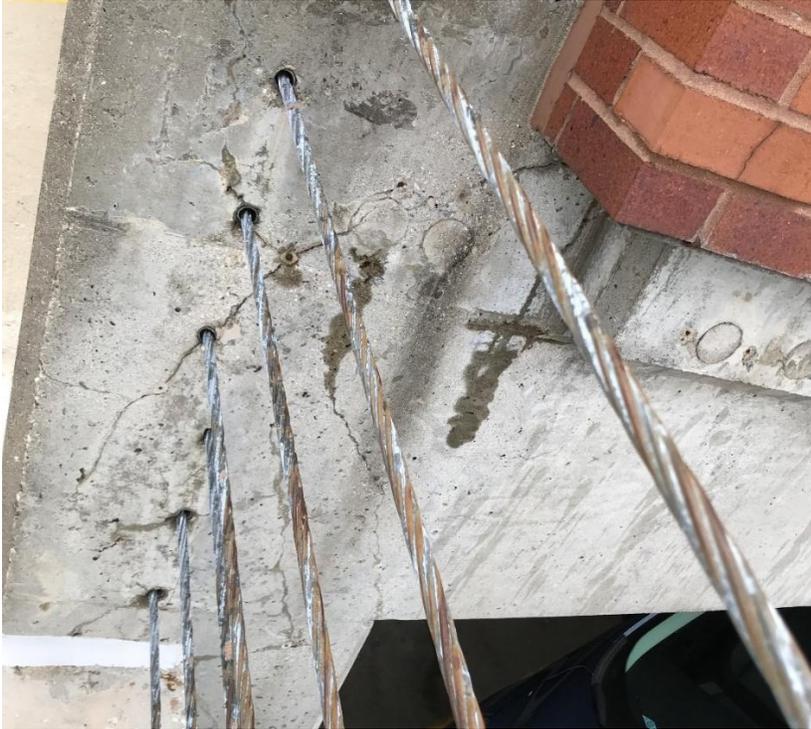
Figure 23. Cracking and water staining at a beam-column intersection.

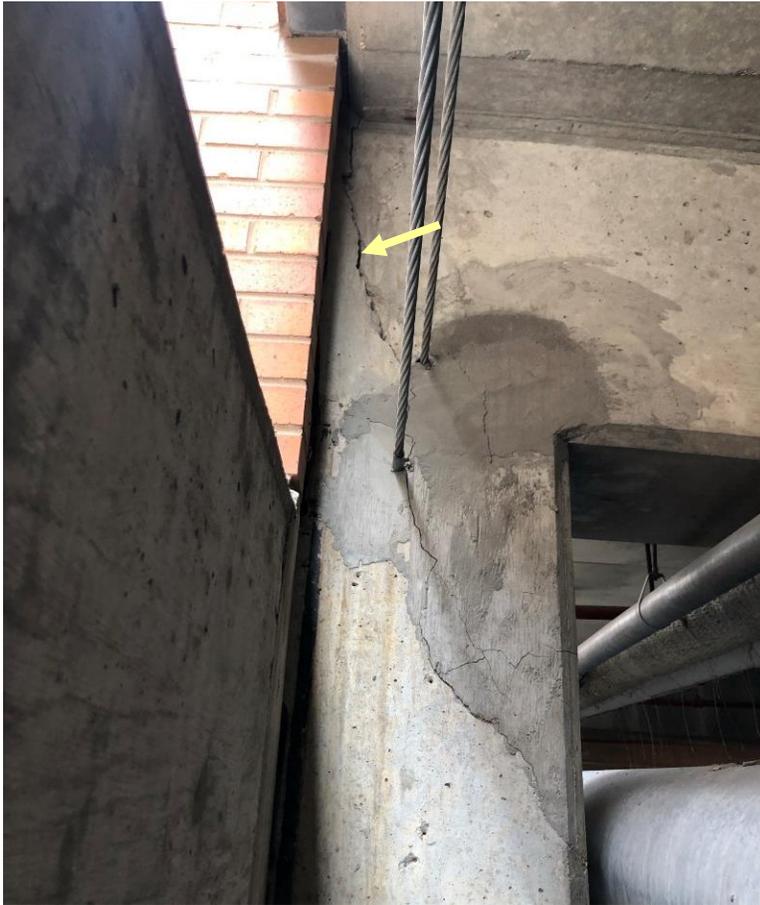
Figure 25. Cracking with column on the Lower Level.

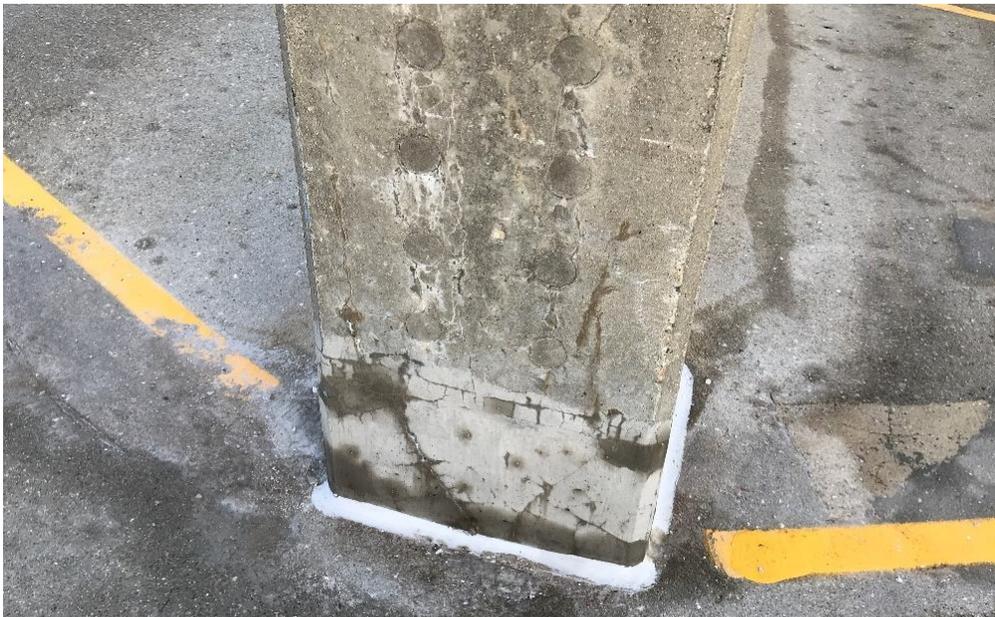
Figure 26. Debonded grout pockets, water staining, and efflorescence within column at vehicle barrier cable anchors. Note unsound concrete patch repair and standing water at base.

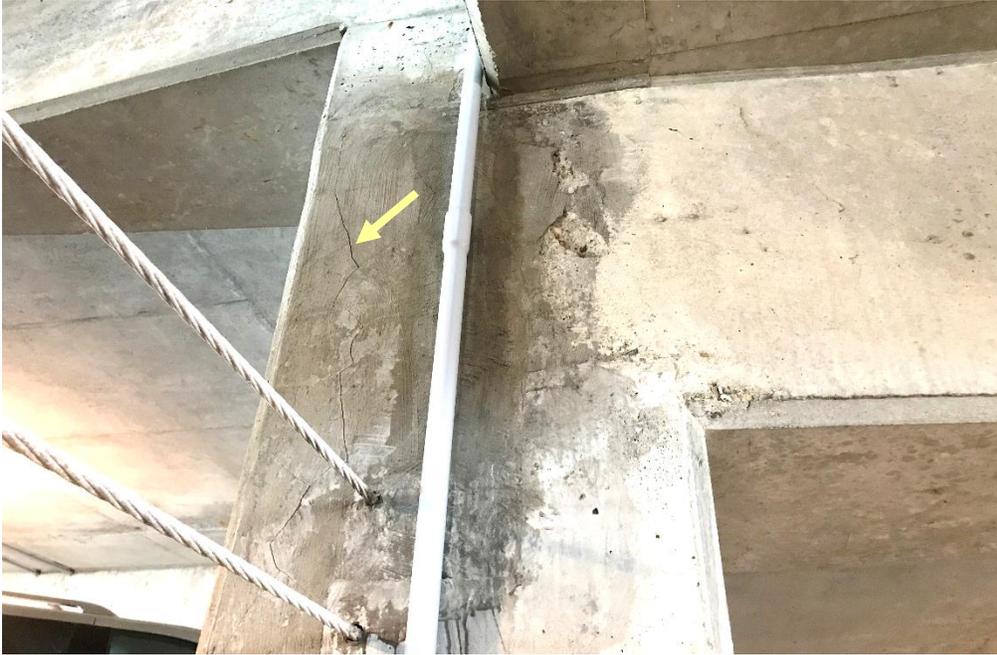
Figure 27. Deterioration within a large concrete patch repair at an interior column.

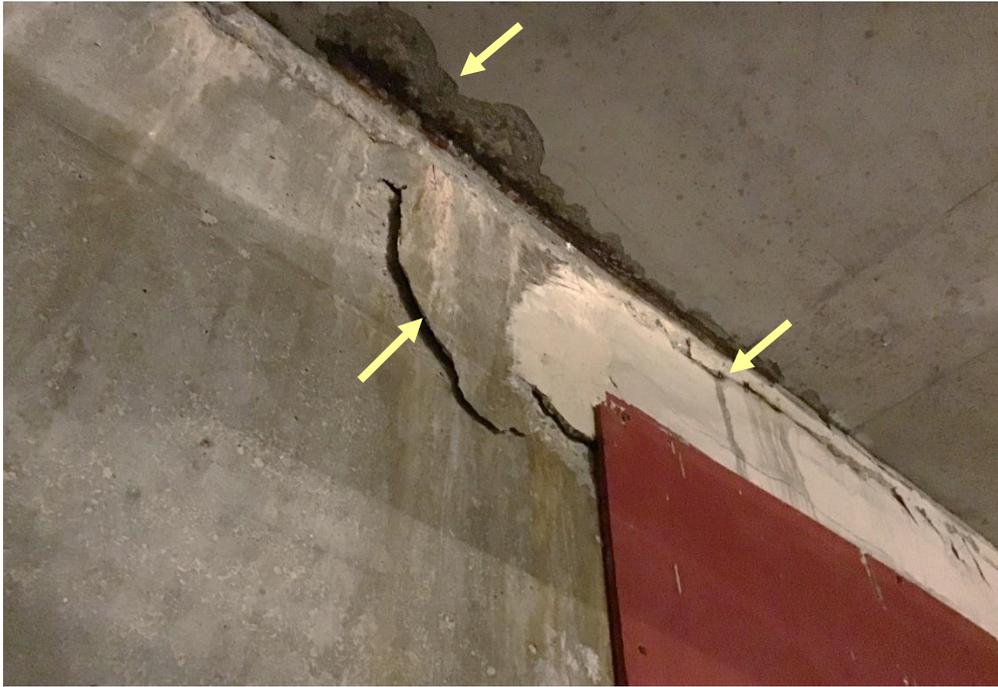
Figure 29. Concrete spall and water staining at foundation wall.

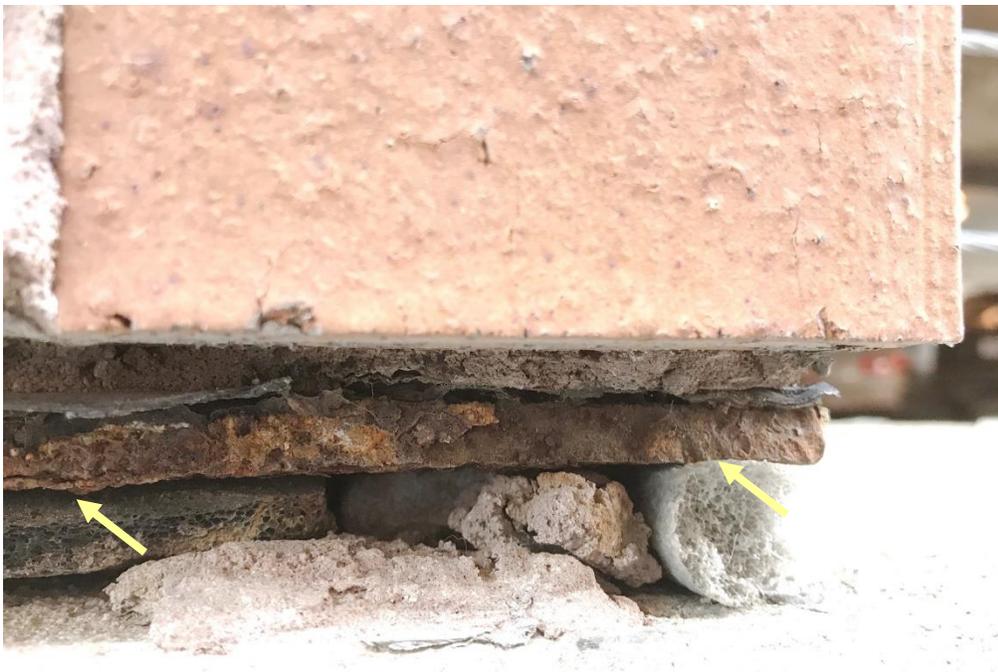
Figure 30. Steel corrosion and section loss of shelf angle near grade.

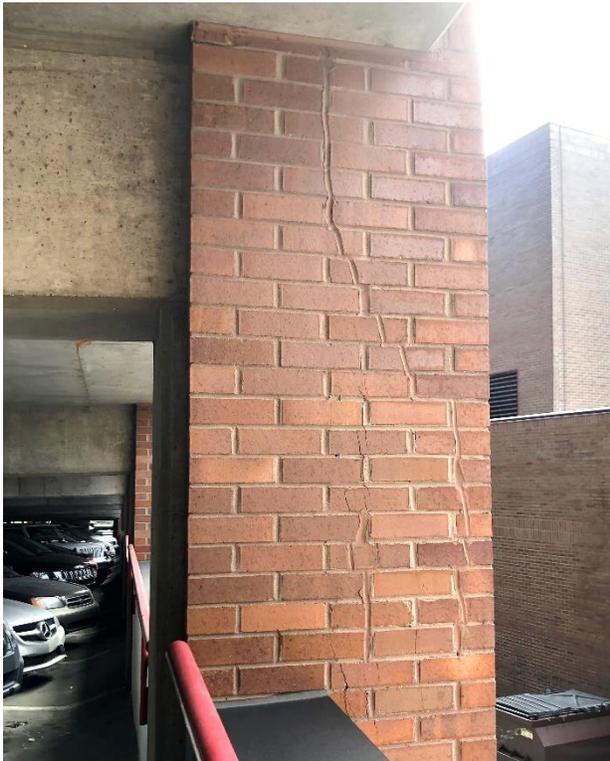
Figure 31. Vertical cracking in brick veneer at column cap.

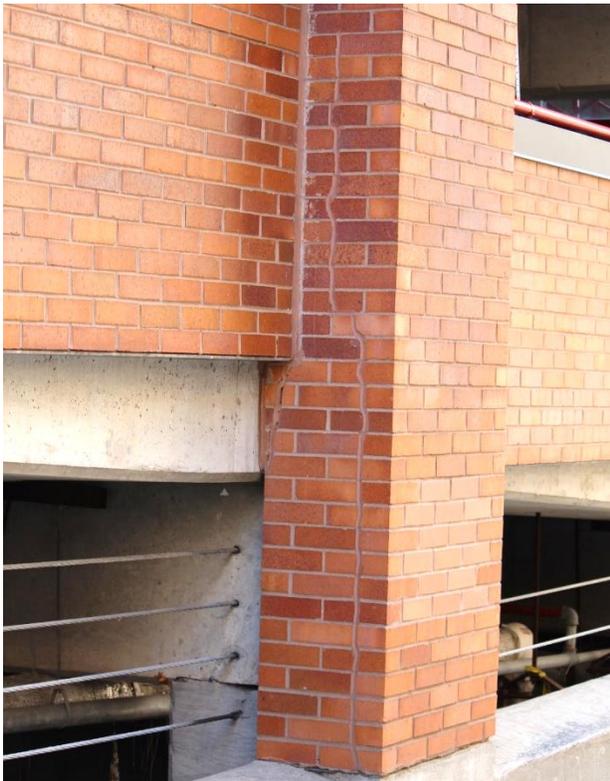
Figure 33. Vertical cracking in brick veneer at column cap.

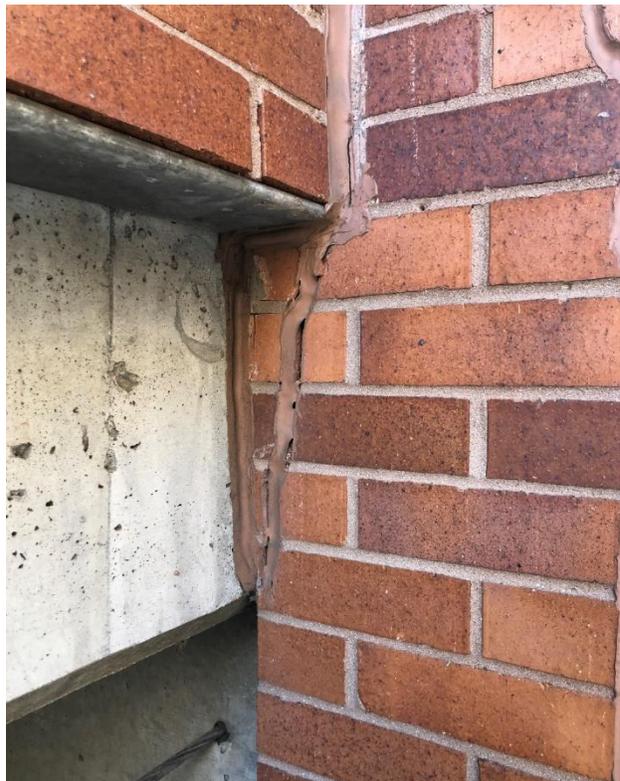
Figure 34. Close-up view of cracking in previous photo.

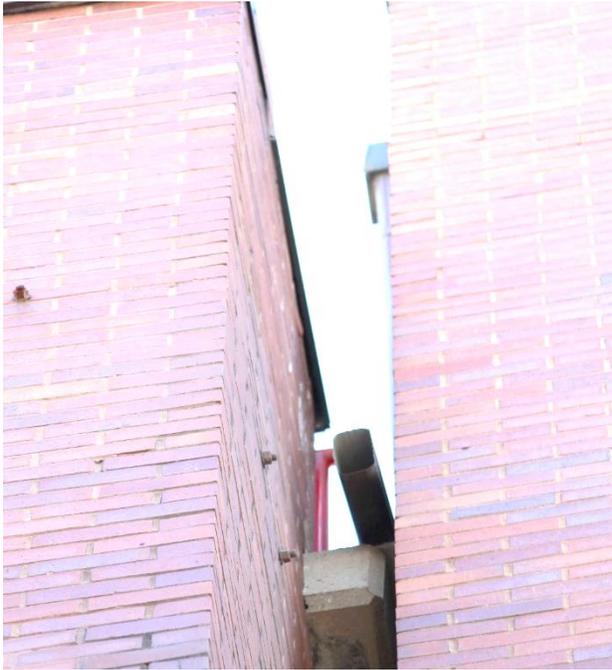
Figure 35. Stair tower roof downspout discharge.

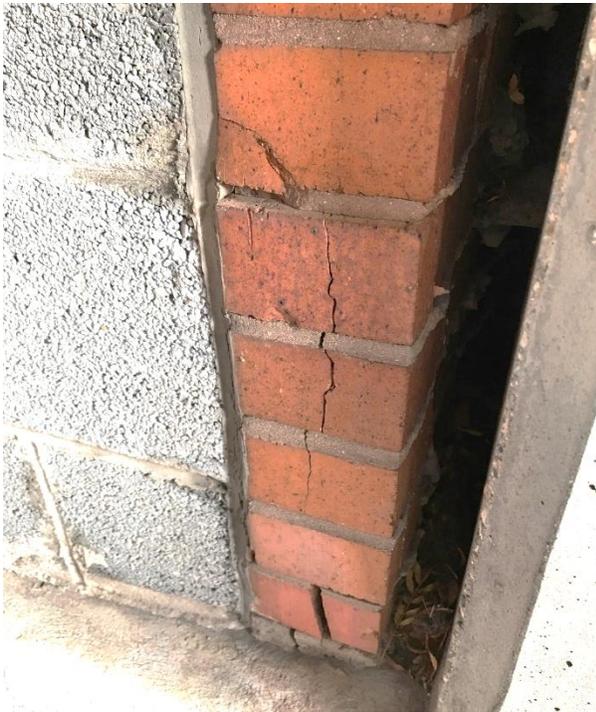
Figure 37. Vertical crack in veneer.

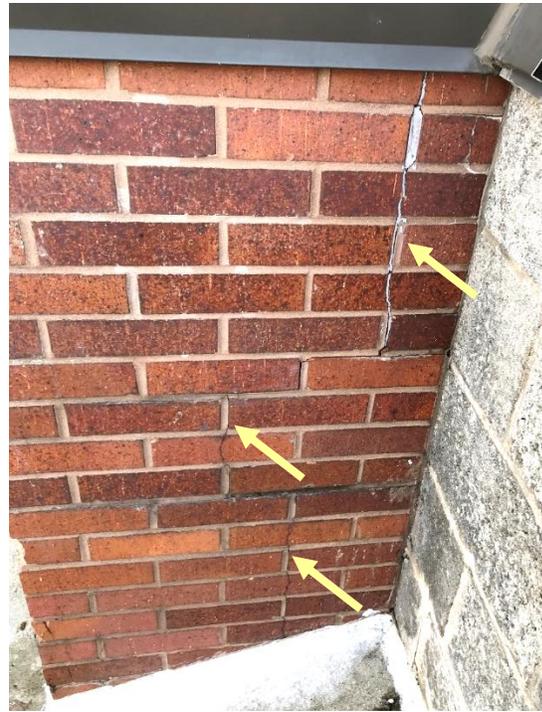
Figure 38. Cracking in brick veneer.

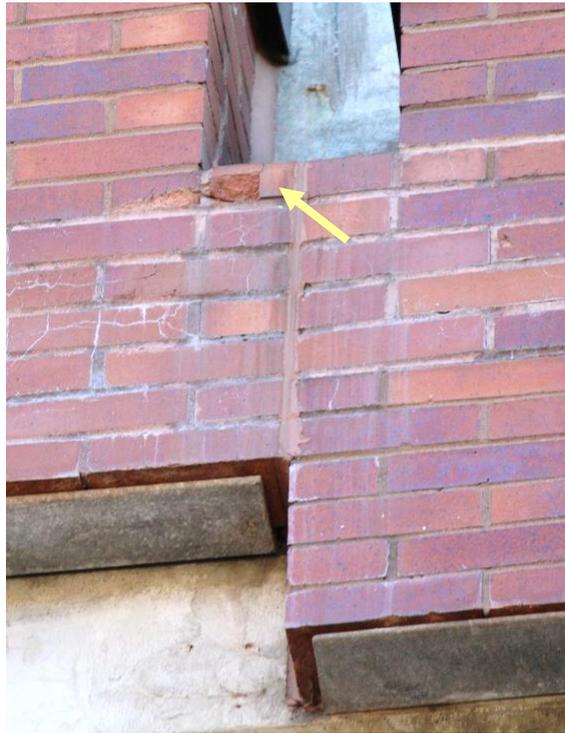
Figure 40. Brick distress at vertical discontinuity.

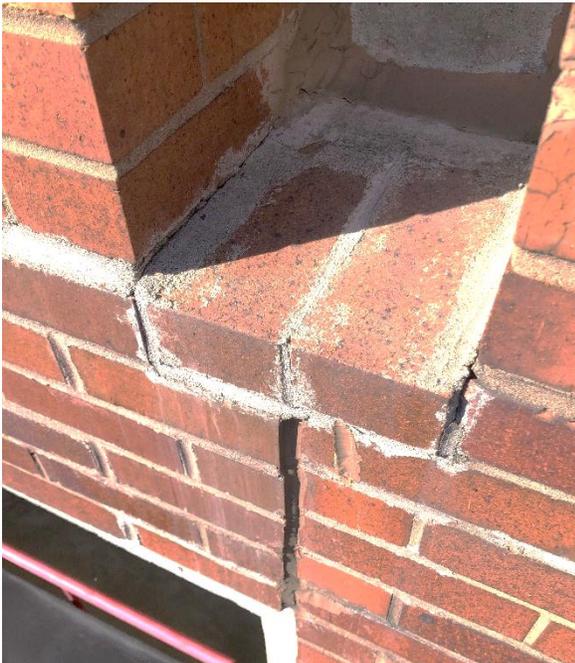
Figure 41. Debonded mortar at vertical discontinuity within brick cladding.

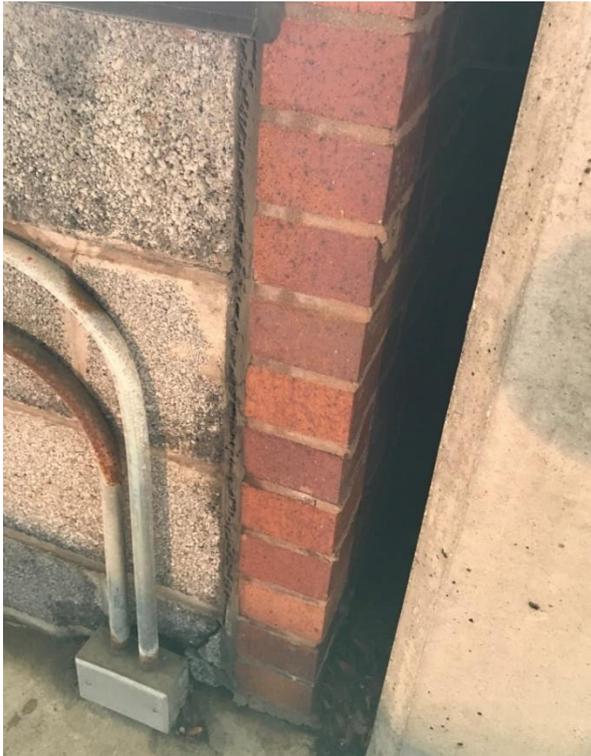
Figure 43. Cohesively failed sealant between CMU wall and brick veneer.

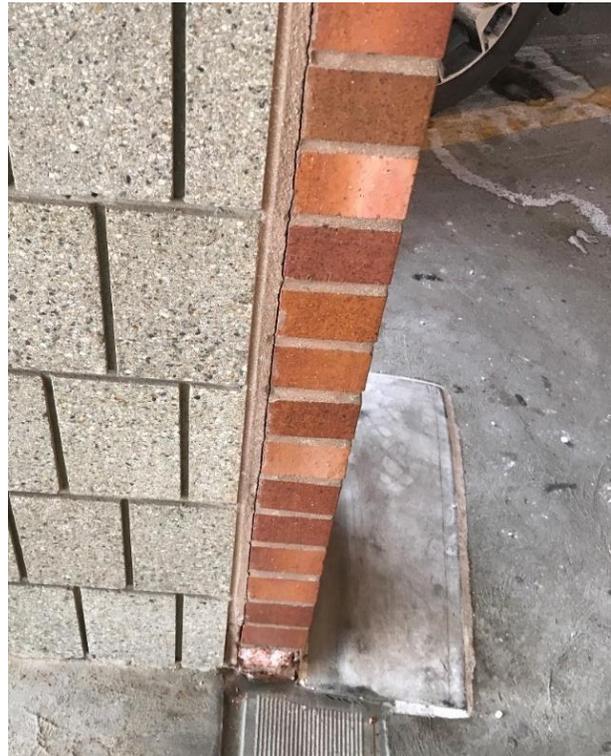
Figure 44. Typical debonded mortar joint between facade and stairwell.

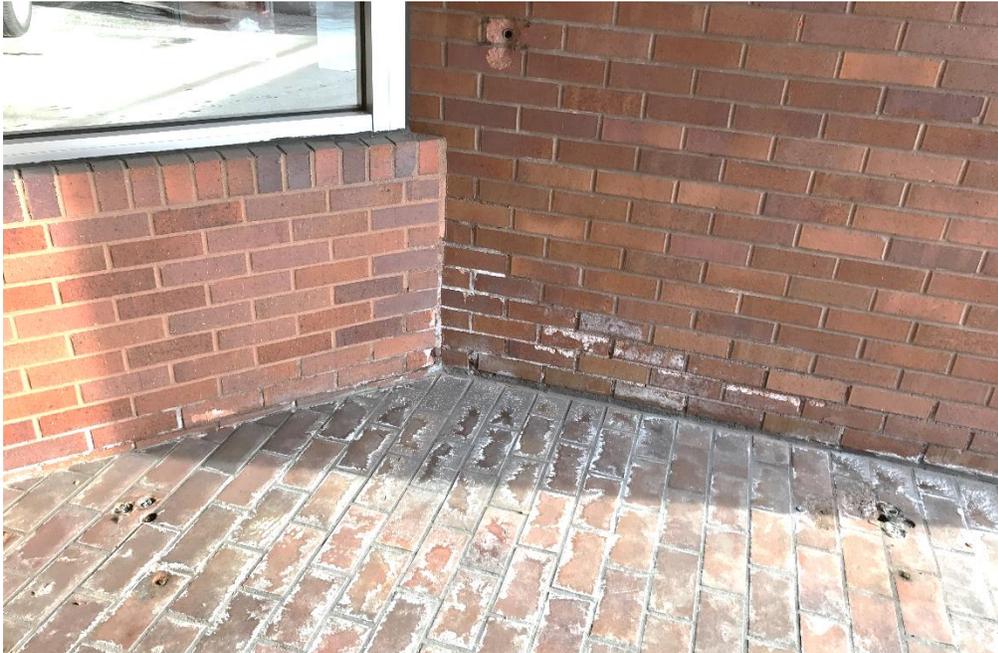
Figure 46. Mortar erosion, efflorescence, and spalled brick units near base of wall at stairwell.

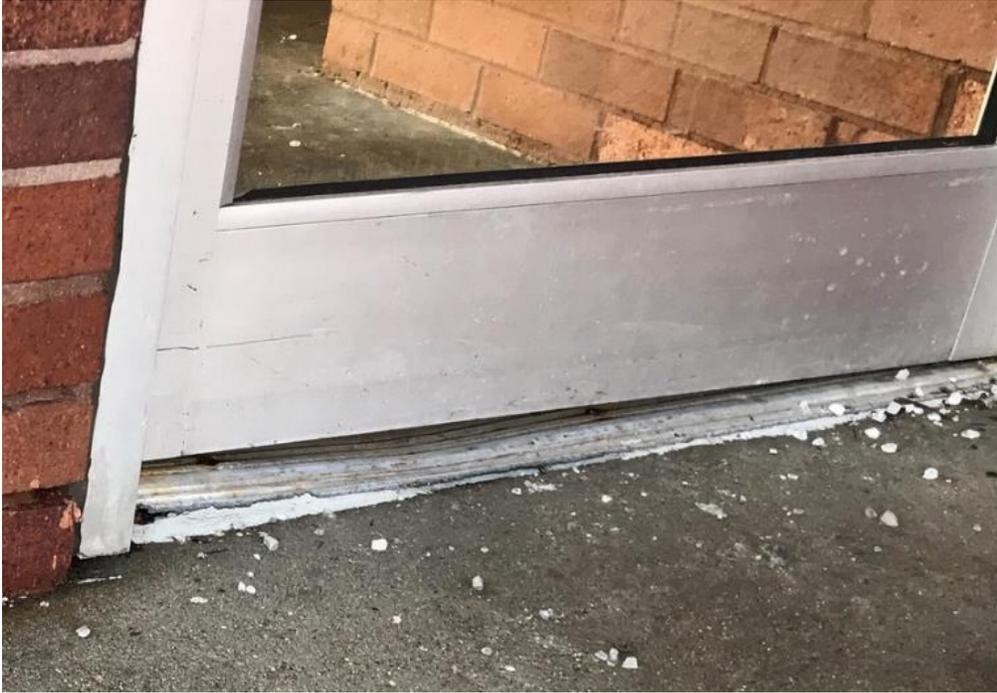
Figure 48. Deformed door threshold at stairwell entry.

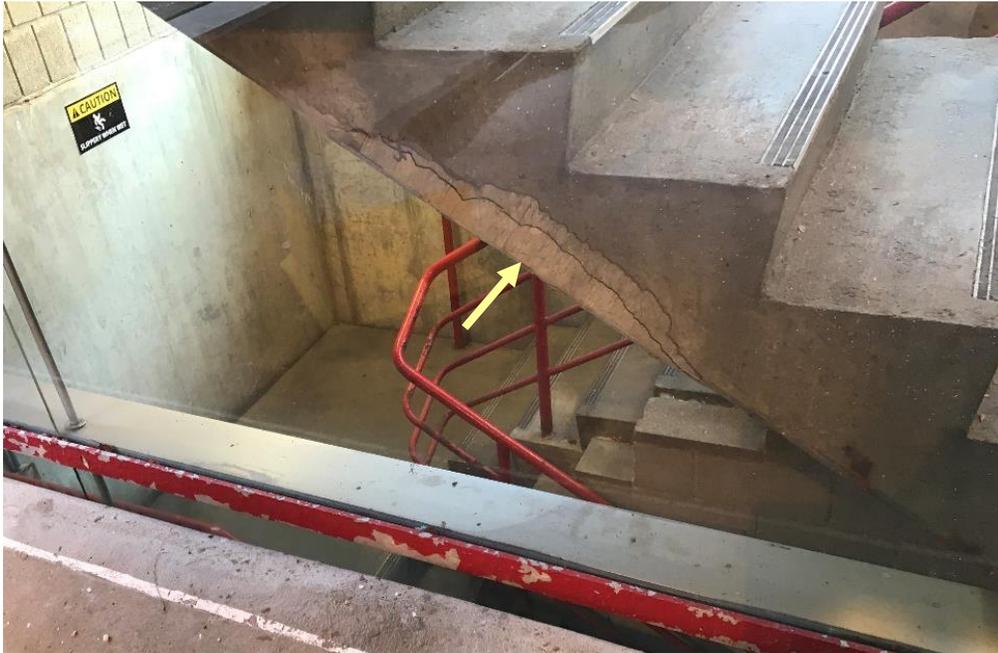
Figure 54. Delamination of previous concrete repair at underside of stair flight.
