VIRTUAL MEETING OF THE ADVISORY PARKING COMMITTEE
WEDNESDAY, June 2, 2021 @ 7:30am
<https://zoom.us/j/98209276859> or dial: 877 853 5247 US Toll-free,
Meeting ID: 982 0927 6859

As requested, Wiss, Janney, Elstner Associates, Inc. (WJE) has completed limited condition assessments of the North Old Woodward, Park Street, Peabody, and Chester parking structures. These assessments were performed with the intent to determine the current and future infrastructure needs in support of a capital improvement plan; the intention of the plan is to extend the useful life of the structures and to maintain the structural integrity to ensure the structure can support the code-prescribed loadings. This report summarizes our observations at the Chester Parking Structure, located at 180 Chester Street in Birmingham, Michigan, and provides recommendations for your consideration.

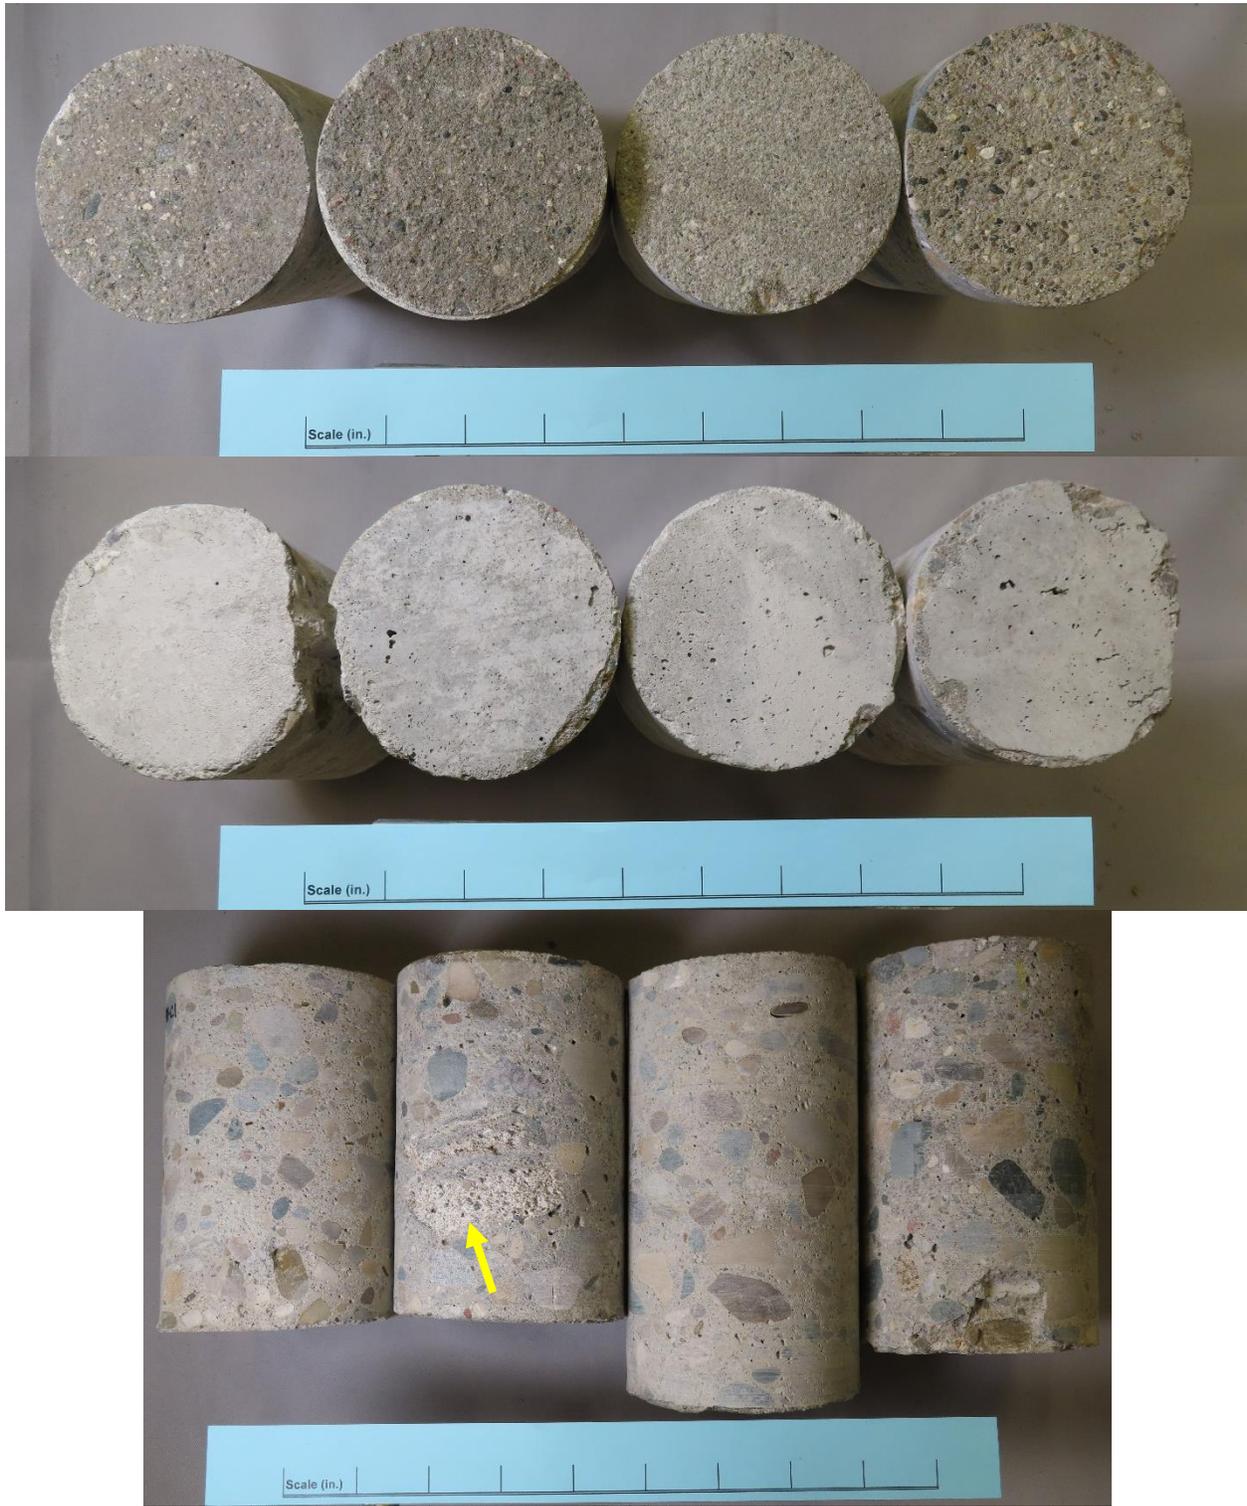
Figure 1. The as-received appearance of the tops (upper), bottoms (middle), and sides (lower) of Cores 1 through 4 are pictured, from the left to right, respectively. An area of dissimilar mortar in Core 2 is identified with an arrow.

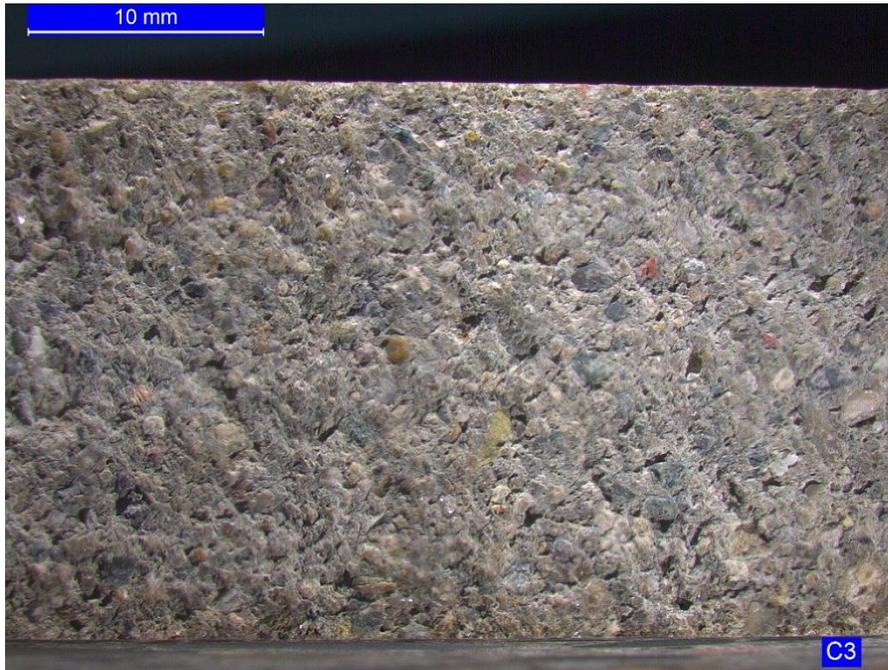
Figure 6. The top eroded surface of Core 3 with partially exposed fine aggregates.

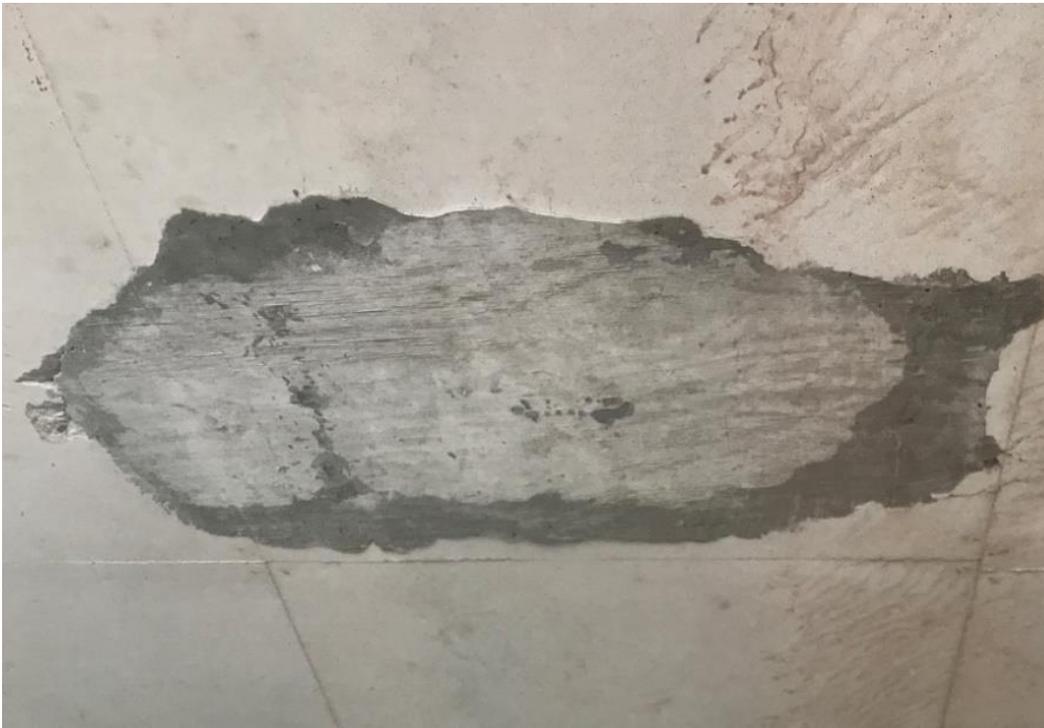
Figure 4. PT repair area

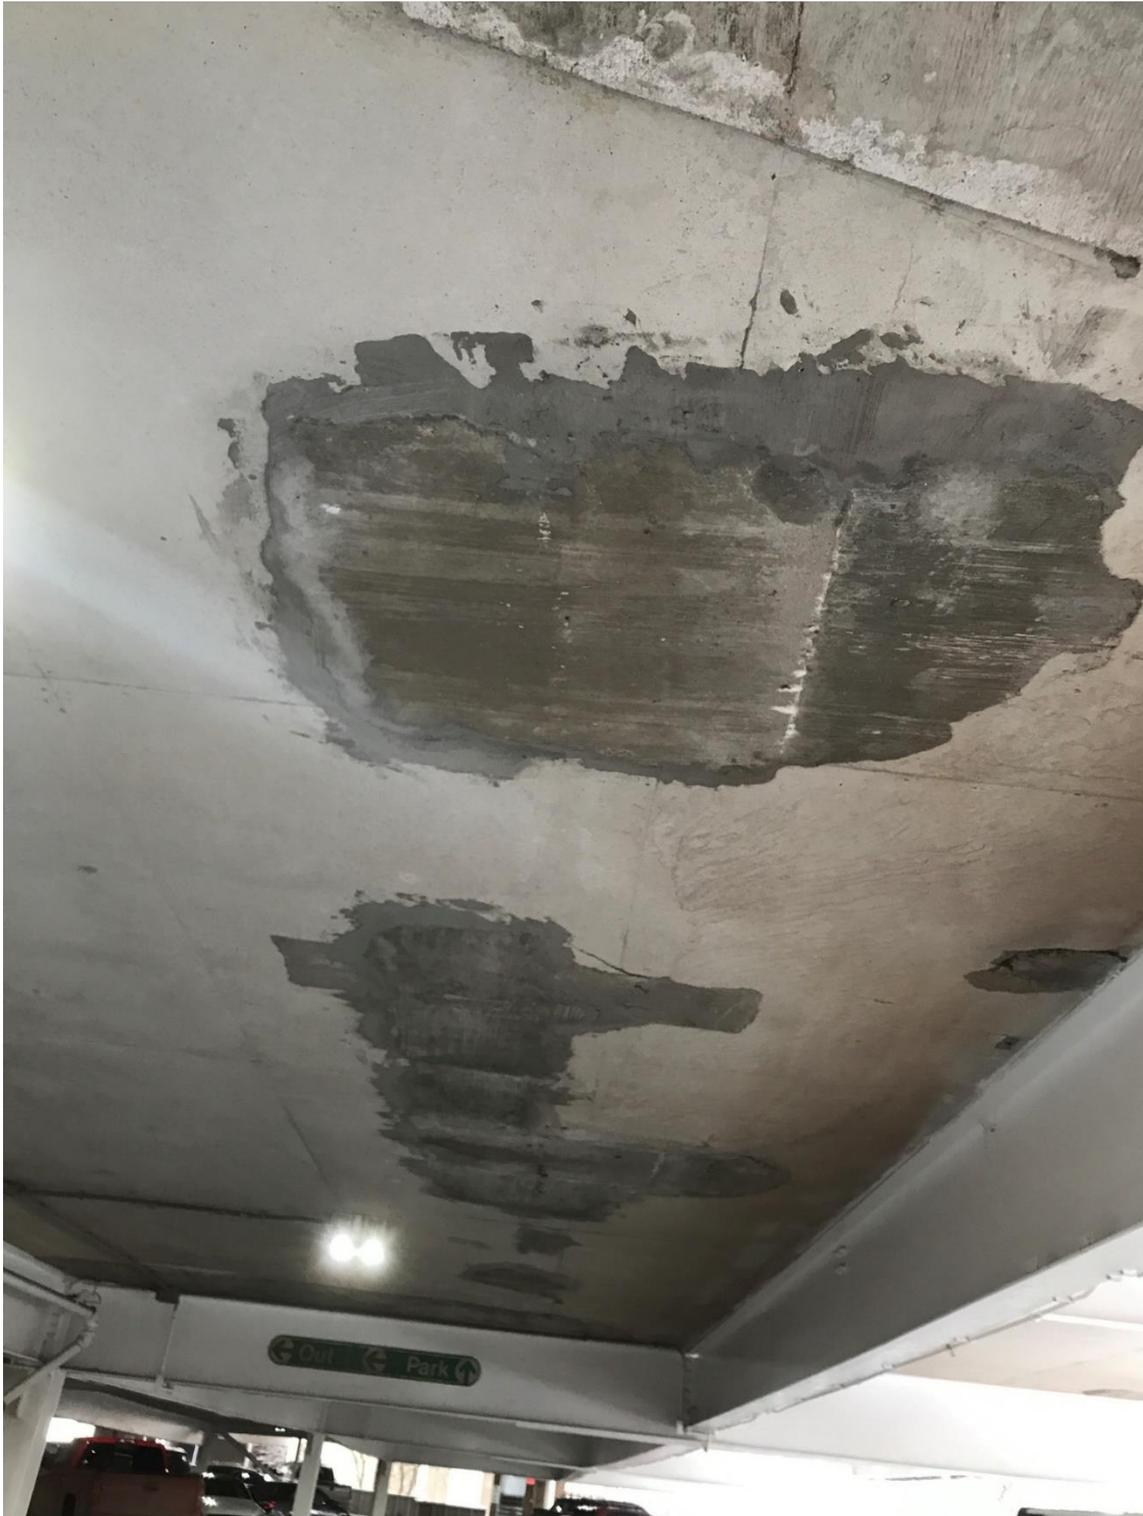
Figure 5. PT intermediate anchorage repairs at a construction joint, as viewed from the underside of Level 4

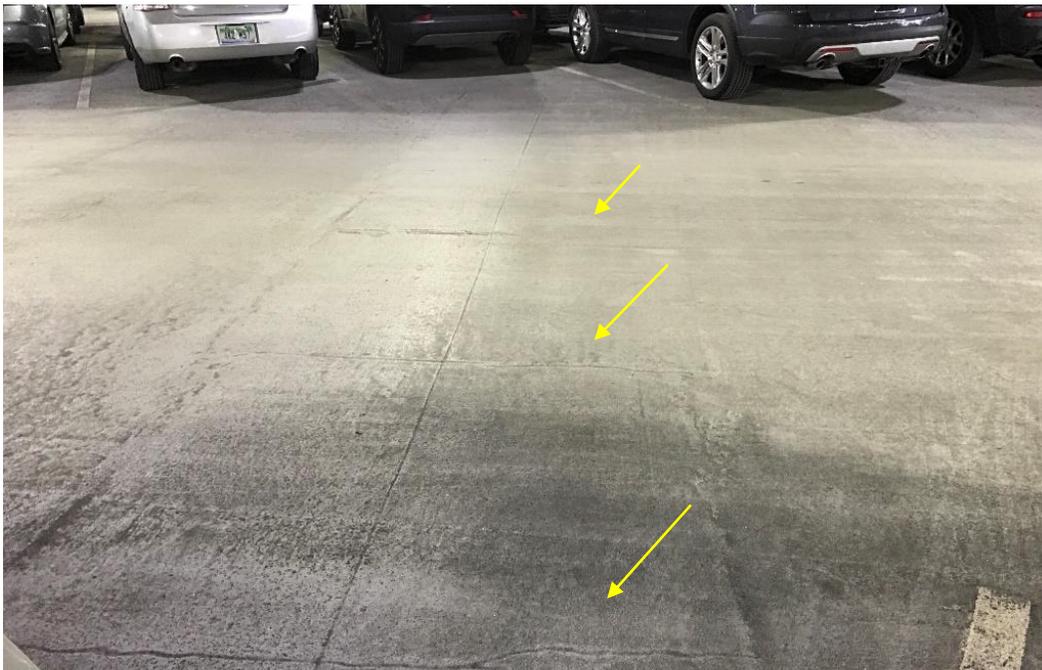
Figure 7. Evenly spaced previous crack repairs at Level 3 construction joint, in line with PT tendons

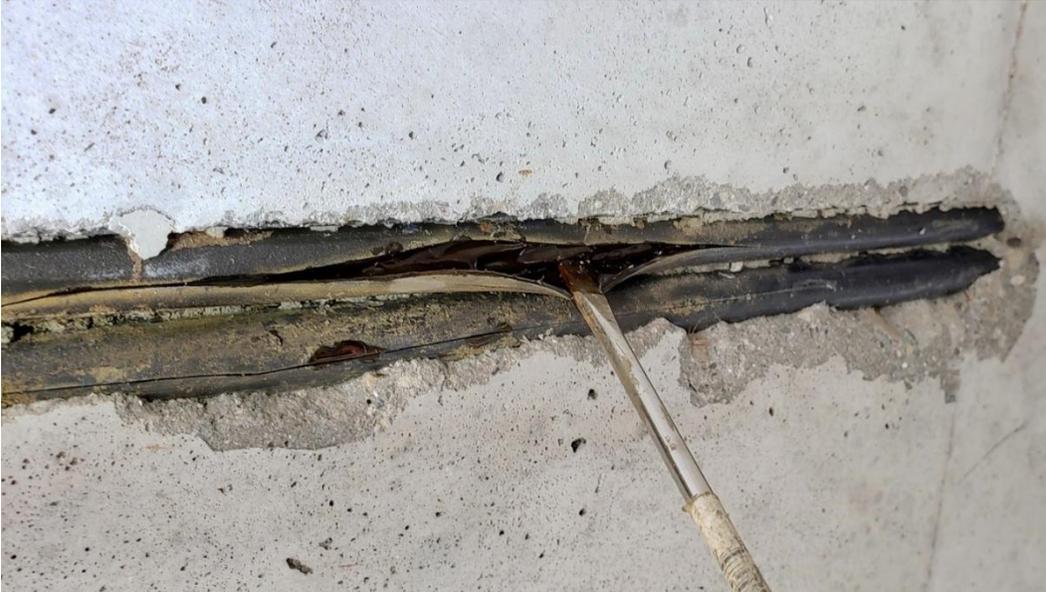
Figure 11. Exposed Tendon Location 1

1. Eleven tendons exposed at existing spalls were inspected on the underside of the floor slabs.
 - a. **Exposed Location 1:** Two tendons are exposed at a location of low concrete cover. Both tendons were holding tension. The sheathing was intact, with grease filling the sheathing voids (Figure 11).

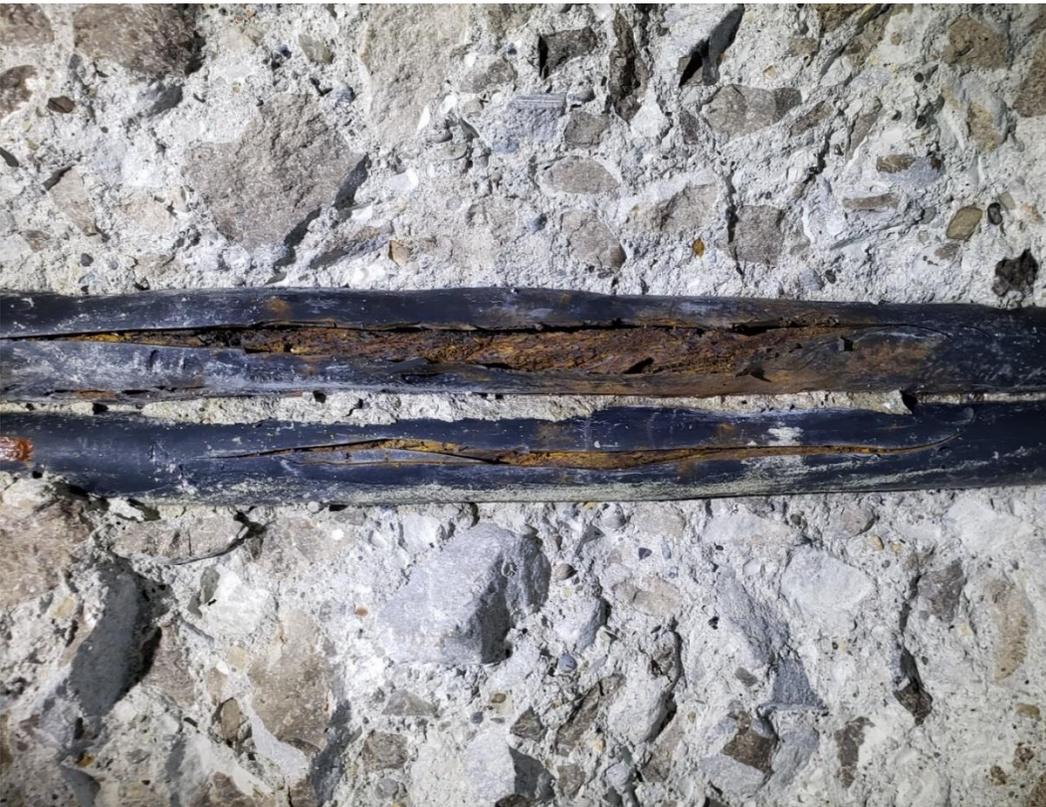
Figure 12. Exposed Tendon Location 2

- b. **Exposed Location 2:** Two tendons are exposed at an area of spalled concrete. Both tendons were holding tension. One tendon had a tear in its sheathing with congealed grease that fell from the opening when probed with a screwdriver. Both tendons exhibit corrosion and minimal grease that was congealed (Figure 12).

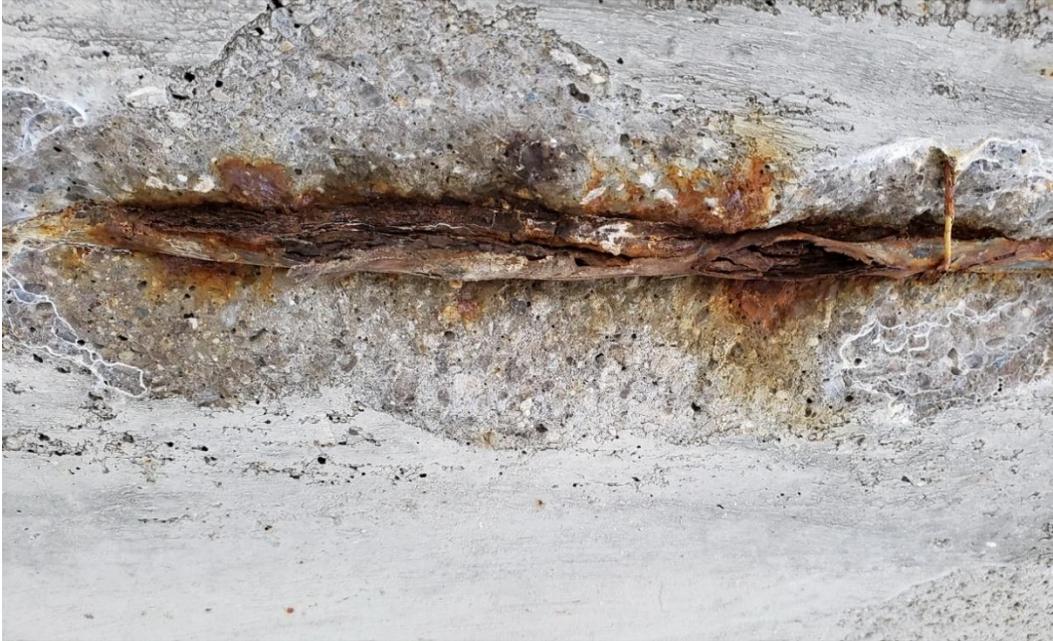
Figure 13. Exposed Tendon Location 3

- c. **Exposed Location 3:** One tendon is exposed at a location of spalled concrete within a previous repair area; a drain is near this location on the roof level above. The tendon is not holding tension (has failed). The strand wires exhibit significant corrosion with complete section loss of most wires. The sheathing is torn and deteriorated along the length of the exposed portion of the tendon, and grease is not present (Figure 13).

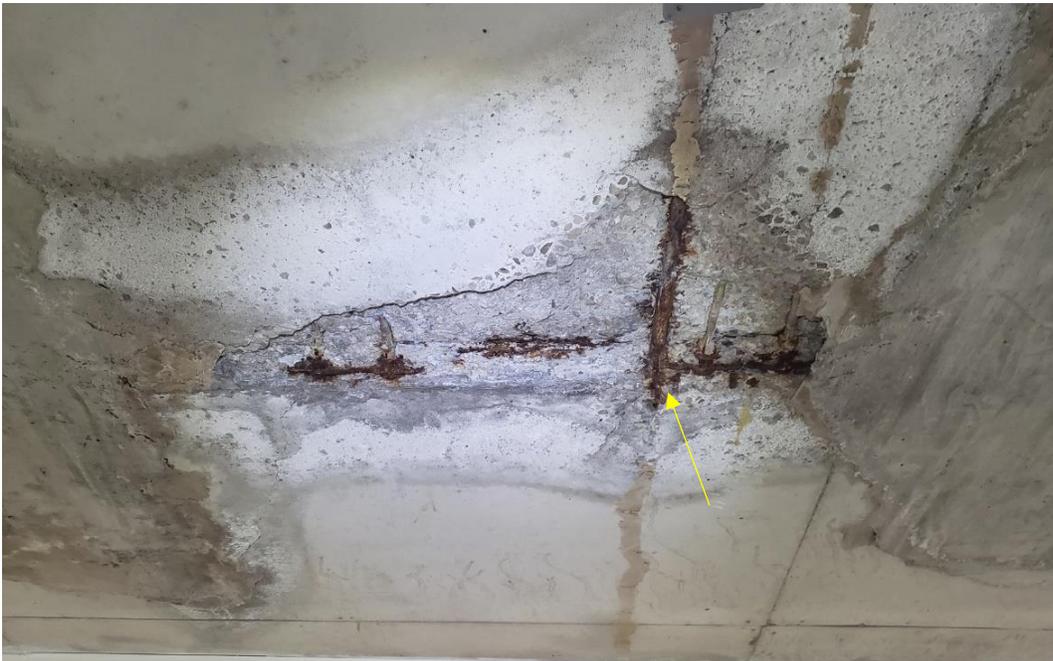
- d. **Exposed Location 4:** Four tendon intermediate anchors are exposed at a construction joint (Figure 14). All four anchors are heavily corroded, and the plastic end encapsulation is broken and/or cracked. Corrosion is visible within the encapsulated end system (Figure 15). The tendons were not tested for tension due to safety concerns related to the risk of destabilizing the anchorage.

Figure 14. Exposed Tendon Location 4. Conduit indicated by arrow.

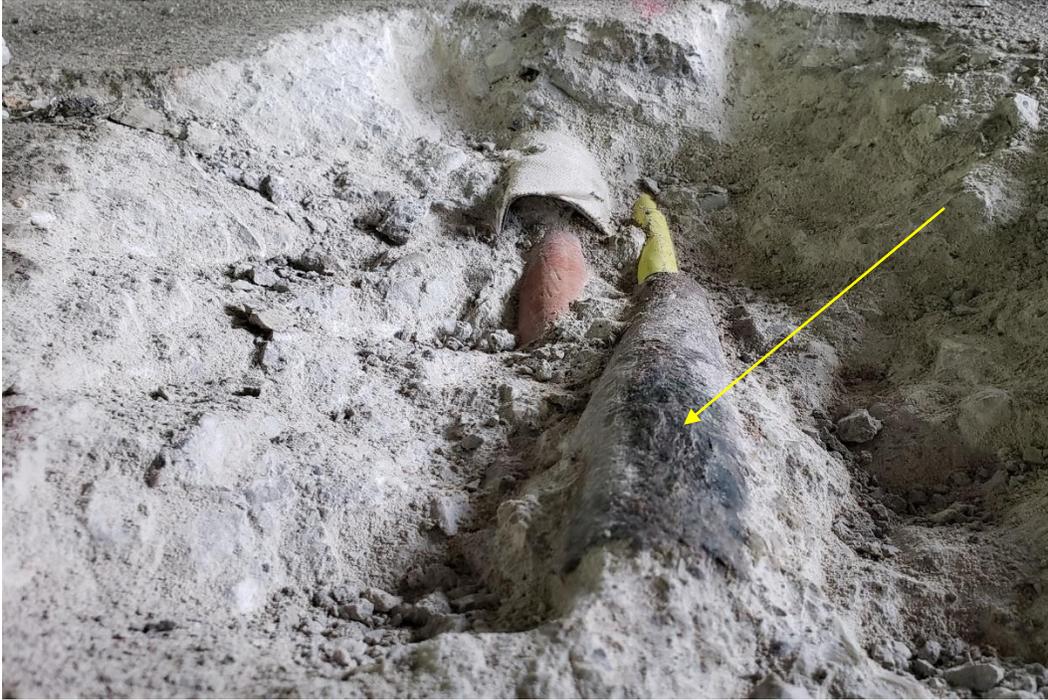
2. Six inspection openings were created throughout the elevated levels of the structure.
 - a. **Inspection Opening 1:** One tendon was exposed at a location of a delaminated previous repair on the topside of the Level 3 slab. This opening exposed a stressing coupler with low concrete cover within the concrete repair area. The tendon sheathing and stressing coupler were intact with no visible distress (Figure 17). A second tendon within the opening appeared to be threaded through a section of hose within a collar, likely HDPE, covered in fabric. This tendon also did not exhibit any signs of distress.

Figure 17. Inspection Opening 1. PT tendon coupler indicated by arrow.

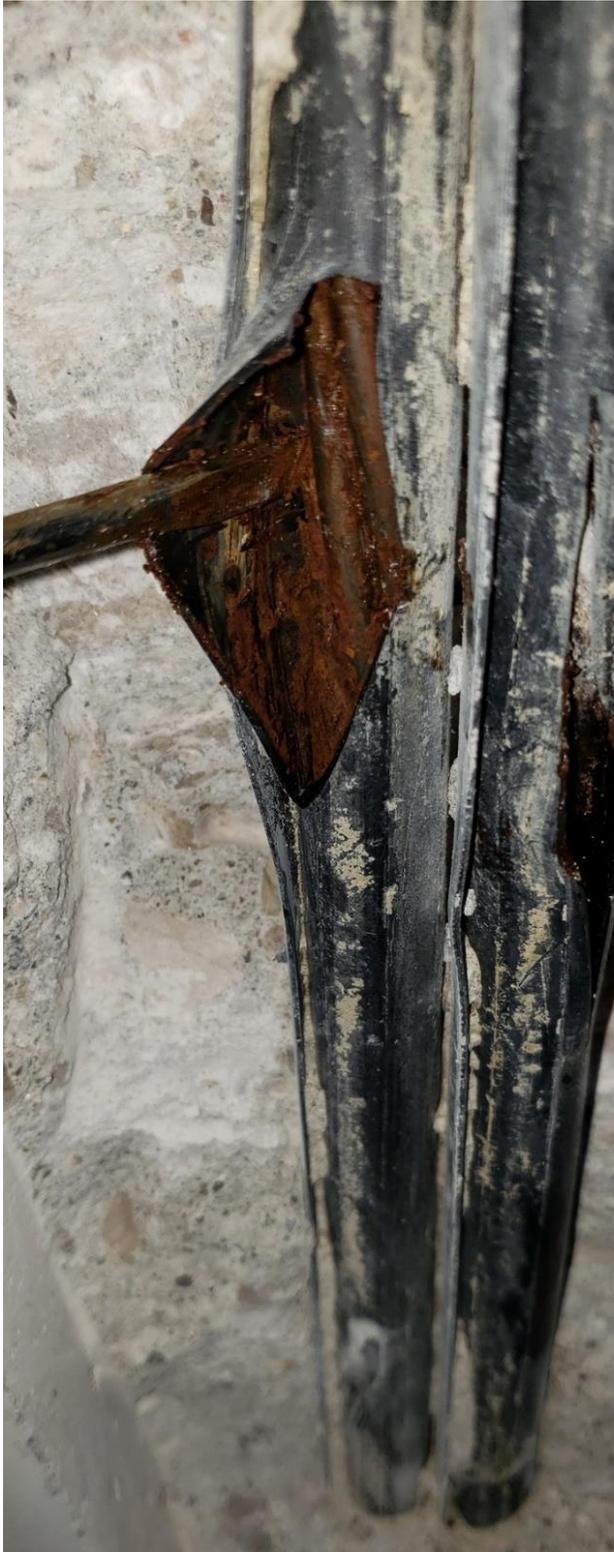
Figure 18. Inspection Opening 2

- b. **Inspection Opening 2:** This opening was created directly in line with a grease stain, and the opening exposed two tendons. Both tendons were holding tension, and the sheathing was intact. The grease on both tendons had corrosion byproduct, indicative of corrosion somewhere along the length of the tendon, and the grease at one tendon was congealed (Figure 18).

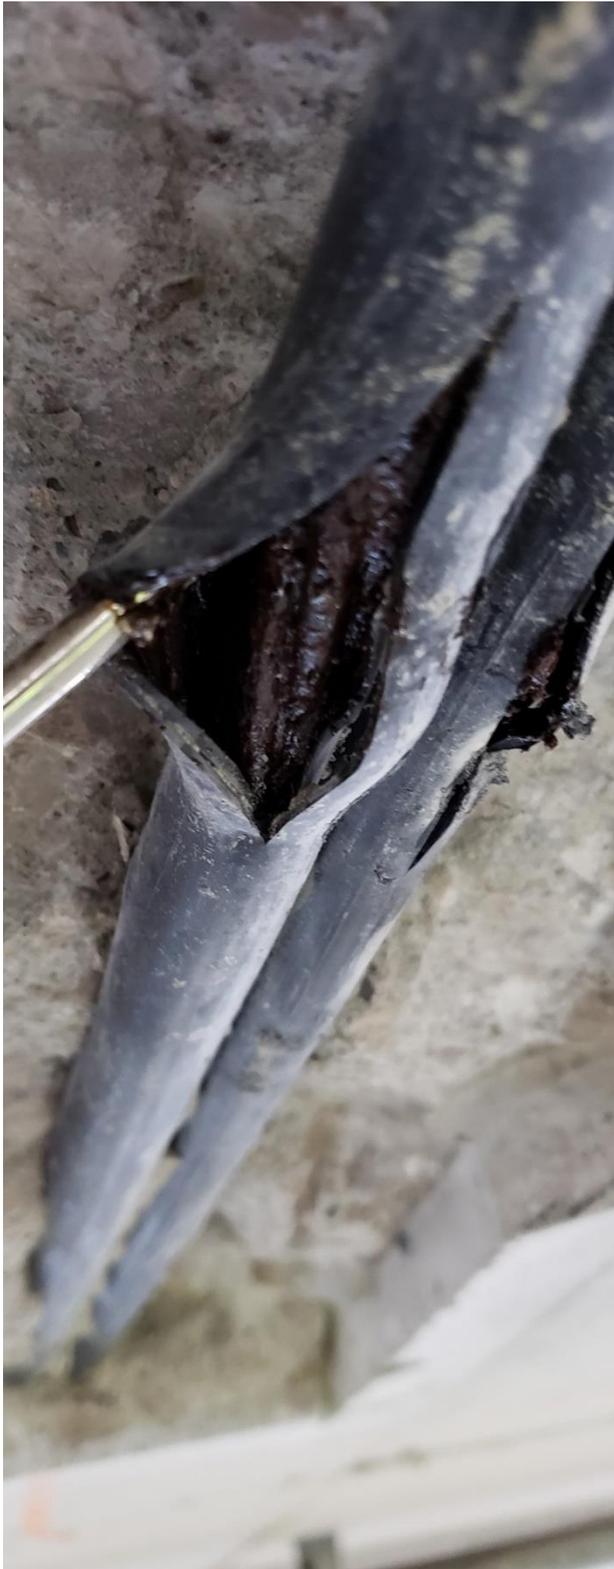
Figure 20. Inspection Opening 4

- d. **Inspection Opening 4:** This opening was created adjacent to Inspection Opening 3 for comparison, not in line with a PT repair area or grease stain, and the opening exposed 2 tendons. Both tendons were holding tension. The sheathing was intact. The grease was congealed and has corrosion byproduct, though no section loss of the tendon due to corrosion was observed (Figure 20).

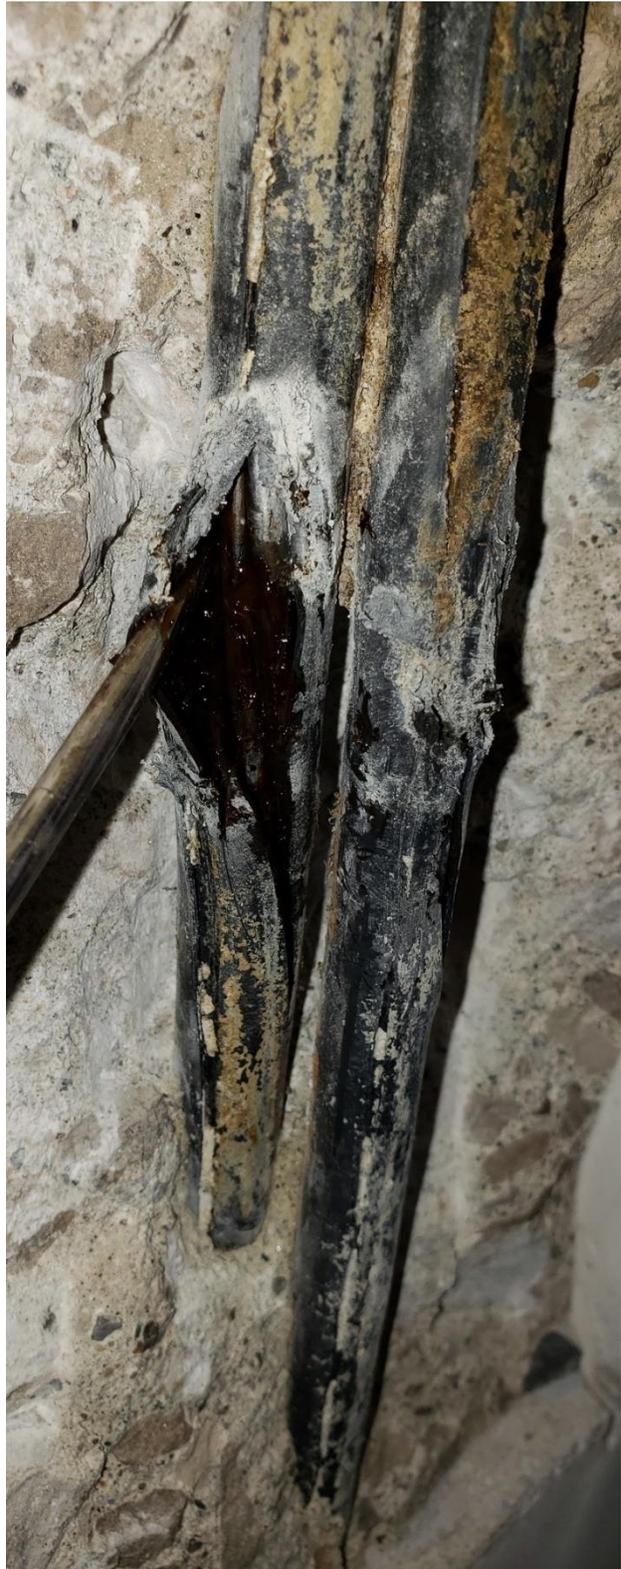
Figure 21. Inspection Opening 5

- e. **Inspection Opening 5:** This opening was created directly in line with a grease stain, and the opening exposed two tendons. Both tendons were holding tension. The sheathing was intact, with grease filling the sheathing voids, and the tendon exhibited no visible corrosion (Figure 21).

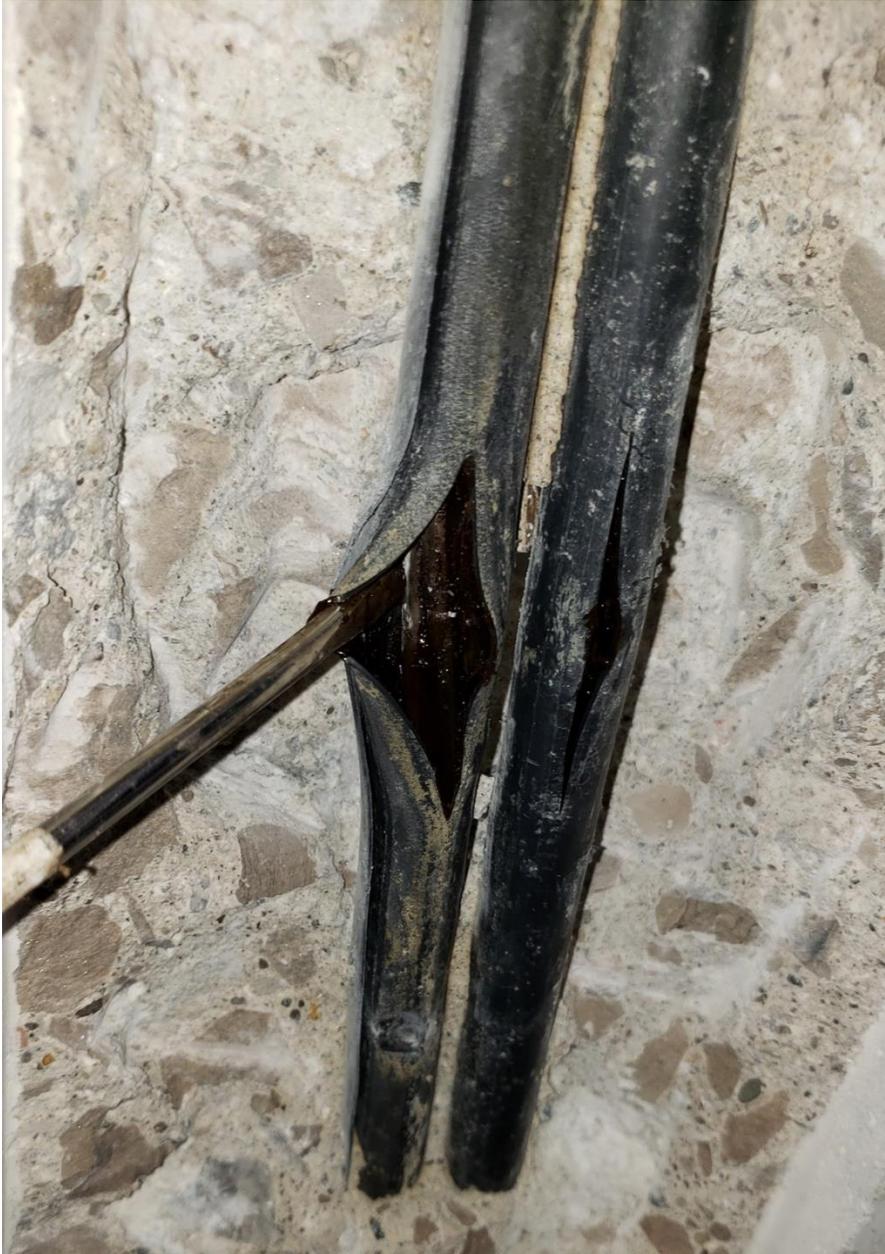
Figure 22. Inspection Opening 6

- f. **Inspection Opening 6:** This opening was created adjacent to Inspection Opening 5 for comparison, not in line with a grease stain, and exposed 2 tendons. Both tendons were holding tension. The sheathing was intact, with grease filling the sheathing voids, and the tendon exhibited no visible corrosion (Figure 22).

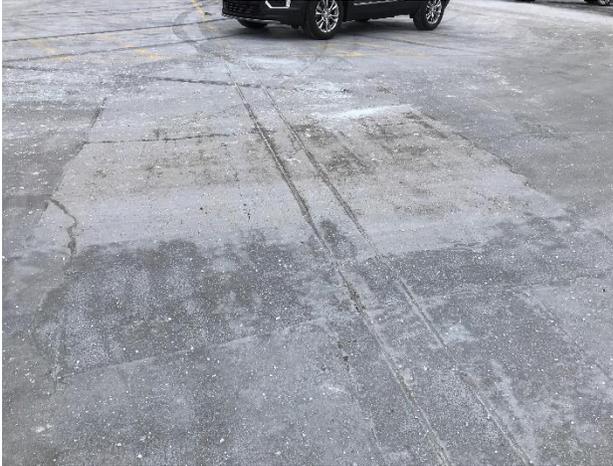
1. A few previous concrete repairs are visible at the topside of the elevated slabs and are generally located near beamlines and drains (Figure 23, Figure 24). These repair areas are typically covered by the traffic-bearing membrane.

Figure 23. Previous repair at construction joint

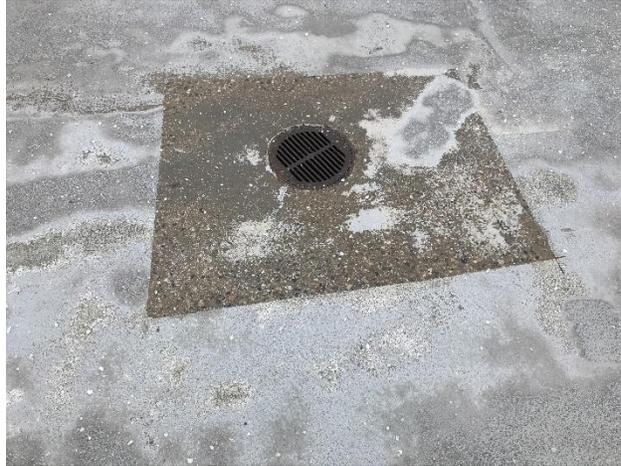
Figure 24. Previous repair at roof drain

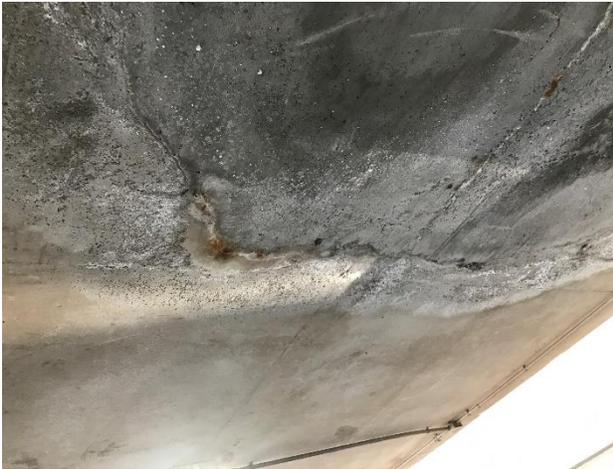
Figure 25. Previous repair exhibiting cracking, efflorescence, and corrosion staining

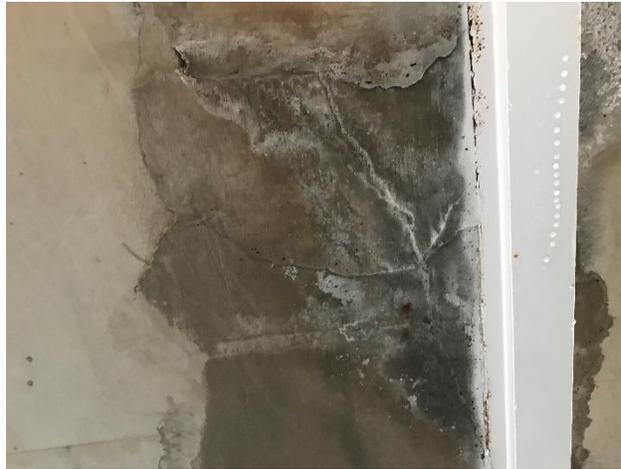
Figure 26. Previous repair exhibiting cracking and efflorescence

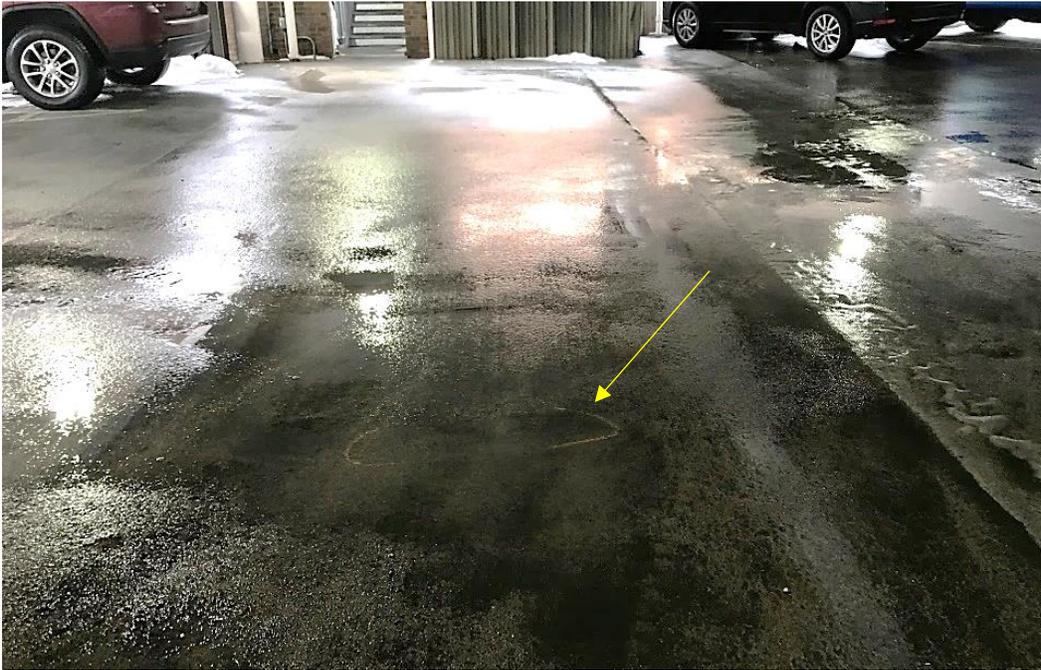
Figure 28. Delamination near drain within ponded water (indicated with arrow)

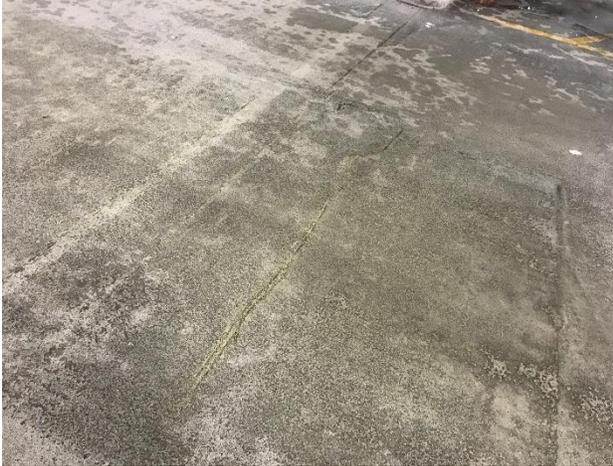
Figure 33. Previously sealed cracks

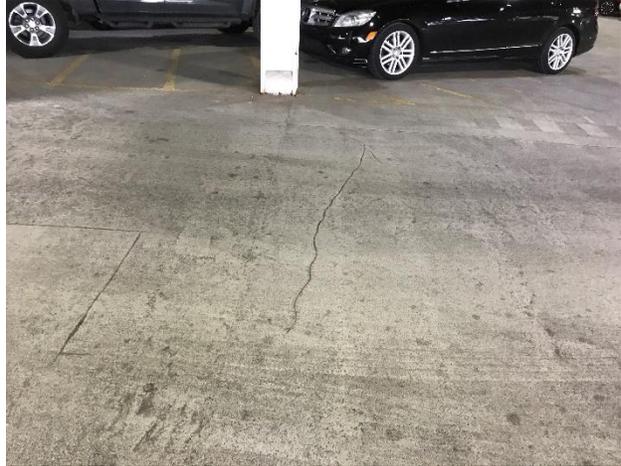
Figure 34. Previously sealed cracks

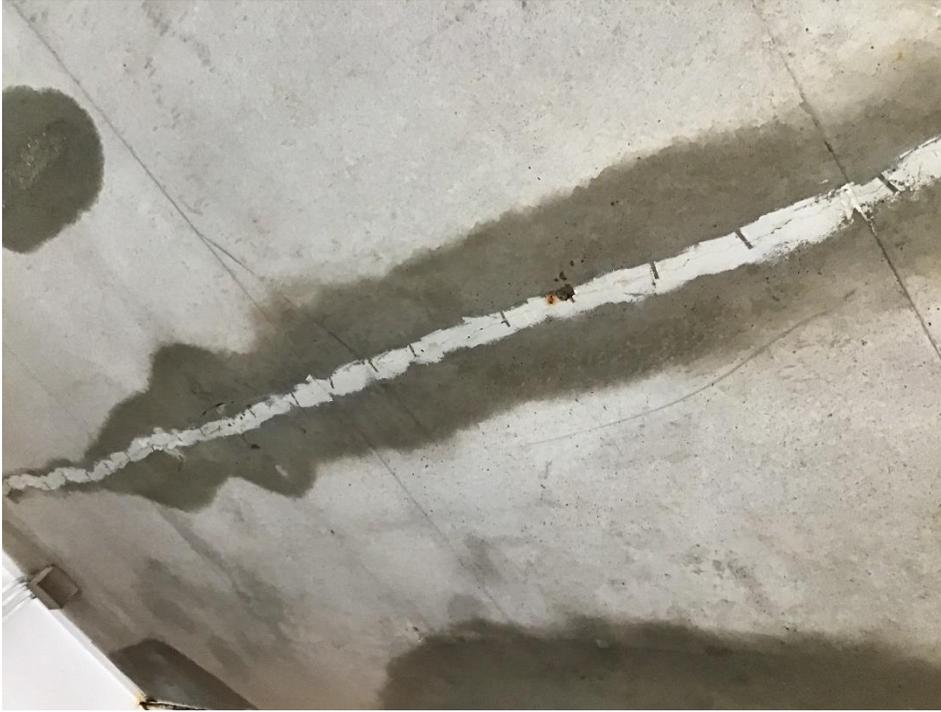
Figure 36. Moisture staining at previous repaired crack at conduit.

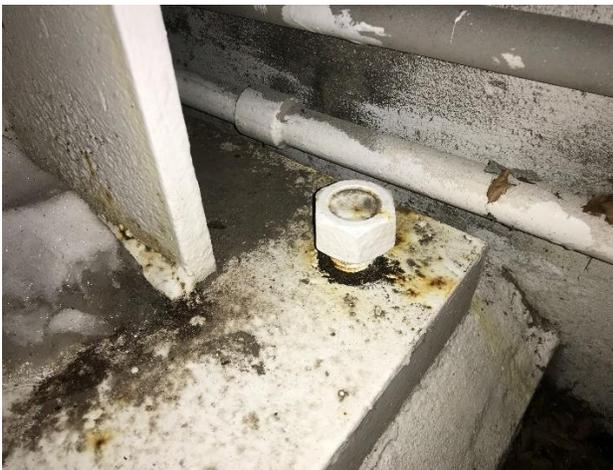
Figure 37. Loose nut at base plate

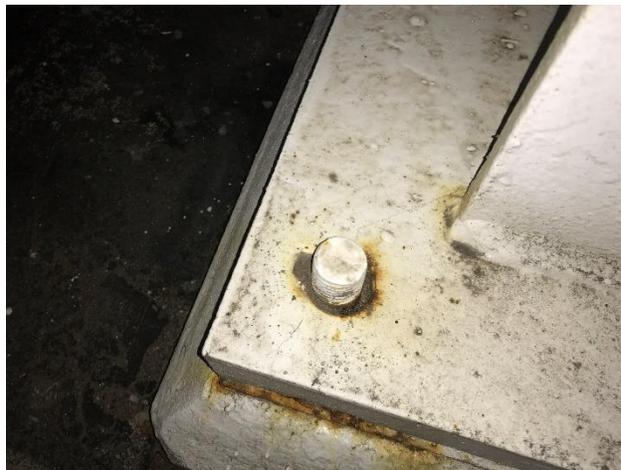
Figure 38. Missing nut at base plate

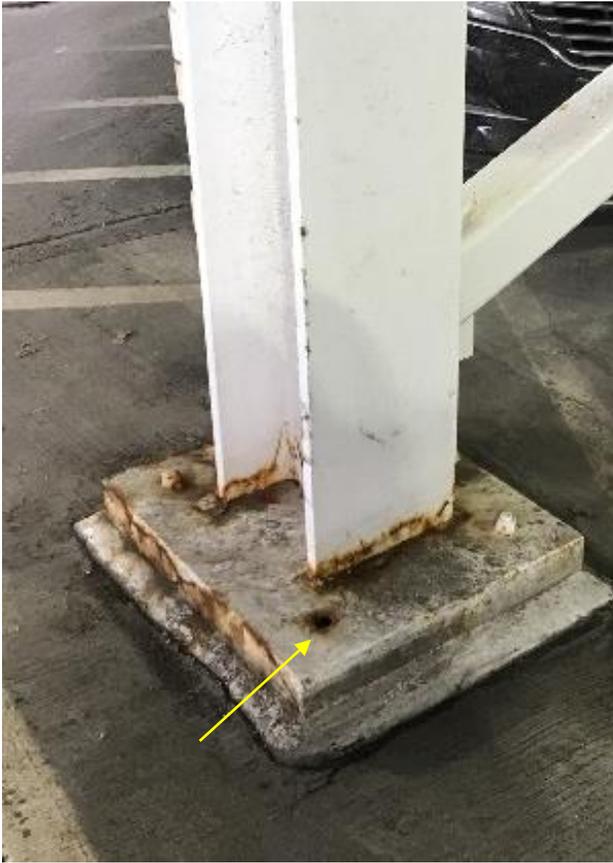
Figure 39. Missing bolt at base plate

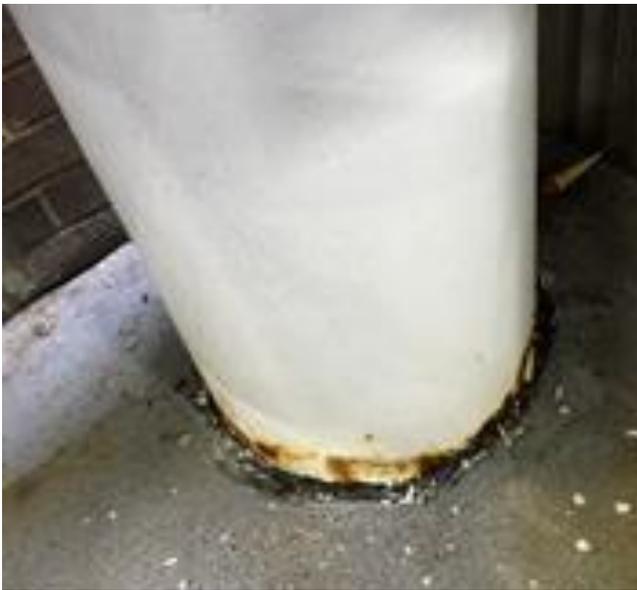
Figure 40. Corrosion at base of exterior pipe column

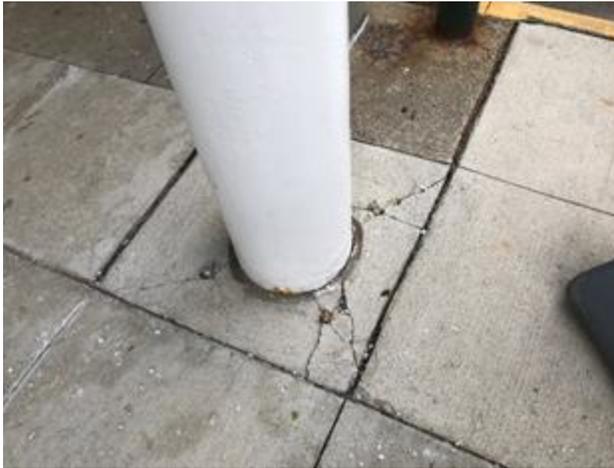
Figure 41. Concrete sidewalk distress at corroded exterior pipe column base

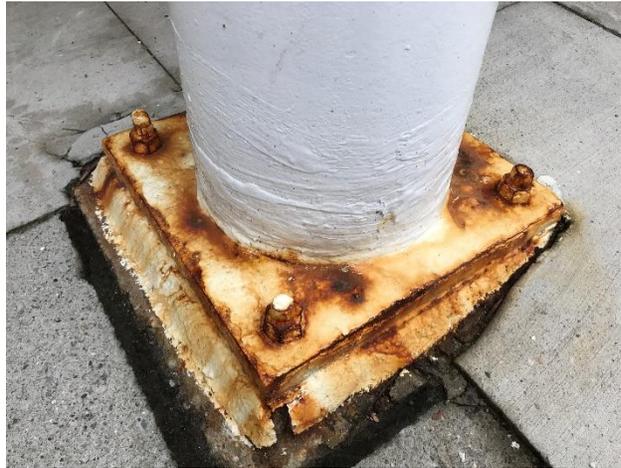
Figure 42. Corroded base plate at exterior pipe column

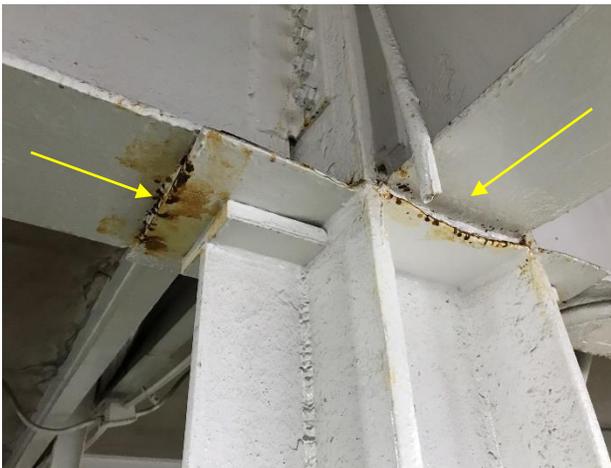
Figure 47. Corrosion byproduct buildup within moment connection

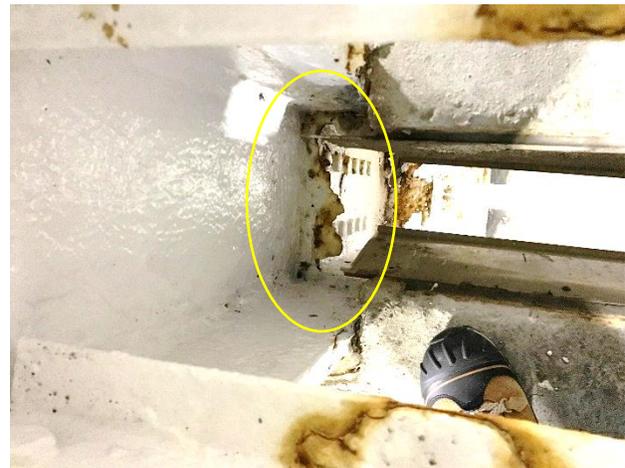
Figure 48. Nearly full section loss of top column stiffener plate

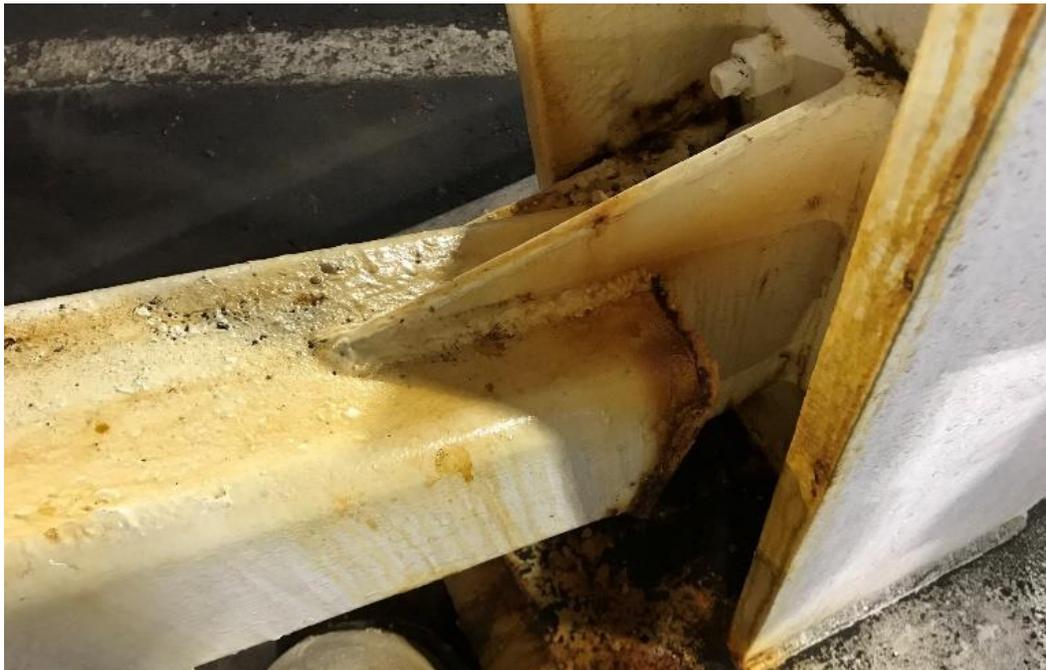
Figure 50. Corroded diagonal bracing connection

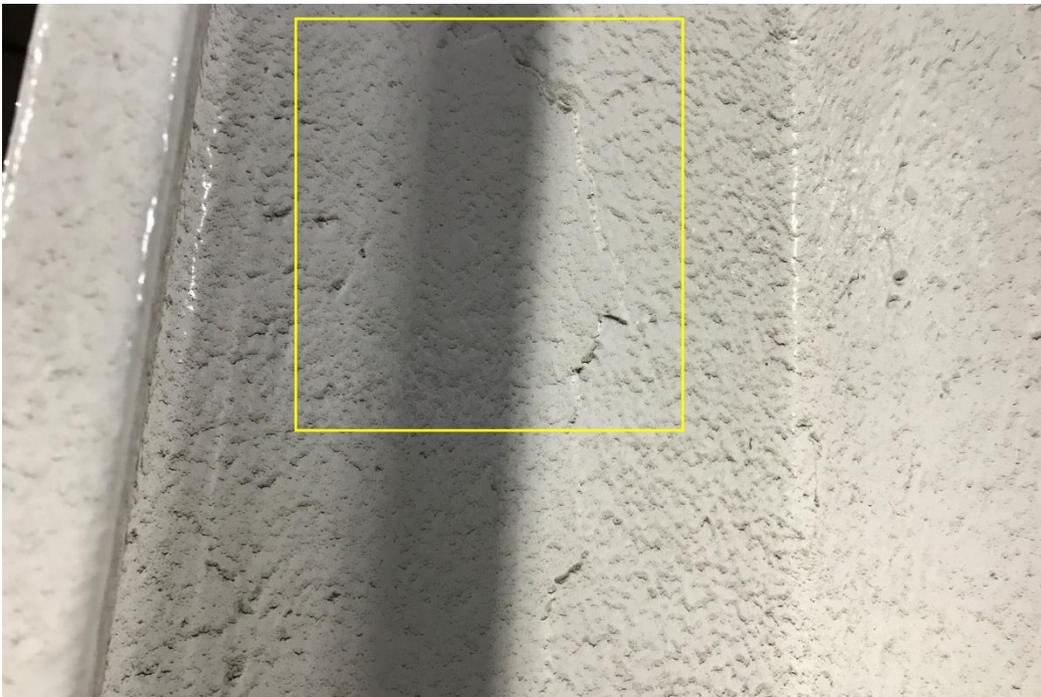
Figure 52. Uneven surface below coating at steel member

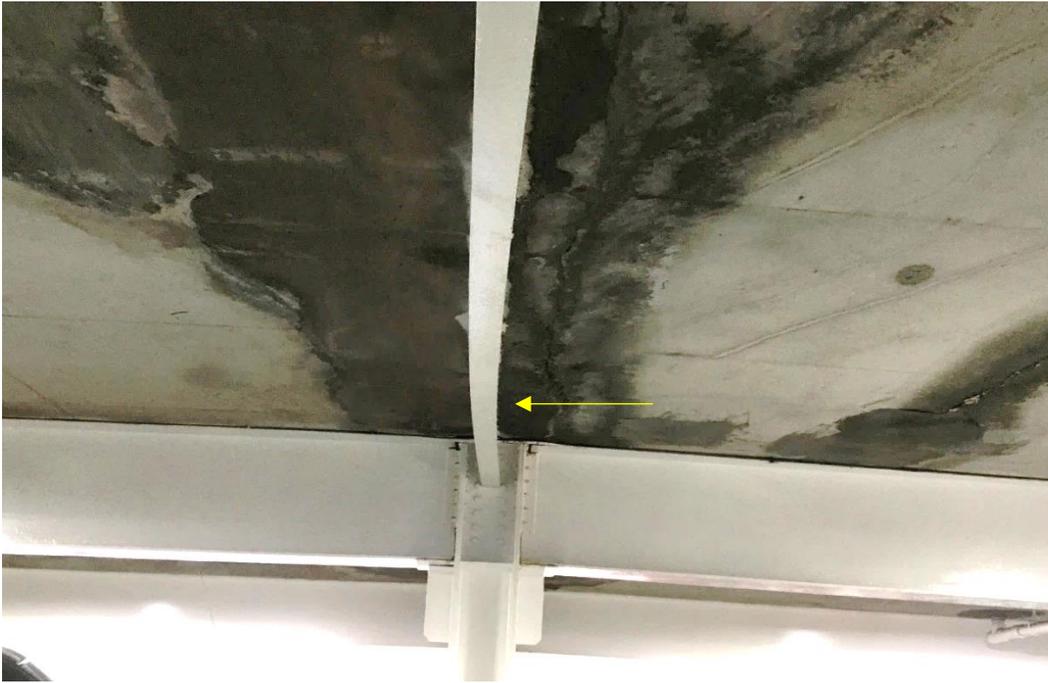
Figure 53. Laterally deformed steel beam
