VIRTUAL MEETING OF THE ADVISORY PARKING COMMITTEE
WEDNESDAY, June 2, 2021 @ 7:30am
<https://zoom.us/j/98209276859> or dial: 877 853 5247 US Toll-free,
Meeting ID: 982 0927 6859

As requested, Wiss, Janney, Elstner Associates, Inc. (WJE) has completed limited condition assessments of the North Old Woodward, Park Street, Peabody, and Chester parking structures. These assessments were performed with the intent to determine the current and future infrastructure needs in support of a capital improvement plan; the intention of the plan is to extend the useful life of the structures and to maintain the structural integrity to ensure the structure can support the code-prescribed loadings. This report summarizes our observations at the Chester Parking Structure, located at 180 Chester Street in Birmingham, Michigan, and provides recommendations for your consideration.

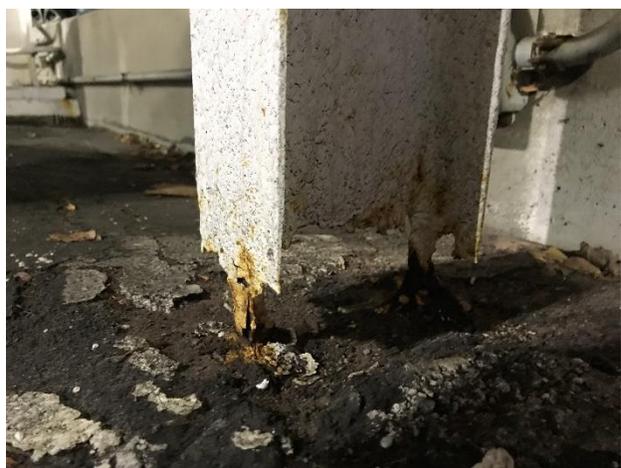
2. The intermediate posts exhibit moderate to severe and, in a few cases, nearly complete section loss at their bases at the slab on ground (Figure 54, Figure 55). One post that has section loss at its base is also deformed due to a potential vehicle impact at Level 1 (Figure 56).

Figure 54. Severe section loss at intermediate post

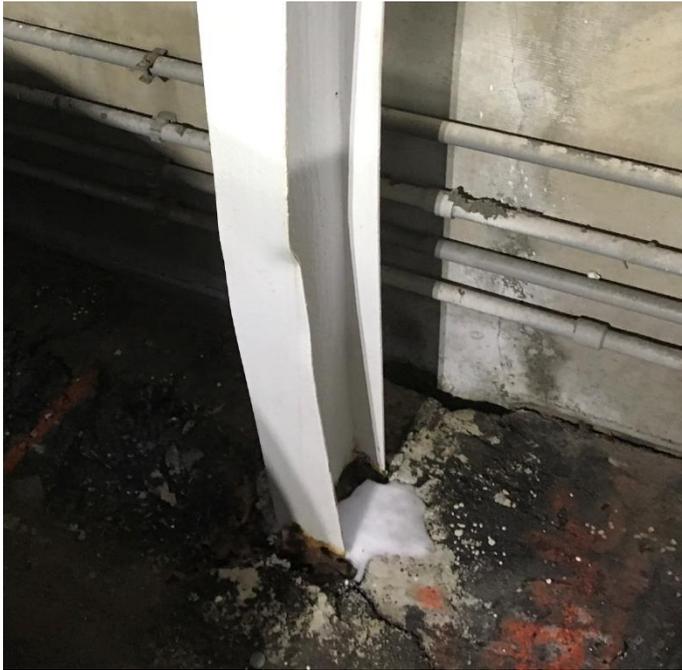
Figure 55. Severe section loss at intermediate post

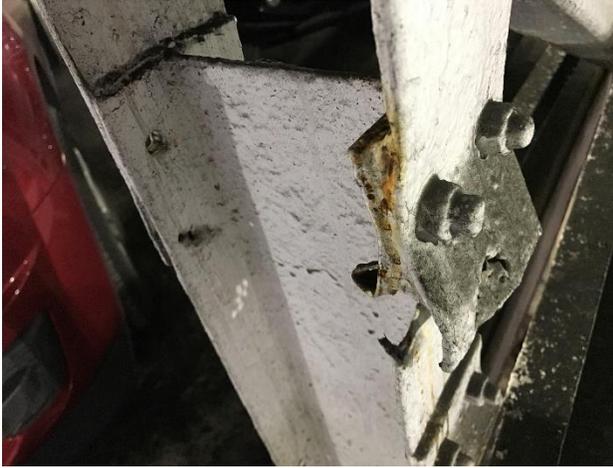
3. Where diagonal bracing passes through the intermediate posts, the posts have been spliced with welded plate connections. These plates are typically deformed and the intermediate posts above and below the splice are not in line with one another (Figure 57, Figure 58). The flange plates are corroded in some cases or are missing bolts (Figure 59, Figure 60).

Figure 58. Deformed intermediate post splice

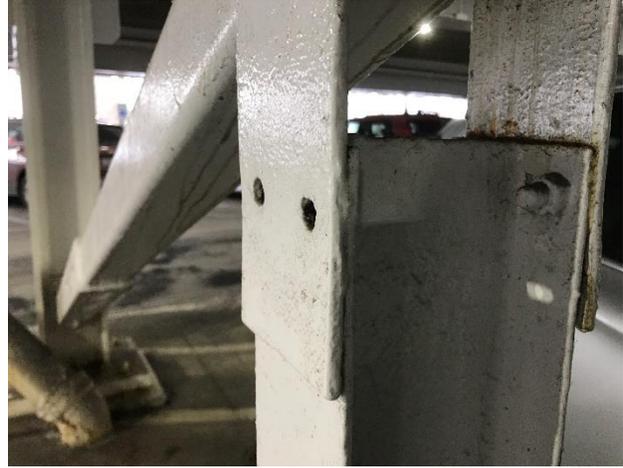
Figure 59. Corroded flange plate at intermediate post splice

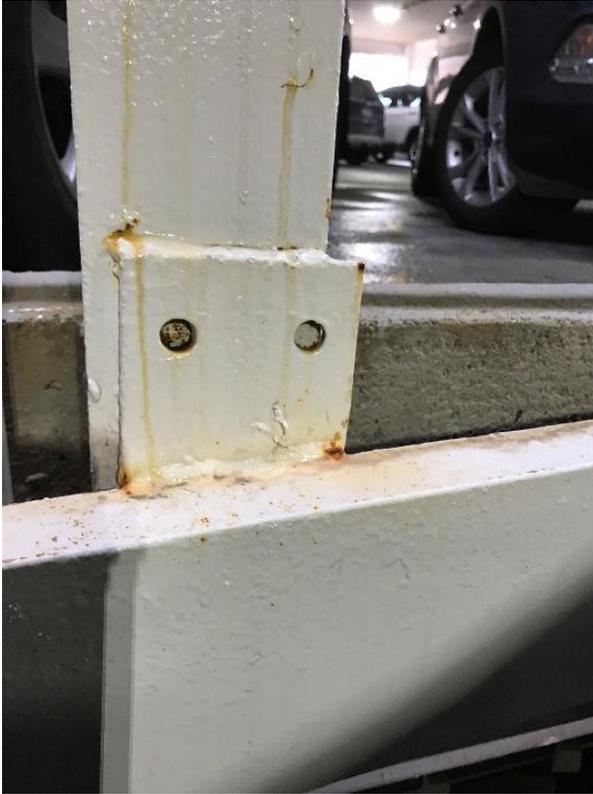
4. The guardrail channels are supported by bolted connections to steel plates, which are welded to the intermediate post flanges. These connections are typically corroded with significant buildup, up to 3/4" thick, of corrosion byproduct between the plate and the post flange (Figure 61). In a few cases, particularly at the upper levels, this buildup has deformed the channel laterally (Figure 62). A few of these connections are missing bolts (Figure 63).

Figure 62. Lateral deformation of channels

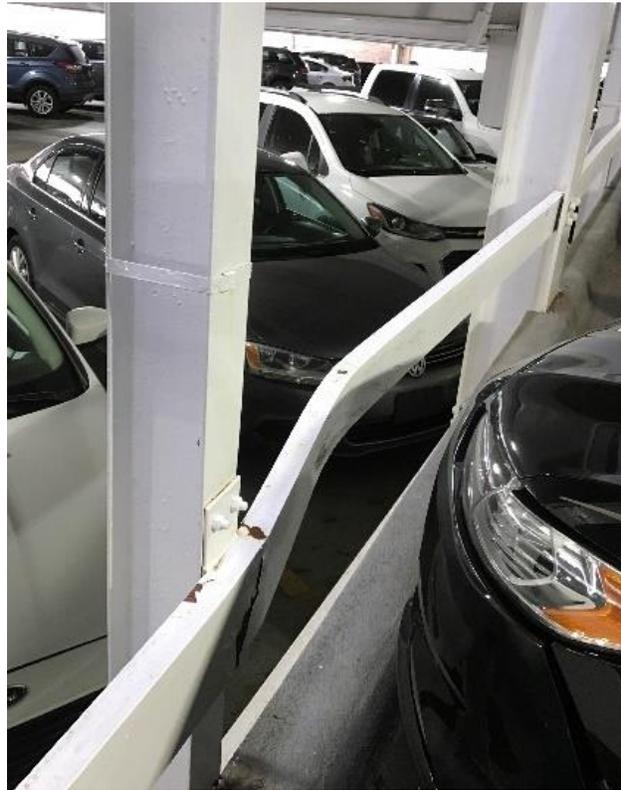
Figure 63. Missing bolts at channel to post connection, but welds present

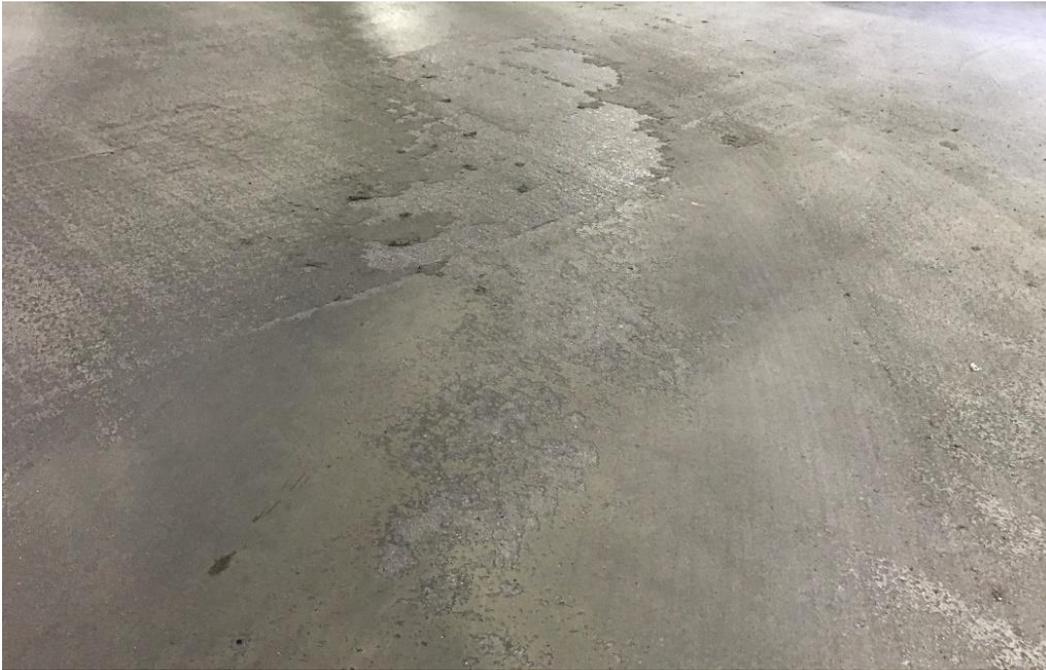
1. The traffic-bearing membrane is in poor condition throughout the roof level, with missing or failed areas concentrated near the drains or previous repairs (Figure 65).

Figure 65. Traffic-bearing membrane failure at previous concrete repair

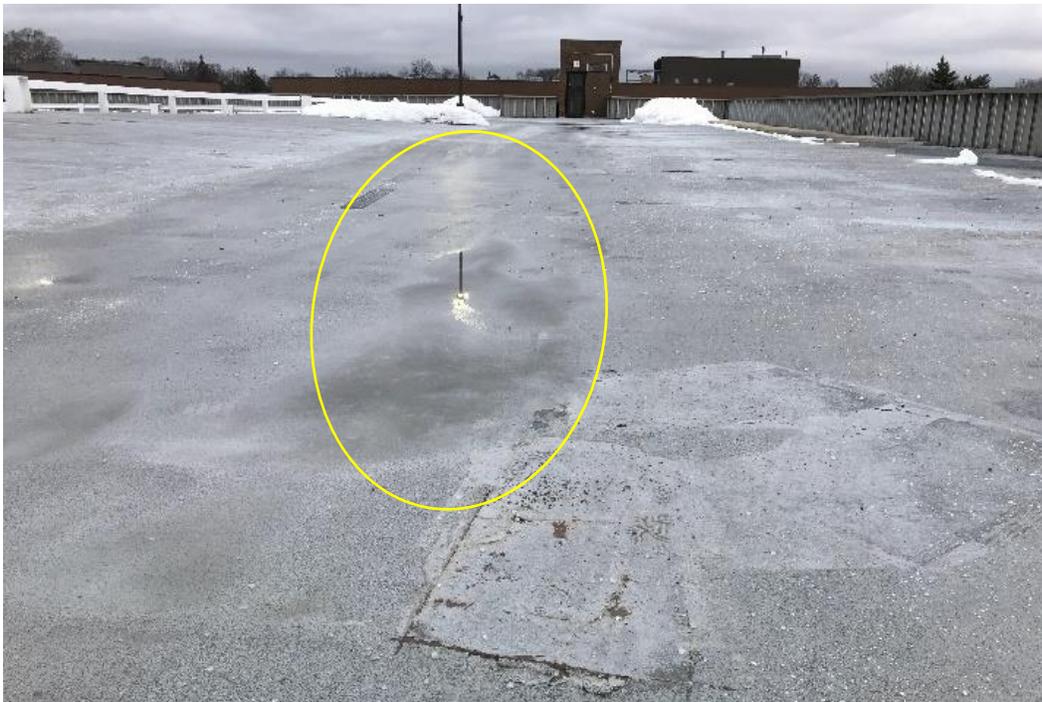
6. A roof drain outlet for the stair tower discharges directly above a failed expansion joint seal at the northwest stairwell of Level 5, which allows water infiltration to the level below (Figure 70).

Figure 70. Roof drain outlet above expansion joint

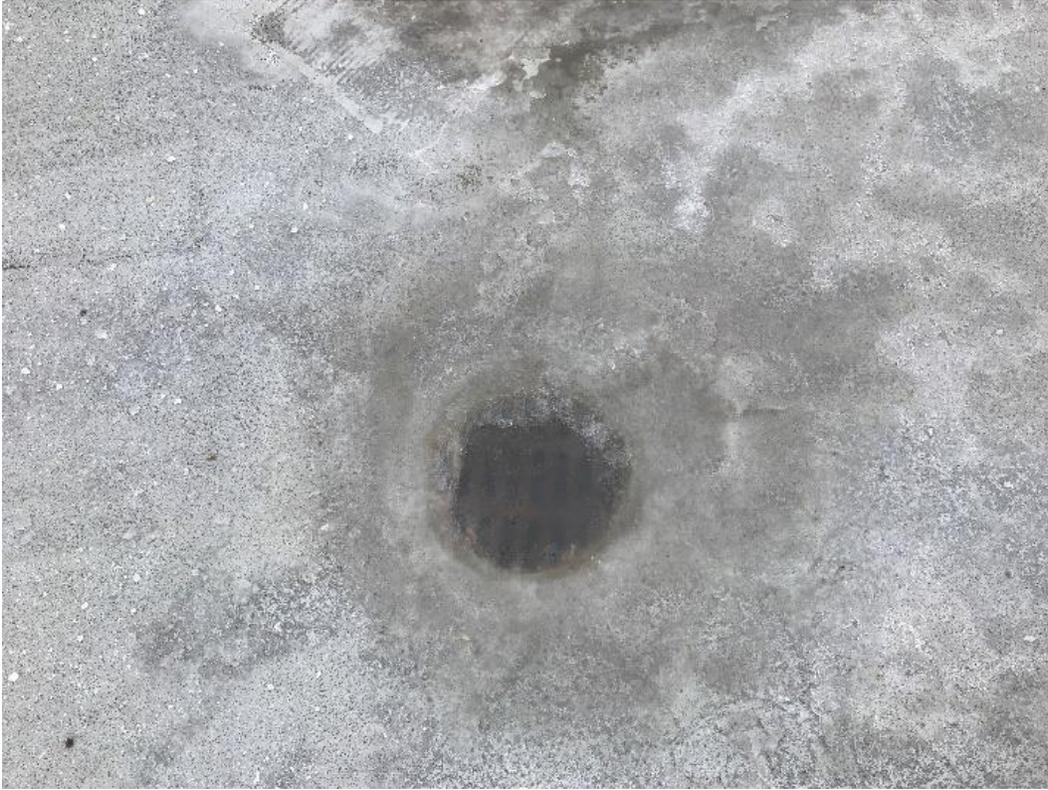
7. Minor areas of ponded water, typically under 10 square feet, were observed, primarily near the drains and at the unsloped north and south bays of the structure (Figure 71).

Figure 71. Standing water at unsloped bay of roof level

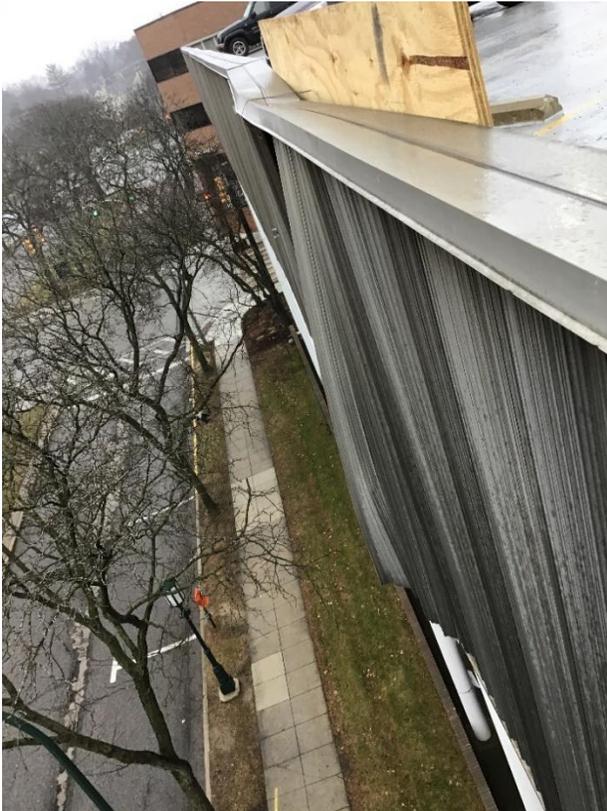
1. The majority of the facade panels are tilted inward throughout the parking garage at all elevations (Figure 73).
2. Approximately 50 to 75 percent of the welds between the steel tie-backs to the bottom flanges of the edge beams at the base of the corrugated metal panels are failed. A few of the tie-backs have screw anchors, perhaps from a previous repair effort, which have also failed. Gaps are present between the failed tie-backs and the bottom flanges (Figure 73, Figure 74). The tie-backs are generally in better condition at the west facade than at the remaining facades, but still exhibit widespread failure.

Figure 74. Failed welds and gaps at tie-backs

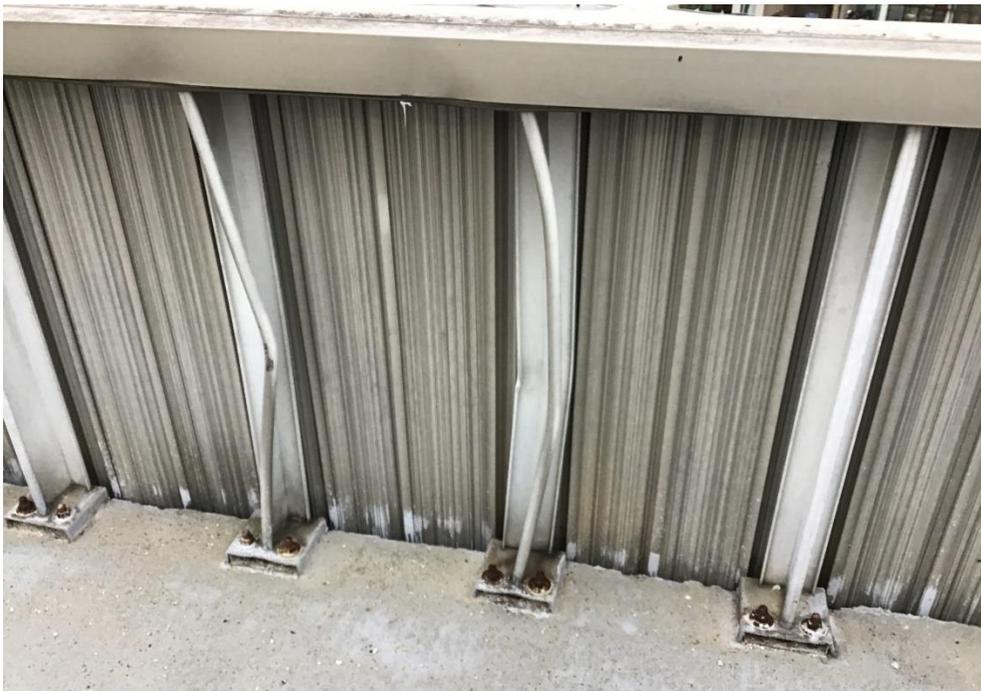
3. There are several instances of minor vehicle impact damage to the facade panels and posts throughout each level (Figure 75, Figure 76). The nearby slab where the panels are anchored typically does not exhibit distress related to the impact.

Figure 75. Vehicle impact at facade panel

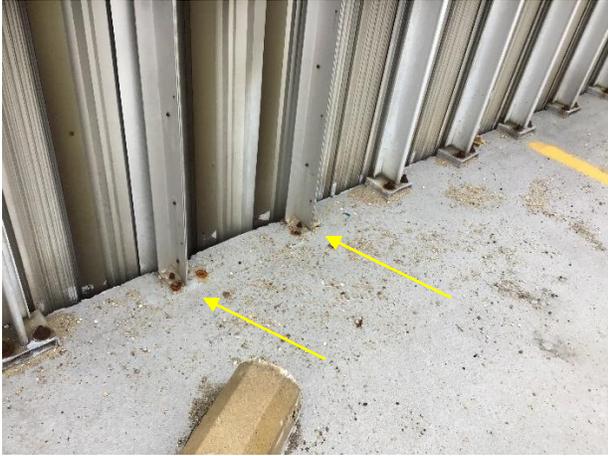
Figure 76. Vehicle impact at facade panel posts

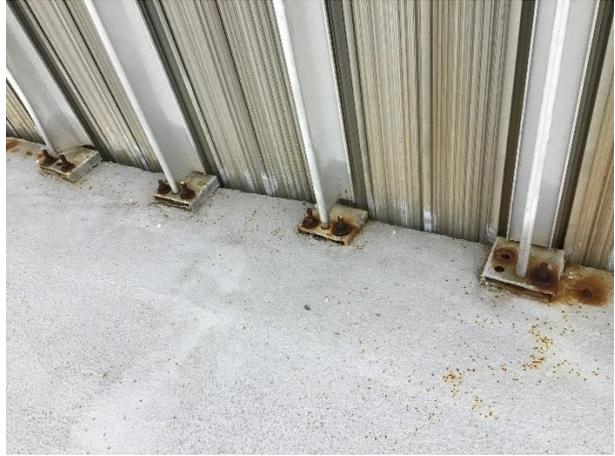
4. Some posts had a different profile and base connection type than the typical condition. At these locations, base plates and anchors were not present or exposed (Figure 77). Most of the facade panel anchors bolts were corroded. (Figure 78).

Figure 77. Missing base plates and anchors

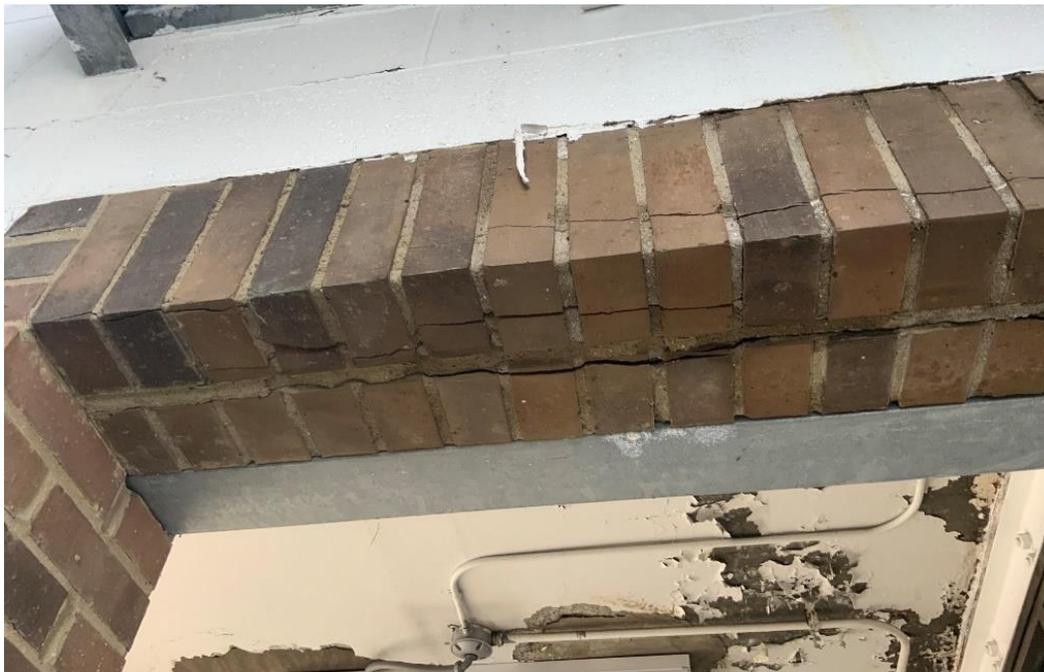
1. Cracks in the concrete masonry typically exist at locations where the supports for the stairs embedded into the masonry walls (Figure 80). Moisture-related distress, including corrosion of steel stair components and failed CMU coating is typically visible at these locations.
2. A few of the brick headers over entries to the stair towers are cracked along their length (Figure 81).
3. Isolated areas of the slab-on-ground are cracked. Some areas have been previously sealed and are in serviceable condition.

Figure 80. Cracks in CMU stair tower walls near corroded steel

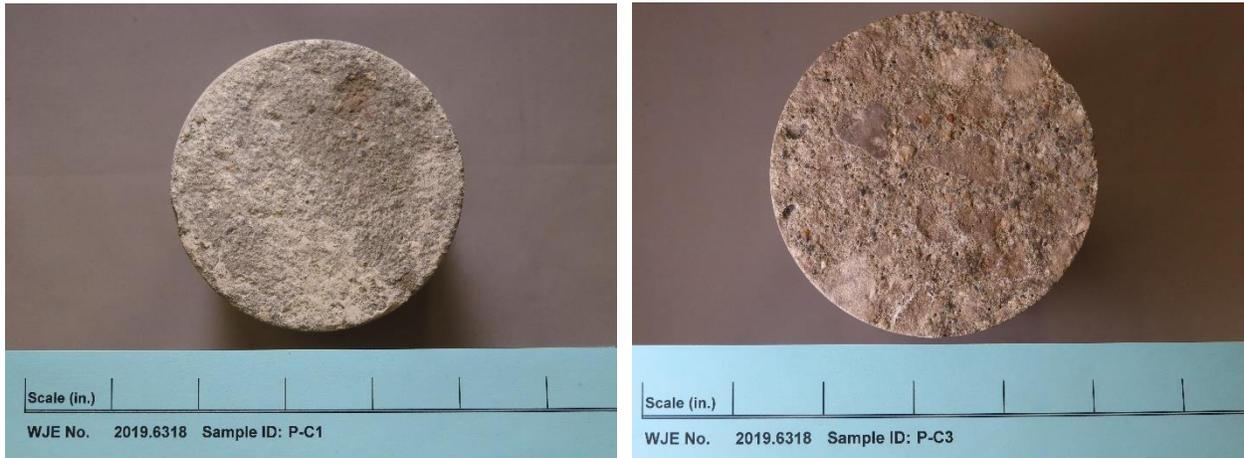
Figure 8. The eroded top surfaces of Core 1 (left) and Core 3 (right).

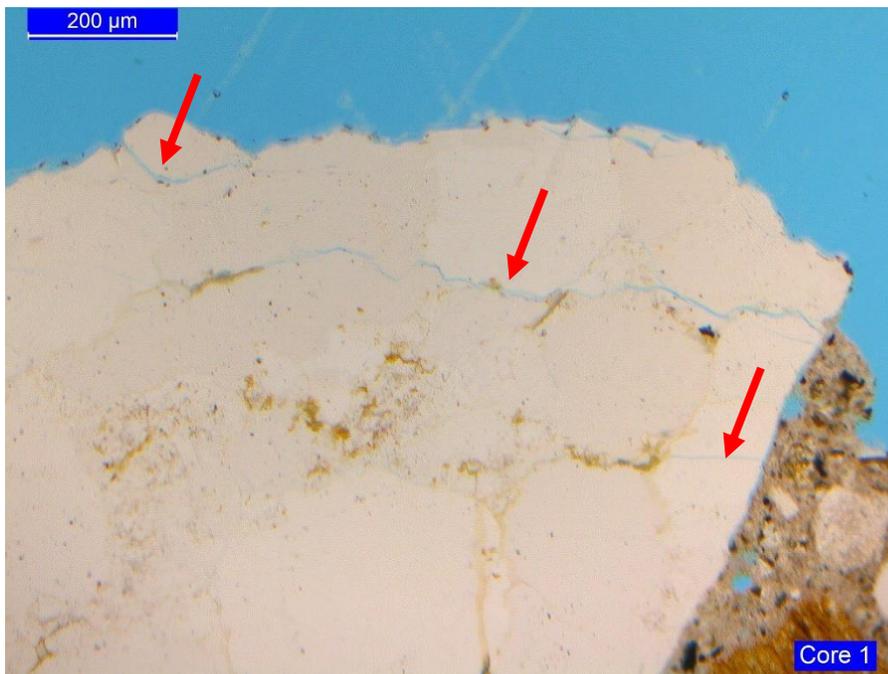
Figure 9. Cracks (arrows) within a protruding aggregate along the top of Core 1.
